Service Bulletin

PRELIMINARY INFORMATION

Subject: Oval Cutout Or Void In Carpet Visible On Passenger Side Of Center Console

Models: 2013 Cadillac ATS built prior to 12/21/12

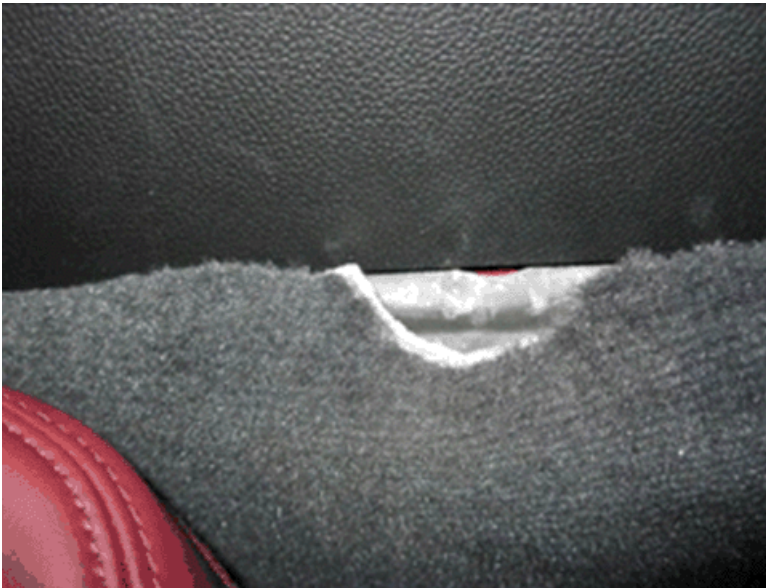
Some customers may comment that there is an oval cutout or void in the carpet on the passenger side of the center console.

The carpet is cut correctly and does not need to be replaced. Instead, the carpet fit must be finessed. Remove the console to allow the carpet to rise to proper position. Then reinstall console.

If the carpet does not come up enough for the notch to be covered, the seat may need to be removed to allow the carpet some slack. (Be sure to refer to PIC5807 before removing the seat bolts.)

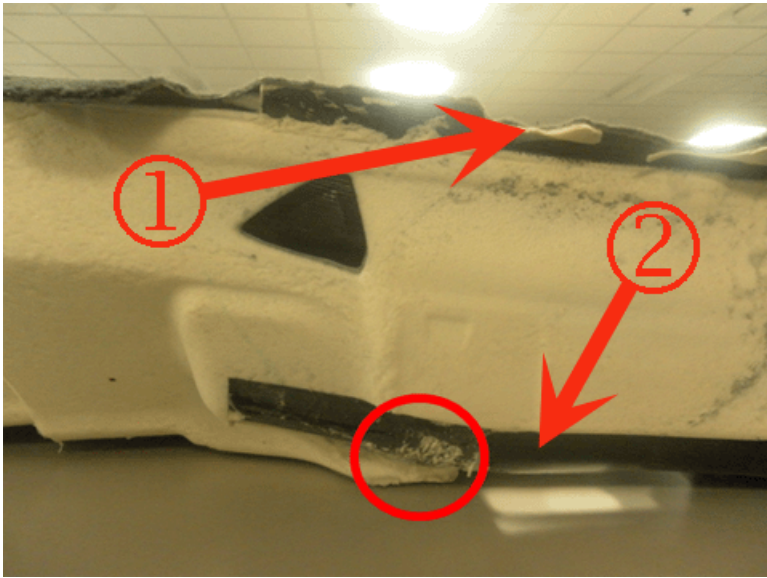
1. Area of defect.
2. Same hole both pictures. Temporary rework removing foam to improve ease of seat track cover install. With no foam, carpet is allowed to be pushed down pulling notch with it.

If the carpet does not stay up under the console, foam may need to be added under the carpet on the floor near the console. Refer to picture below.

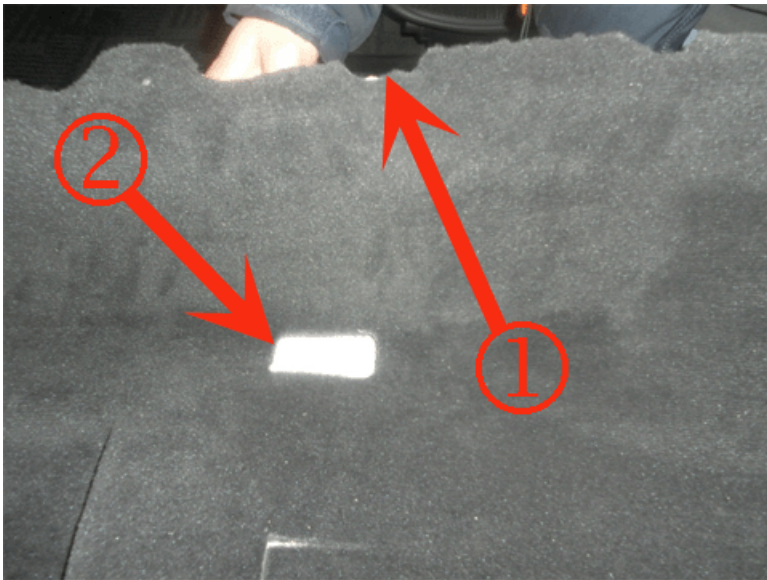
1. Area of defect.
2. Same hole both pictures.
