Service Bulletin

PRELIMINARY INFORMATION

Subject: Various Electrical Concerns And / Or Blown Fuse

Models: 2013 Buick Enclave
2013 Chevrolet Traverse
2013 GMC Acadia

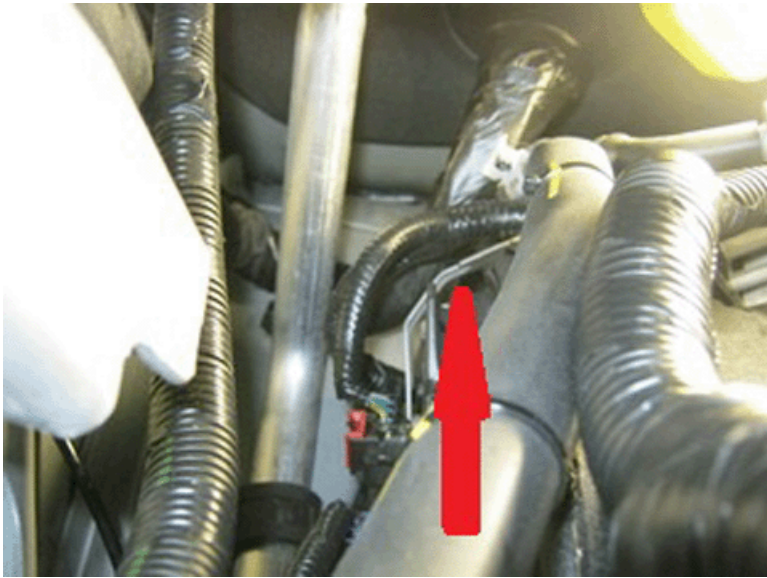
This condition may be caused by the engine wiring harness damaged at the right rear side of the engine compartment. The harness may have chafing or damage to the wires at the power steering bracket or line.

If the SI diagnostics do not isolate a cause for this concern, inspect the wiring harness for a potential short to ground, at the right rear side of the engine compartment about 6 inches from the pass-through where the harness may contact the steering line or the steering line bracket:

Repair any chaffed or damaged wires by following SI repair procedures.

Further, re-route the engine harness by following the procedure below:
