# Service Bulletin

## PRELIMINARY INFORMATION

**Subject:** Water On Floor And/Or Carpet

**Models:** 2013 Chevrolet Malibu

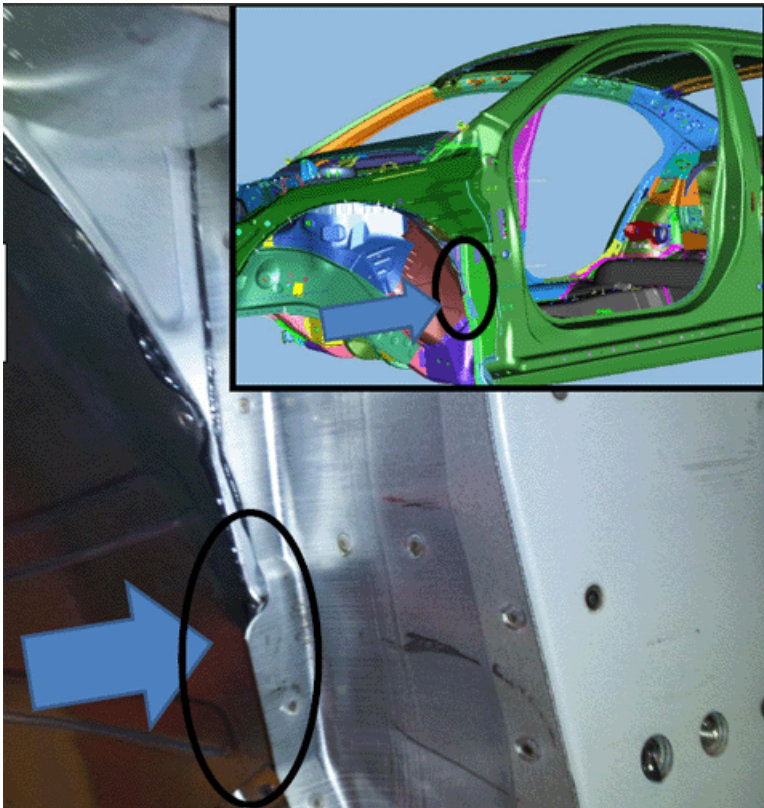
Front wheel house flange may have a void in the sealer.

Seal the void using a thumb grade sealer (also referenced as a "heavy-bodied caulking material" in SI) pushed into the void from the wheel opening. For location of flange see the graphics below.
