# Service Bulletin

**Subject:** Service Stability Traction ABS Rear Wheel Speed DTC Or Chassis Expansion Bus Communication Fault

**Models:** 2010 - 2012 Chevrolet Equinox

2010 - 2012 GMC Terrain

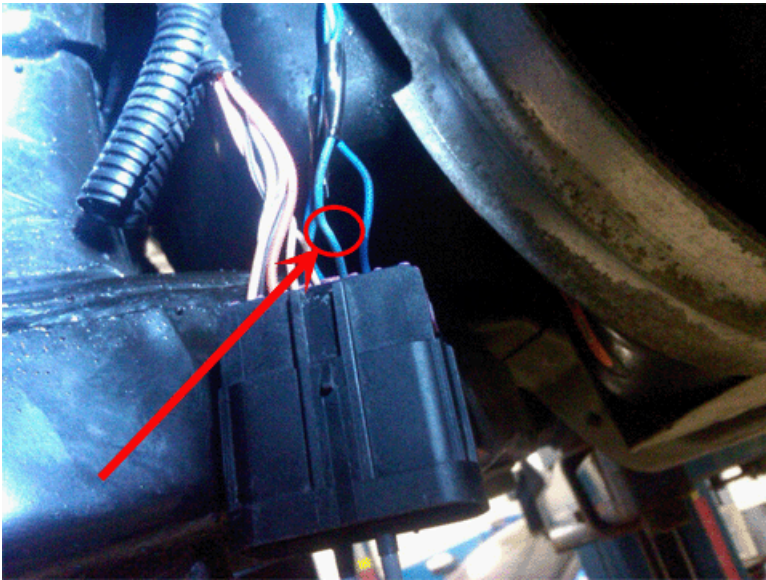
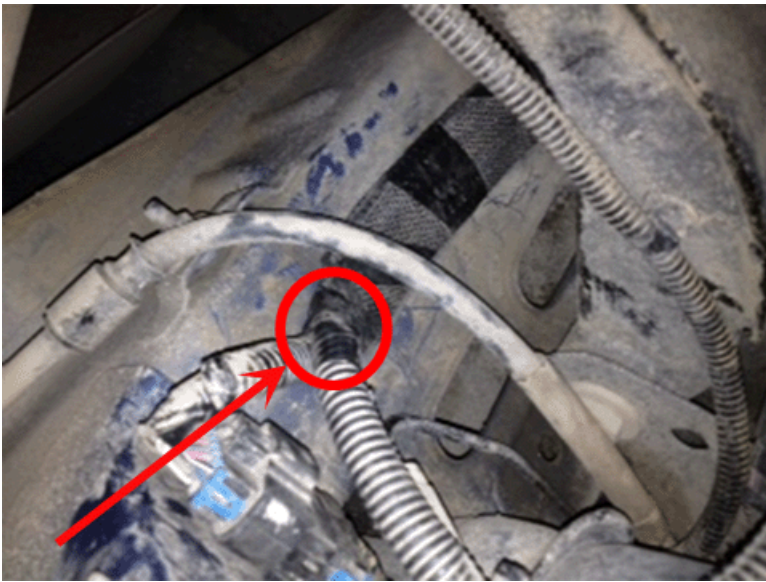
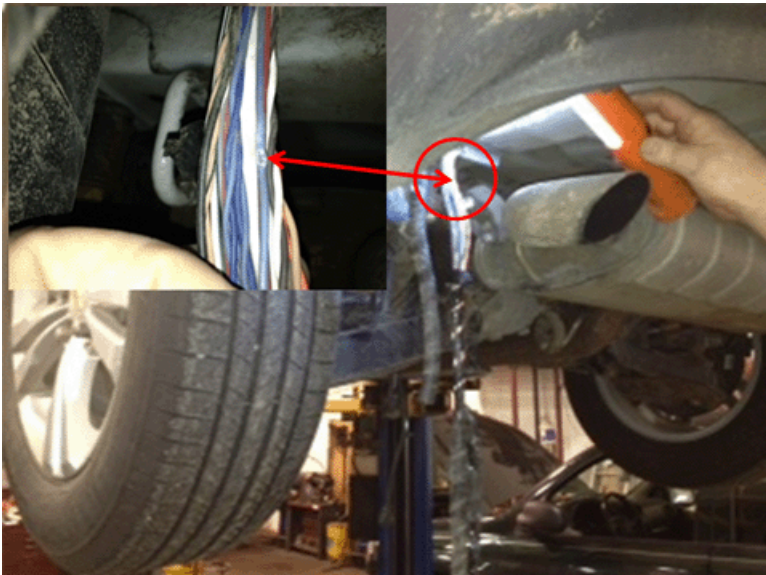
Several conditions and symptoms have been found to be related to a wire harness at the left rear under vehicle. Inspect the wire harness insulation within 1 inch of the X411 before and after connector. It may be necessary to remove the tape and conduit from the wire harness for inspection upstream from the X411 connector. Some Issues have been found with circuits 6105 and 6106 for chassis bus wires and serial enable circuit 5986 and 120 ohm opens in 2500 and 2501 or 6106 and 6106. Other circuits 884, 885, 882, and 883 when related to rear wheel speed sensor codes C0045 or C0050. During inspection you may notice a discoloration in insulation in one spot of the wire. If you pull the wire near that area the insulation will break exposing the broken wire. Repair the circuit to complete the procedure.

**Note:** Wire broken within the insulation has also been found high up in the harness X411. Reference the following photos:
