# Service Bulletin

**Subject:** BAS+ (HYBRID) eAssist Drive Motor Generator Belt Broken Noisy Worn Or Misaligned

**Models:** 2012 - 2013 Buick LaCrosse and Regal eAssist  
2013 Chevrolet Malibu Eco eAssist  
All with RPO HP6

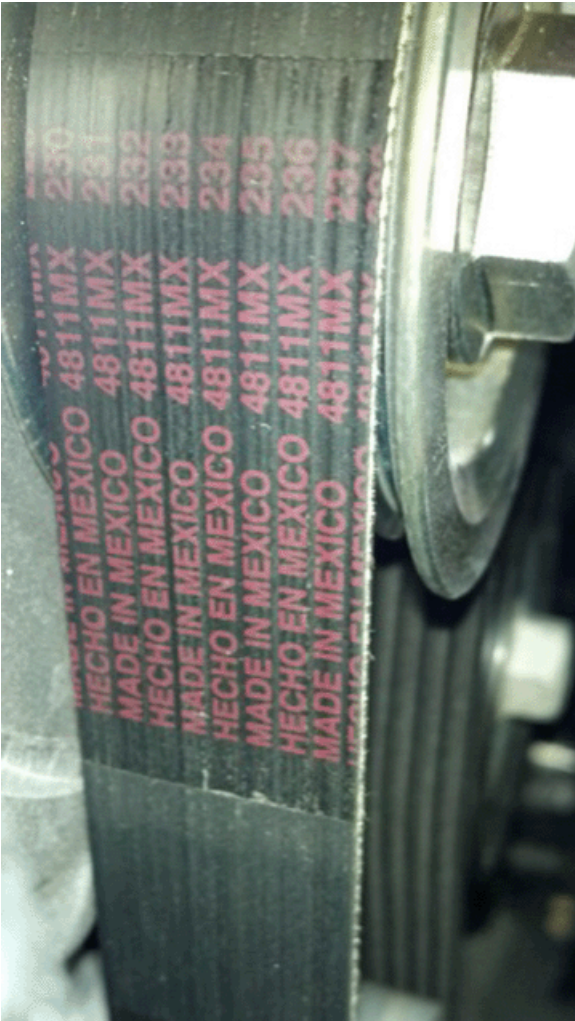
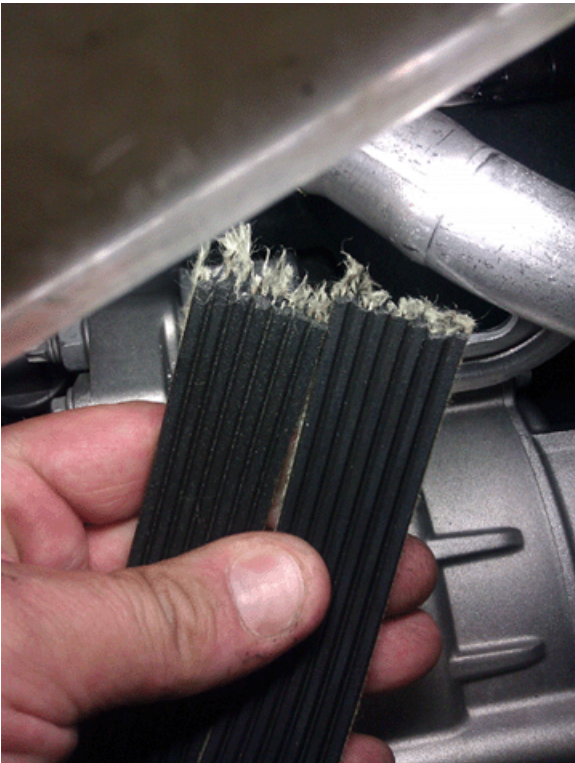
1. Inspect the under hood area for any damage (engine, CV boots, etc.) that may have been induced when the belt had broken.
2. Inspect the Drive Belt and note whether it looks like the belt just snapped cleanly, if it is shredded or worn due to misalignment, incorrect tension, or damaged due to contamination from any fluids. Take a digital photo of the broken belt ends and note the belt date code. The code is four numbers followed by "MX" printed in red lettering as shown below.

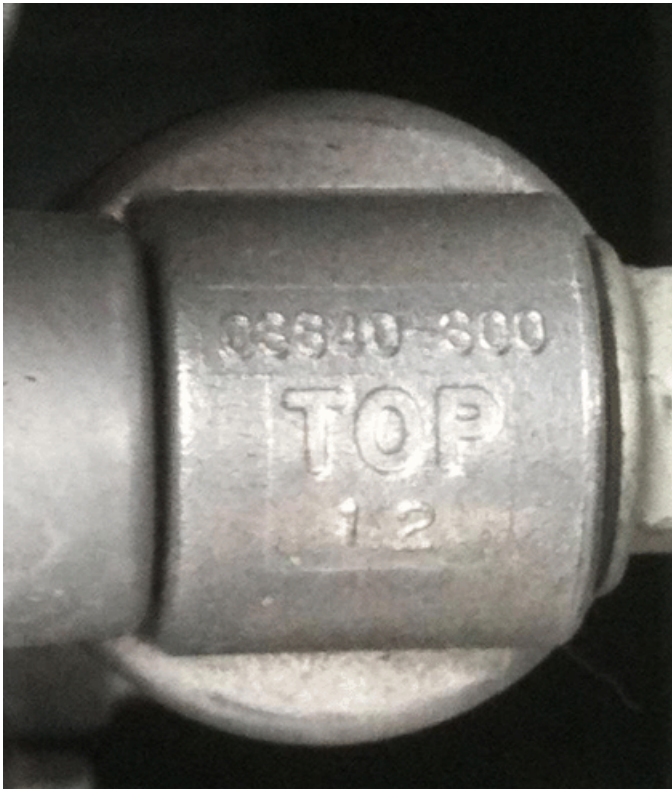
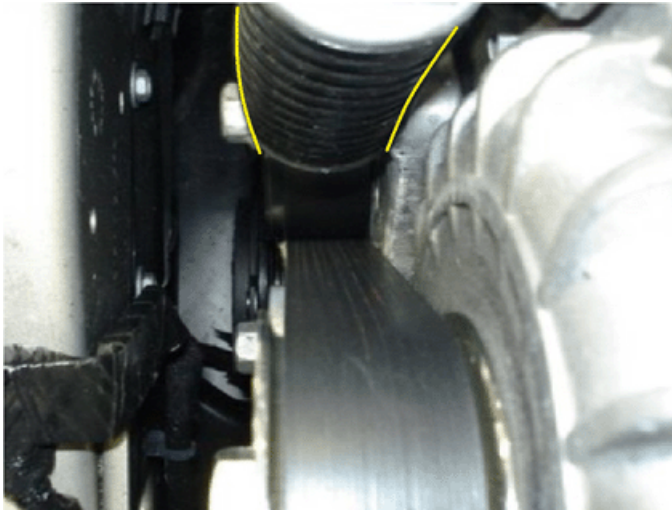
3. If a Laser Belt Alignment Tool (EN-49228 or equivalent) is available, use it to check for proper pulley alignment.
4. Inspect the drive belt Tensioner strut assembly to ensure that it is installed correctly - "TOP" is stamped on the upper rounded end of the tensioner strut housing as shown below. If it is installed upside down or if the upper and lower retaining bolts have been reversed during previous repairs, it could

cause an alignment concern as shown below. It is not necessary to remove the tensioner bolts from the bracket or remove the spring from the tensioner. The upper bolt of the tensioner is longer than the lower bolt.

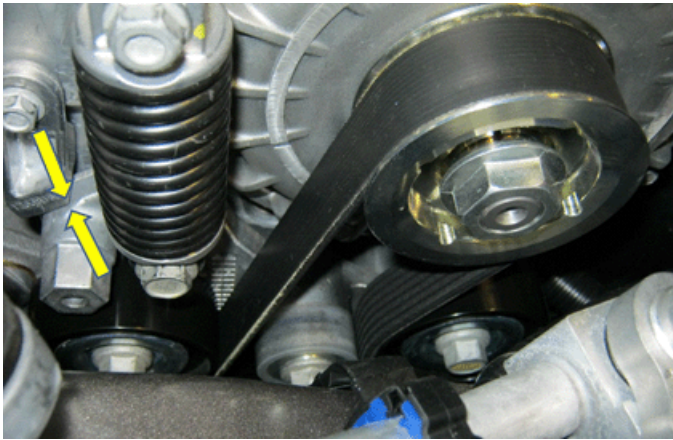
5. Check for clearance/gap between tensioner stop and the tensioner assembly.
  - Loosen M6 tensioner stop bolt. Using a 19mm socket, rotate the hex feature beneath the strut counter-clockwise to extend the strut. Tighten M6 tensioner stop bolt and confirm you now have clearance/gap between tensioner stop and the tensioner asm.
  - Check and note if the tensioner stop is in place and the bolt is tight.
  - Remove the top tensioner bolt (requires 1st removing stop, then compressing strut, then removing bolt (if present)).
  - Verify that the tensioner assembly rotates about center pivot, but that the pivot or bolt is not loose. The tensioner should be able to move back and forth smoothly with only a small amount of force.

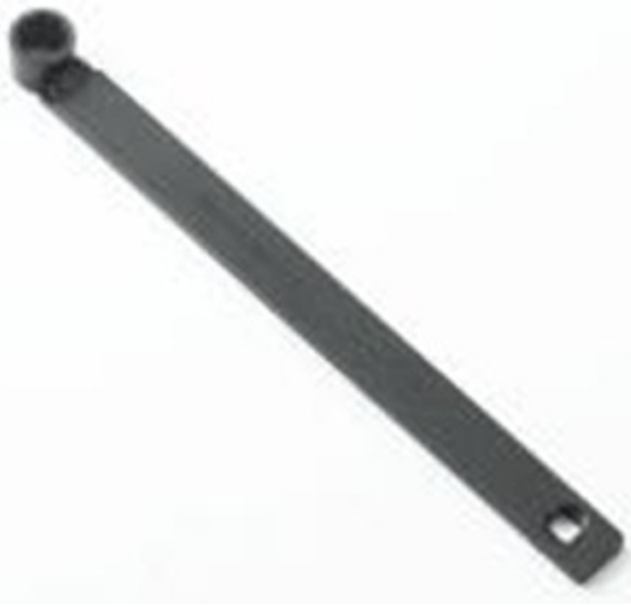
When checking the center pivot bolt torque, it is necessary to use the Torque Wrench Adapter J-45025 when performing this repair. Without this tool, the torque specification in SI will be inaccurate. Achieving the correct torque specification is critical or the bolt may loosen, resulting in premature wear or breakage. The specification in SI is considering that the tech has the Torque Wrench Adapter installed on a 3/8 drive Torque Wrench while they are both kept in a straight line with each other.
