Service Bulletin

PRELIMINARY INFORMATION

Subject: Navigation or Radio Display Blank Or Flashing DTC B1265 B1288 Or B1289

Models: 2007-2013 Cadillac Escalade Models
2007-2013 Chevrolet Avalanche, Silverado, Suburban, Tahoe
2007-2013 GMC Sierra, Yukon, Yukon XL, Yukon Denali, Yukon Denali XL

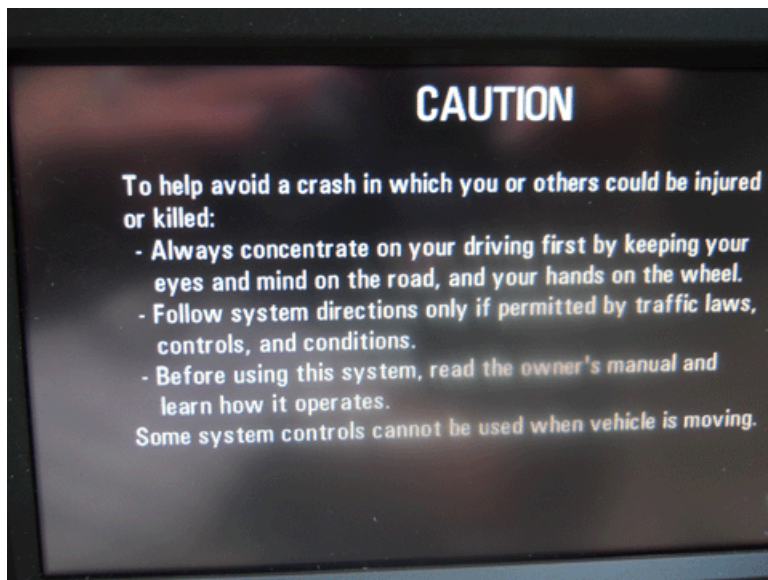
- Navigation or radio screen is blank or flashes on and off
- No sound from speakers
- Rear DVD screen inoperative
- DTC B1265, B1288 Or B1289
- Navigation disclaimer message intermittently will be displayed (see below)

This condition may be caused by the remote enable signal wire circuit 7066 being shorted to ground. This remote enable signal comes from the radio and feeds the Amplifier (except vehicles with RPO Y91 or any 2009 and later Chevrolet Utility equipped with RPO STZ), the antenna module (utilities only), and the rear video display (with RPO U42).

Note: When the remote enable signal wire (Circuit 7066) is first shorted to ground, the navigation screen or radio display may start to flash. If the wire remains shorted for more than 2 minutes, the navigation or radio display goes blank. The radio's current limiting logic will not re-enable the output on the entertainment remote enable circuit until after the radio performs a full power-down. It may be necessary to wait 5 minutes with the key OFF and retained accessory power OFF for the radio to re-enable this output.

If you experience this concern, check for a short to ground on the remote enable signal wire (Circuit 7066) and repair and re-route the circuit as needed. The most common area of concern is a shorted wiring harness near the rear DVD display screen under the headliner.
