Service Bulletin

PRELIMINARY INFORMATION

Subject: Diagnostic Tip - Ratchet Click or Grind Noise In Front Of Vehicle Traveling Straight At Slow Speeds

Models: 2010 - 2014 Chevrolet Camaro

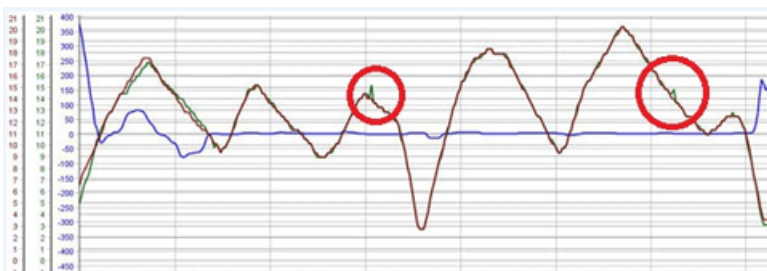
3. Review EBCM > Antilock Braking Data Session Logs in GDS2, specifically monitoring the WSS (Wheel Speed Sensor) parameters for one of the WSS inputs to either spike up or drop down in a speed inconsistent with the speed reading of the other 3 wheel speed sensors. Typically, a 3 mph or greater variance may be detected in one or more data session logs which will indicate which WSS and hub bearing need further inspection. In rare cases, it could be as little as 1 mph variance between WSS. It is suggested to use the Line Graph to plot out the Steering Angle Sensor (to know when the car is going straight) and both rear WSS parameters first. To do so, select the parameters you wish to plot by clicking on the parameters in the Diagnostic Display Data Display Tab, then click on the padlock to move that parameter to the top of the list. Once the parameters are selected, move to the Line Graph Tab to view an overlaid plot of the selected parameters. The front WSS parameters can be viewed later if the cause is not found in the rear, but the cause is more common to be found with the rear parameters. You must zoom in to view the fine detail needed to isolate the cause as this is only a slight difference spiking down or up from the other WSS.

In the example above, the vehicle is travelling straight (Steering Column Position in Blue); the Left Rear WSS (Green) is spiking; while the Right Rear WSS (red) is not.

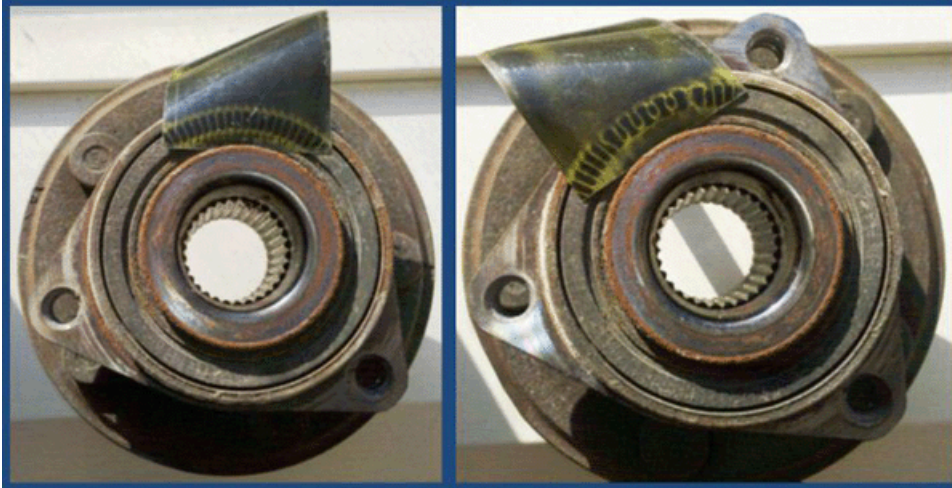
Important: There is some confusion over where the encoder is located on the hub. It is the brown rubber ring, it is not located behind this ring and this ring is NOT just a bearing seal. It is the encoder.

Note: This photo depicts a condition of the encoder magnetic poles not alternating properly. Instead of the magnets being laid North, South, North, South, as the photo on the left illustrates, the poles may have been laid out of sequence as illustrated by the photo on the right. The magnetic paper is not readily available in most areas so this photo is only being used to illustrate that not all conditions are visible to the naked eye and that if this condition were present then swapping the WSS would not aid in isolating this cause. It may be necessary, as explained below, to swap the hub bearing from side to side to identify the condition shown in this photo.

* If there is no evidence of physical damage, contamination or debris it is acceptable to swap the hub bearings from side to side, test drive the vehicle again and confirm the problem followed the hub. If the problem follows the hub, replace the hub. If problem stays with the WSS, replace the WSS.
