Service Bulletin

Subject: BAS+ (Hybrid) eAssist MIL Battery Indicator Or Service Charging System Message On With P1EAB

Models: 2012 - 2013 Buick Lacrosse, Regal eAssist
2013 Chevrolet Malibu ECO eAssist
All with RPO HP6

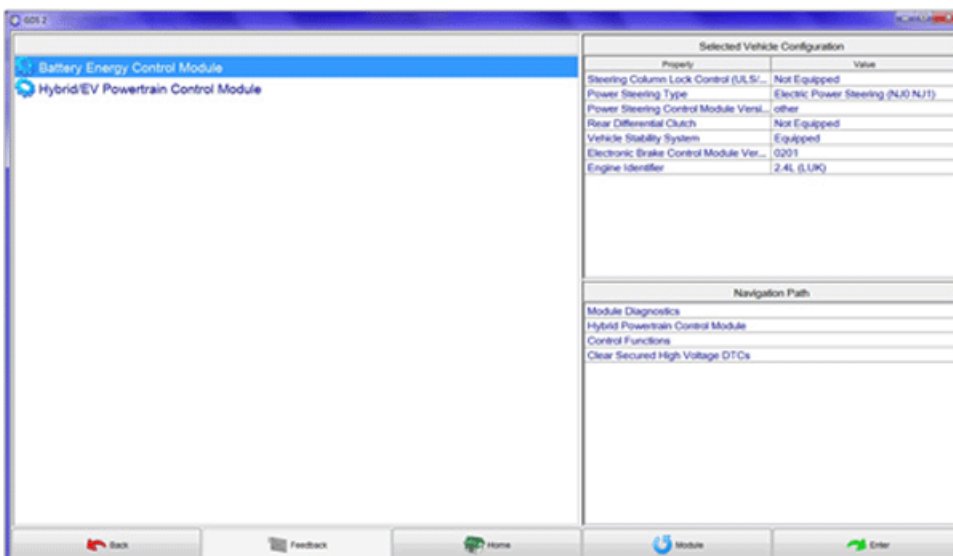
Note: If P1EAB is set it will be necessary to clear the High Voltage (HV) DTC using GDS2. After selecting the proper vehicle information in GDS2 follow the Navigation Path as shown to clear the HV DTC. After the reset is selected the ignition will need to be turned off for a minimum of two minutes.
