Service Bulletin

Subject: BAS+ (Hybrid) eAssist Service Charging System Message, MIL On With or Without DTCs P0A8F and P062F

Models: 2012 - 2013 Buick LaCrosse, Regal eAssist
2013 Chevrolet Malibu ECO eAssist
All with RPO HP6

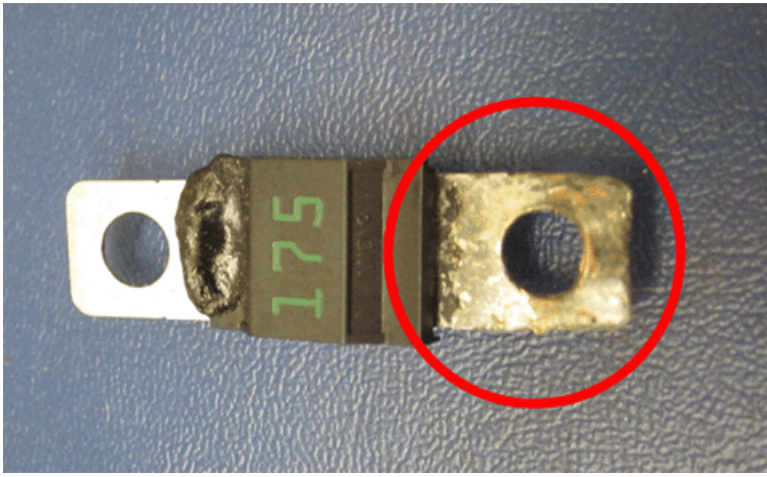
If the fuses are within specifications, inspect around the edge of the black plastic portion of these fuses for any sign of voltage stress as shown in the photo below. Make sure that the metal blades of the fuse are not bent or showing signs of thermal damage. Service P/N is 19119015.

If the fuses show voltage stress is present, this is most likely the result of a poor connection. The Fuses are now available individually. If the entire fuse block needs to be replaced for any reason the fuse block includes both fuses.

If the fuses pass inspection and they are not visually damaged in any way, install the fuses, carefully torque them to 4.7 Nm (42 lb-in), and re-evaluate the charging system operation. If the 175A fuse is open or has a poor connection, a P0A8F may be stored in history but the DTC may not consistently reset.
