Service Bulletin

PRELIMINARY INFORMATION

Subject: Diagnostic Tip - Intermittent No Crank When Ignition Key Is Turned To The Crank Position

Models: 2010 - 2014 Buick LaCrosse, Regal 2012 – 2014 Buick Verano (Without RPO BAH Or ATH) 2013 – 2014 Buick Encore 2013 – 2014 Chevrolet Trax (Canada only) 2010 - 2014 Chevrolet Camaro, Equinox 2011 - 2014 Chevrolet Cruze 2012 - 2014 Chevrolet Sonic 2010 - 2014 GMC Terrain

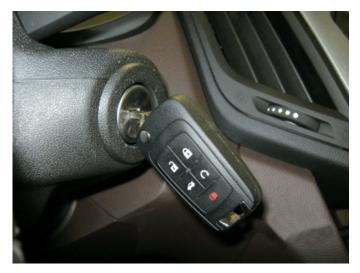
Incorrect

Customers may comment on an intermittent no crank. The design of the key and fob is to have the key extended straight out. If the key is not in the fully locked position and the head of the key is angled down, the vehicle may not crank. This may be caused by the customer contacting the release button on the fob when inserting the key into the ignition.

If the vehicle will not crank, remove the key and make sure it is fully extended. Reinsert the ignition key in the extended straight out position and turn to crank engine. Reference photos below.
