Service Bulletin

PRELIMINARY INFORMATION

Subject: Engine Misfires Due To Major Carbon Deposits On The Intake And Or Exhaust Valves

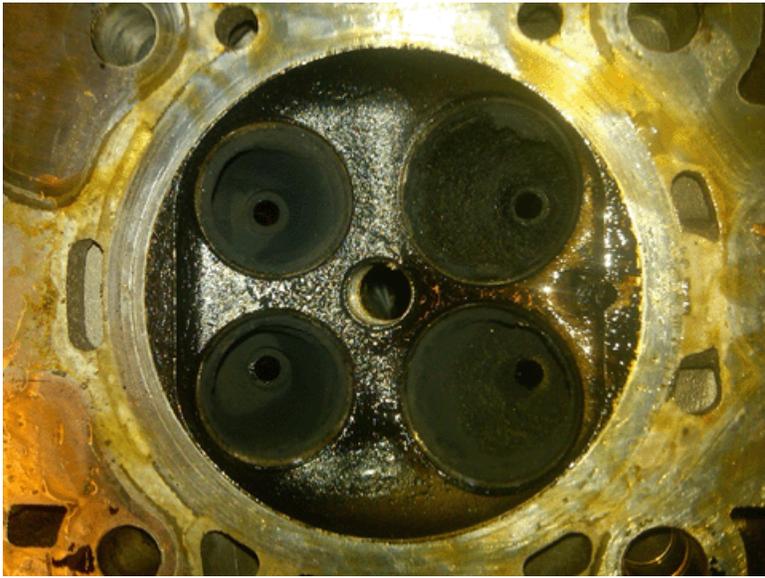
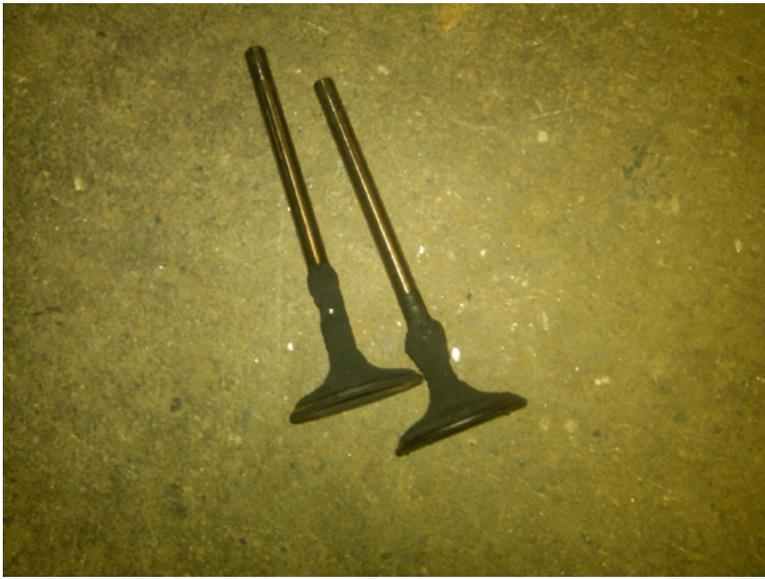
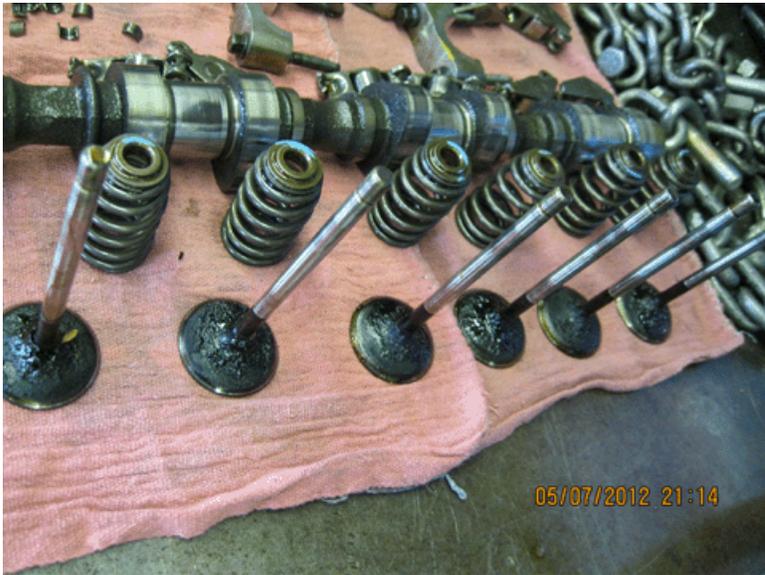
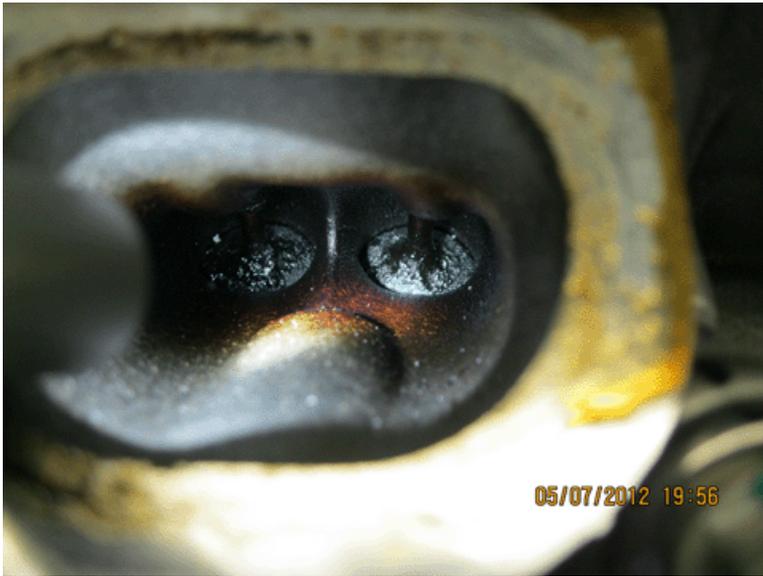
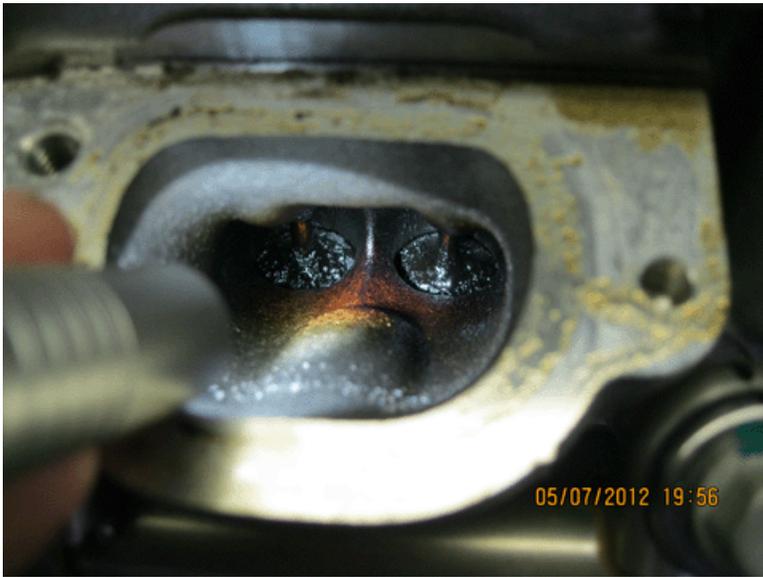
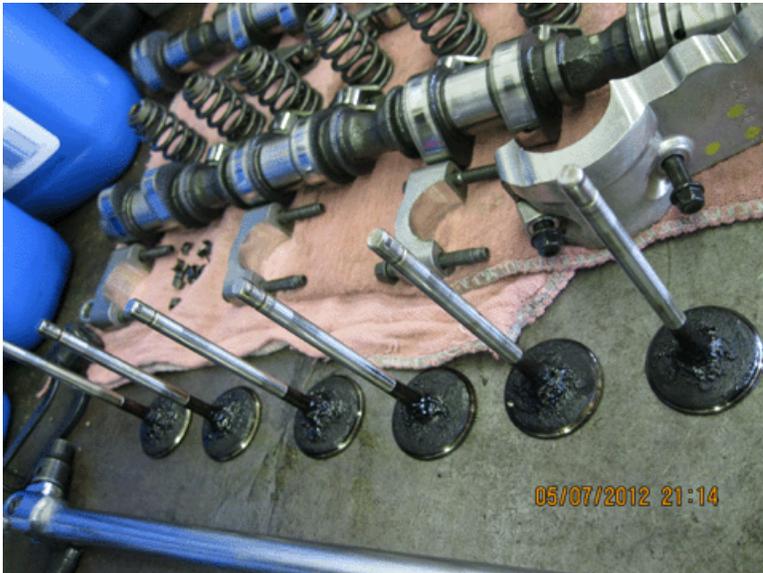
Some customers may complain of a MIL and engine misfire. In some cases, the misfire may be more apparent on a cold start, may count on a single cylinder or several cylinders, and may or may not be felt by the driver. Upon inspection, the technician will find one or more misfire codes (DTC P0300-P0306) stored in the ECM and SI diagnosis may or may not isolate the cause of the misfire depending on whether the intake/exhaust valves are sticking at the time of the diagnosis.

This may be the result of major carbon build up on the intake and/or exhaust valves as shown below so the misfires should not have appeared until accumulating at least 5,000 miles or more.

If this concern is encountered, perform SI diagnosis. If SI diagnosis isolates a valve sealing concern and/or eliminates everything else external to the engine, decarbon the engine with Upper Engine and Fuel Injector Cleaner by following the guidelines below:

1. In a well-ventilated area with the engine at operating temperature, slowly/carefully induce a bottle of GM Upper Engine and Fuel Injection Cleaner into the engine with RPM off of idle enough to prevent the engine from stalling (typically around 2,000 RPM or so). Depending on the engine configuration, induce the cleaner through the throttle body or an engine vacuum hose/pipe. For best results, it is suggested to induce the cleaner through the throttle body with Kent Moore Tool # J-45076 / J-35800-A or equivalent (shown below).

2. Turn the engine off after inducing the cleaner and allow the cleaner to soak with the engine off for 2.5 to 3 hours (Do not let cleaner soak for more than 3 hours as remaining deposits may start to harden back up again).

3. Add a bottle of GM Fuel System Treatment Plus to the fuel tank and fill the vehicle with one of the Top Tier gasolines listed at <http://www.toptiergas.com> and/or in the latest version of 04-06-04-047 (USA) or 05-06-04-022 (Canada). See Bulletin 05-00-89-078 for more details on GM Fuel System Treatment Plus.

4. Test drive the vehicle extensively to circulate the GM Fuel System Treatment Plus.
5. Re-evaluate the concern to determine if it is repaired or improved at all. If the concern is improved but not repaired, it may be necessary to perform the above decarboning process a 2nd time.

6. To complete the repairs, change the engine oil and filter, and advise the customer to only use one of the Top Tier Gasolines listed at <http://www.toptiergas.com> and/or in the latest version of 04-06-04-047 (USA) or 05-06-04-022 (Canada) to minimize future deposits. It can also be recommended to add a bottle of GM Fuel System Treatment Plus at every oil change as mentioned in the latest version of 04-06-04-051.

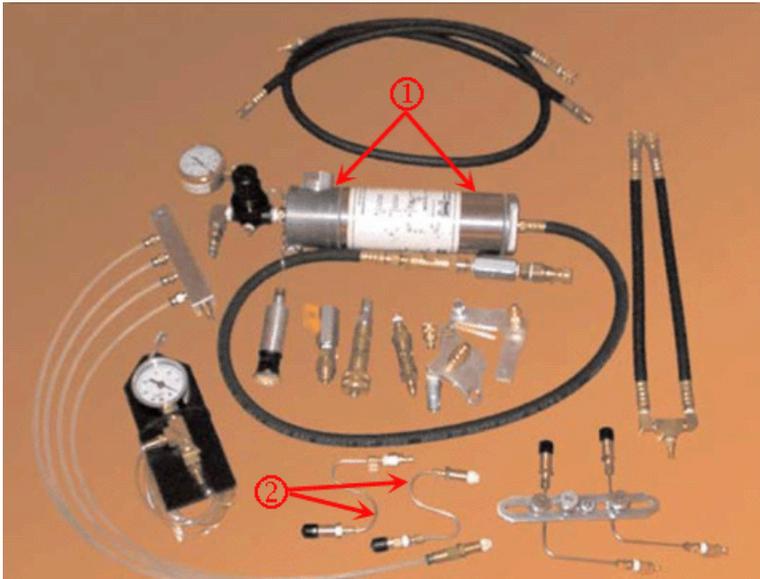
Kent Moore Tool Kit # J-45076

1. Pressurized Canister from J-45076 is Shown - J-35800-A is Similar (Equivalent Pressurized Canister Acceptable)
2. Throttle Body Cleaning Adapters J-45076-46 and J-45076-55 Shown (Equivalent Adapters Acceptable)

Notice: J-45076 was originally released to Cadillac dealers for decarboning Northstar engines but it has since been discontinued. This kit came with the pressurized canister and throttle body cleaning adapters shown above. As mentioned above, the J-35800-A is another pressurized canister that can be used. It was originally released in the 1990s for cleaning fuel injectors on the 4.3L, 5.0L, and 5.7L truck engines. If these tools are not available, it is also acceptable to use equivalent tools to perform this decarboning procedure.
