# Service Bulletin

## PRELIMINARY INFORMATION

**Subject:** SES Lamp P0011 Setting After Camshaft Replacement

**Models:** 2010-2014 Cadillac Escalade  
2010-2014 Chevrolet Camaro  
2010-2014 GMC Yukon Denali  
With engine RPO 6.2L L94 L99

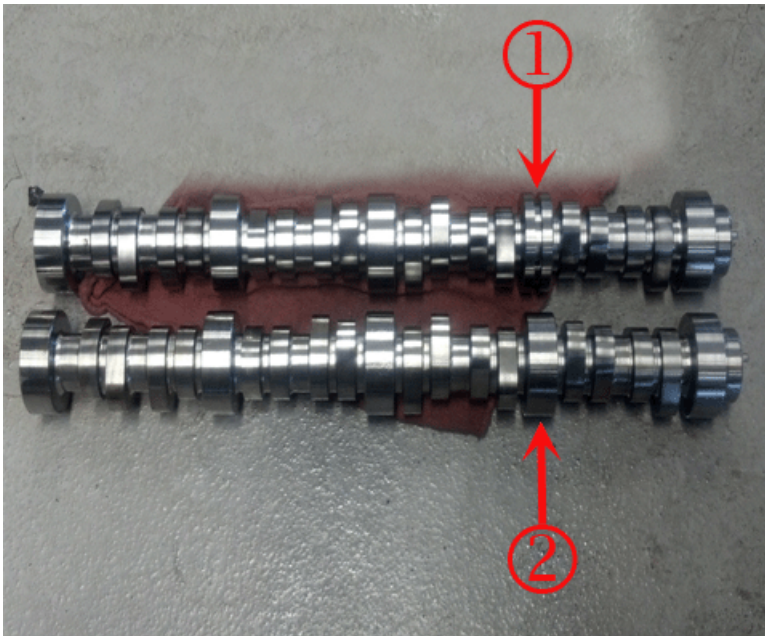
You may encounter a P0011 setting after the replacement of the camshaft.

- 1. Shows a good camshaft
- 2. Shows the wrong camshaft

Inspect the camshaft to determine if the correct Part number has been installed. The inspection consists of verifying the last 4 digits on the camshaft (stamped on the end) match the part number listed on the box.
