Service Bulletin

Subject: Duramax Diesel Injector Driver Codes

Models: 2004-2005 Chevrolet Kodiak, Silverado
2004-2005 GMC Sierra, Topkick
with 6.6 Engine (VIN 2 - RPO LLY)

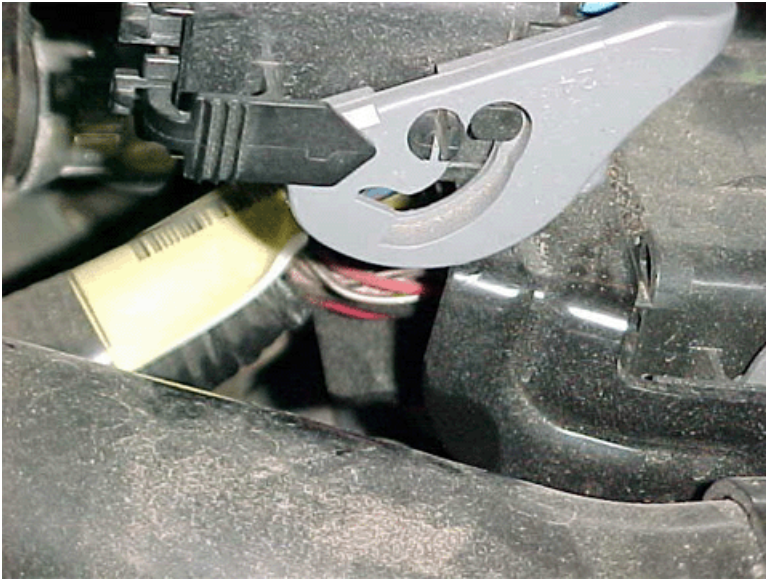
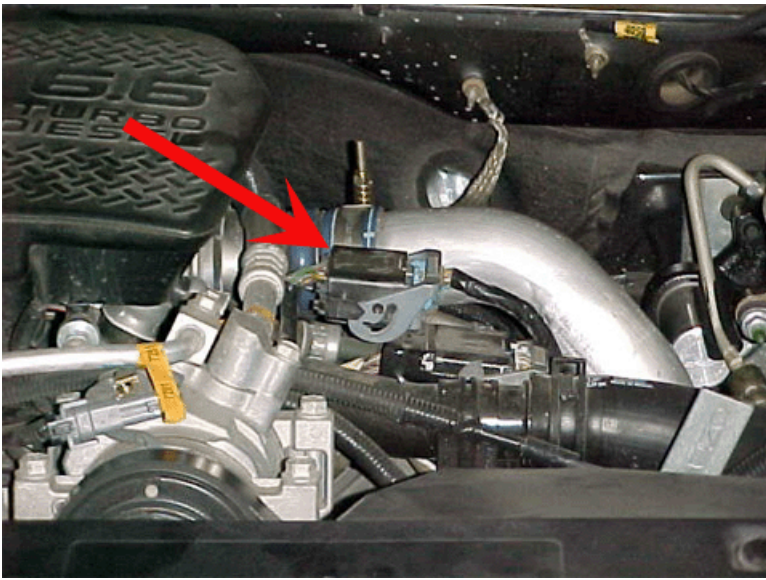
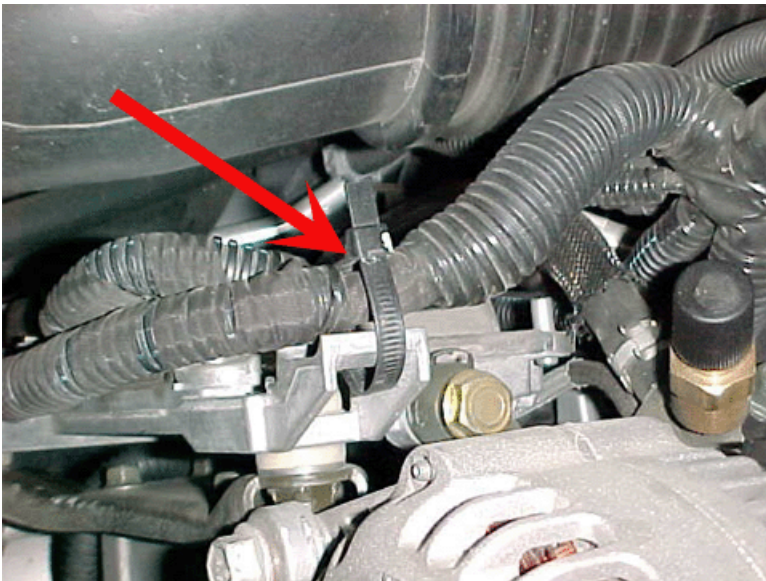
1. Diagnose all injector driver codes using the current SI diagnostics.
2. If all SI diagnostics are inconclusive, inspect for wire chafes at the Fuel Injector Control Module (FICM) wiring harness brace. The wiring harness brace is located 4 to 6 inches away from the FICM connectors. The wiring harness is nylon tied to the wiring harness brace. It may be necessary to remove the nylon tie to inspect the harness. Repair any wire chafes following SI wire repair procedures. Insulate the harness with wiring conduit or a suitable material so the wires will not chafe again.

3. Also inspect the C107 (Silverado and Sierra) or C118 (Kodiak and Topkick) connector for wire chafes. The C107 (Silverado and Sierra) or C118 (Kodiak and Topkick) connector is found above the left (driver side) rocker cover. The wiring harness may relax and lay on top of the C107 (Silverado and Sierra) or C118 (Kodiak and Topkick) support brace. This support brace is located right below the C107 (Silverado and Sierra) or C118 (Kodiak and Topkick) connector. Repair any wire chafes following SI wire repair procedures. Insulate the harness with wiring conduit or a suitable material so the wires will not chafe again.
