Service Bulletin

PRELIMINARY INFORMATION

Subject: Suspension DTCs C0696 Or C0711, Incorrect Trim Height, Compressor Inlet Hose Loose, Or Compressor Self Test Inoperative

Models: 2001-2013 Cadillac Escalade, Escalade ESV, Escalade EXT
2001-2013 Chevrolet Avalanche, Tahoe, Suburban LD
2001-2013 GMC Yukon, Yukon XL LD, Yukon Denali, Yukon Denali XL
With RPO Z55 or Z95

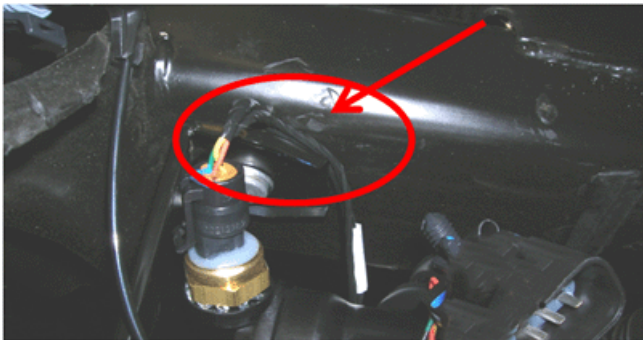
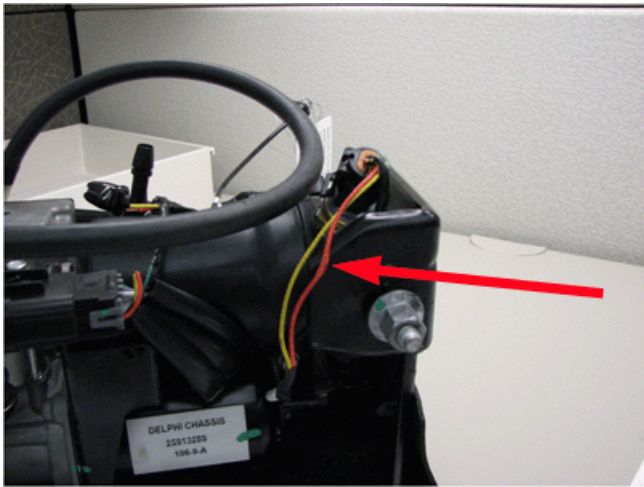
Some customers of 2009 or prior vehicles, may comment of a Service Suspension System message on the DIC and the rear suspension ride height is incorrect. When checking for DTCs the Electronic Suspension Control (ESC) module will have DTC C0696 or C0711 set. This concern could be caused by the wiring to the automatic level control (ALC) pressure sensor being shorted to ground, as shown below.

Note: The air compressor assembly may need to be removed from the vehicle to determine if the wiring is possibly pinched between the compressor assembly and frame.

Note: DO NOT replace the complete air compressor assembly for this concern.

Repair any damaged or shorted circuits and then reposition the wiring so it does not get damaged again during the compressor assembly installation.

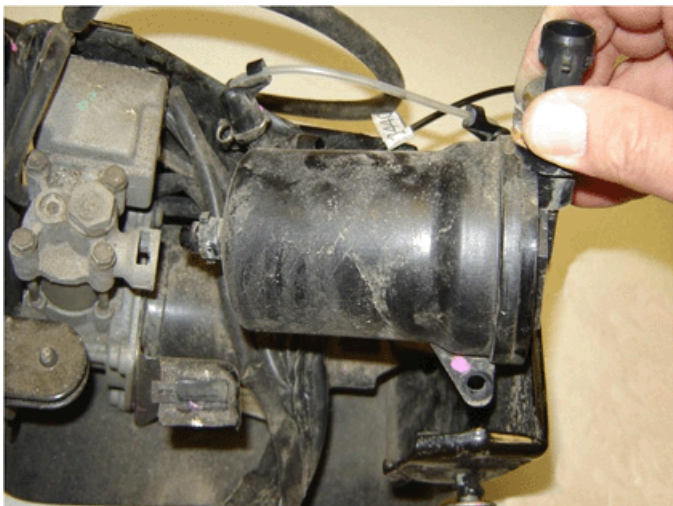
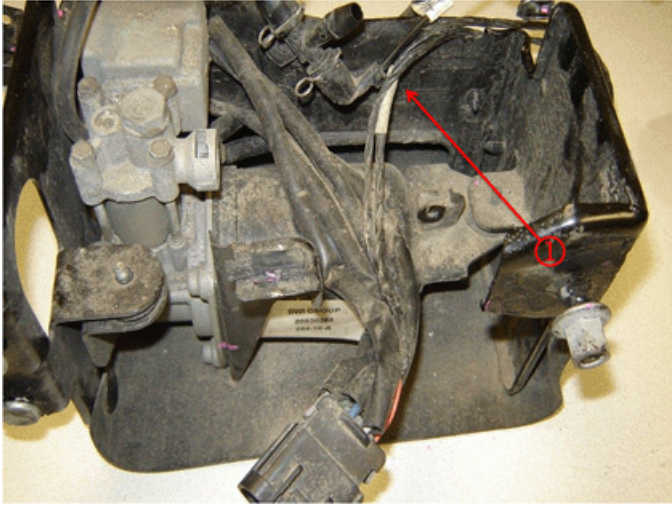
Some customers may comment of a Service Suspension System message on the DIC and may also comment that the rear suspension ride height may be low under a heavy payload. When checking for DTCs the Electronic Suspension Control (ESC) module will have DTC C0711 set. This concern may be caused by an internal fault in the automatic level control (ALC) pressure sensor. This may occur due to moisture getting into the sensor.

Note: Ensure the sensor wiring (1) is routed carefully under and around the air filter, dryer, and sensor assembly to prevent damage along the vehicle frame

during compressor assembly installation.

Follow diagnostic procedures to determine if the sensor needs to be replaced. The sensor is no longer serviced separately. For sensor replacement, install a complete air filter, dryer, and sensor assembly. Installing this complete assembly will provide a better repair than replacing the sensor only. Refer to SI procedure, Automatic Level Control Air Compressor Filter Replacement.

Note: An improved sensor design was implemented beginning with vehicles built in May, 2012. Vehicles built before May, 2012, will require a jumper harness for the updated sensor design. The jumper harness is included with complete air filter, dryer, and sensor assembly, PN 22964558. Vehicles built in May, 2012 and later do not require the jumper harness, and use PN 22941807.

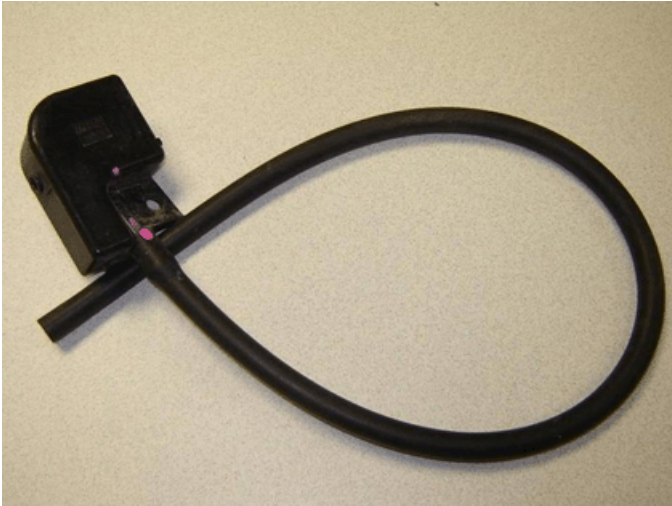
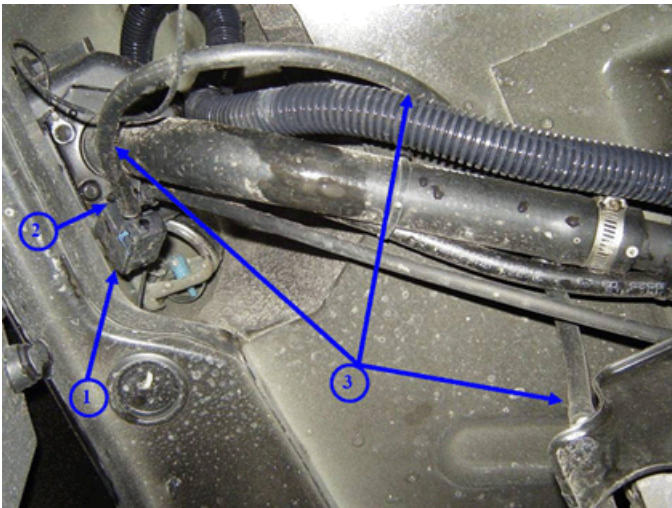
Some customers may comment of a loose hose hanging down in the left rear of the vehicle. Upon inspection it may be determined that the hose is damaged or has become disconnected from the air inlet filter of the auto leveling suspension air compressor.

Replace the auto leveling compressor air inlet filter and hose assembly (PN 22197160), shown below.

1. Raise and support the vehicle. Refer to Vehicle Lifting and Jacking in SI.
2. Release the air compressor air inlet filter (1) from the retainer (2) securing the rear axle vent hose and compressor air inlet to the fuel fill pipe assembly.
3. Remove the remaining air inlet hose (3) from the air compressor.
4. Install the new air inlet filter and hose assembly, PN 22197160. Ensure the air inlet hose (3) is routed as shown.
