Service Bulletin

PRELIMINARY INFORMATION

Subject: SES Light, Engine Misfire, and/or Shudder - Inspect Ignition Coils

Models: 2009 Buick Enclave
2008-2009 Cadillac CTS, STS
2009 Chevrolet Traverse
2009 GMC Acadia
2009 Saturn Outlook
With Direct Injected 3.6L V6 Engine (RPO LLT)

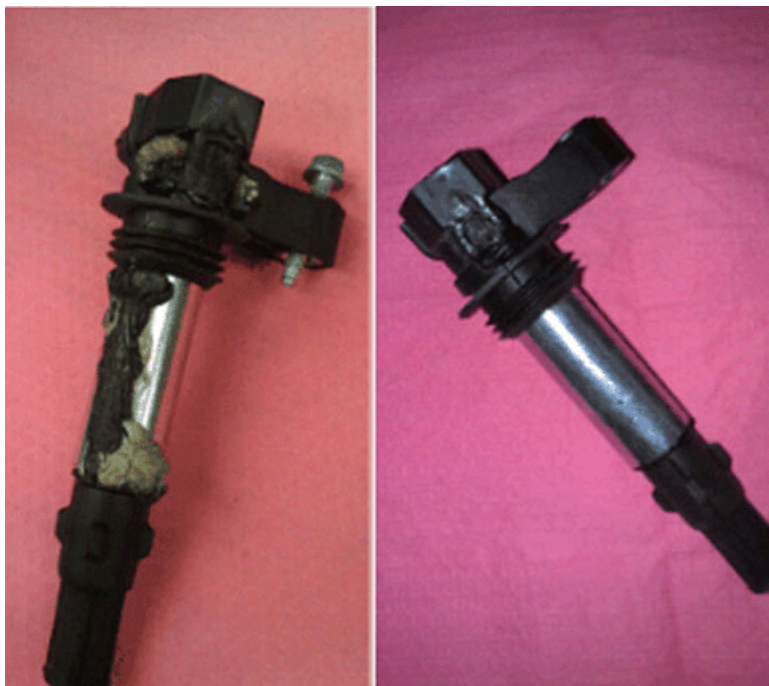
This may be the result of a heat stressed/damaged ignition coil.

The coil damage could be due to the ECM latching "ON" the associated coil EST (dwell) line.

Dwell times greater than 50msec will result in coil damage (see photos)

Note: The cylinder with the damaged coil may not be the cylinder causing the issue (coil damage).

3. Visually inspect the sides of the top of the related ignition coil for any sign of damage due to voltage/heat stress.
Traces or Lines under the epoxy is not damage from voltage/heat stress, and should not be replaced.

- 3.1. If there is no sign of ignition coil damage, this PI does not apply.
 - 3.2. If any ignition coil is damaged due to voltage/heat stress, follow the remaining steps below.

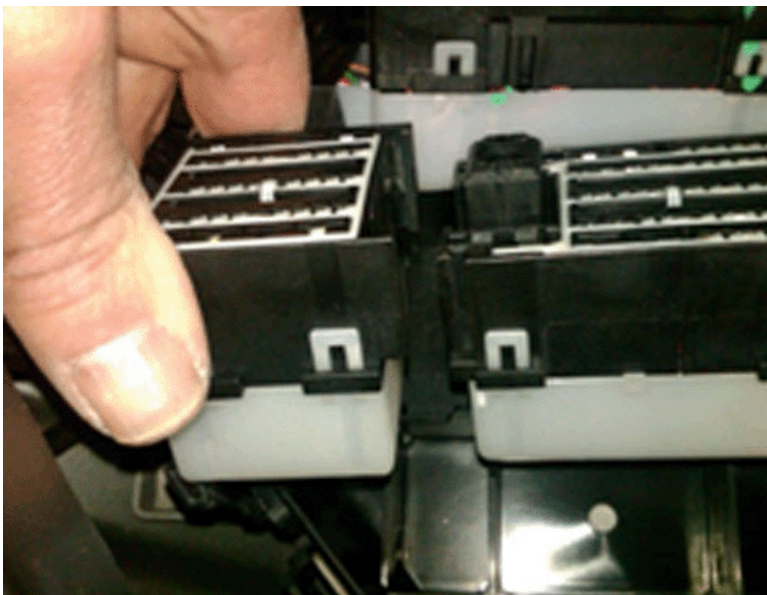
Incomplete connector engagement into the base of the UBEC can cause intermittent conditions for many engine circuits.

U BEC (Under Hood Body Electrical Center) - Poor connector engagement on bottom of the UBEC, loose terminal fits and low pin drag can cause intermittent transient.

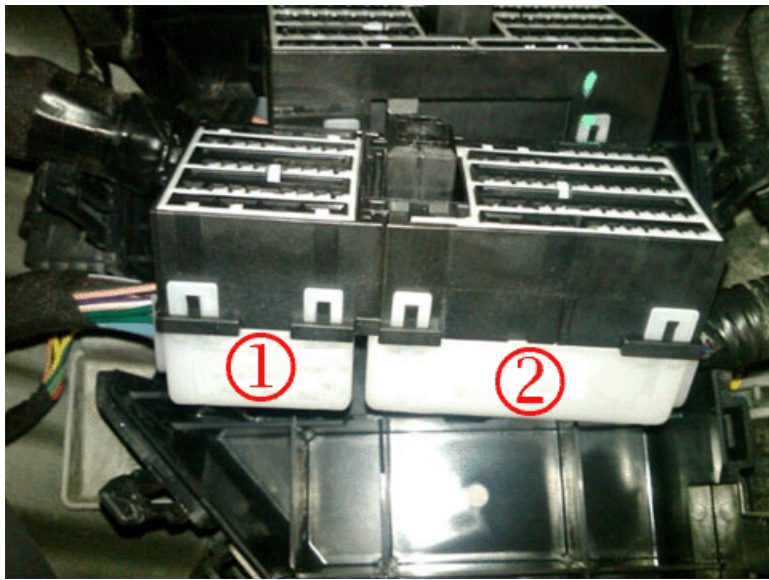
1) Connector 1 2) connector 3

X1 and X3 Connectors slide together. Connectors must be fully seated.

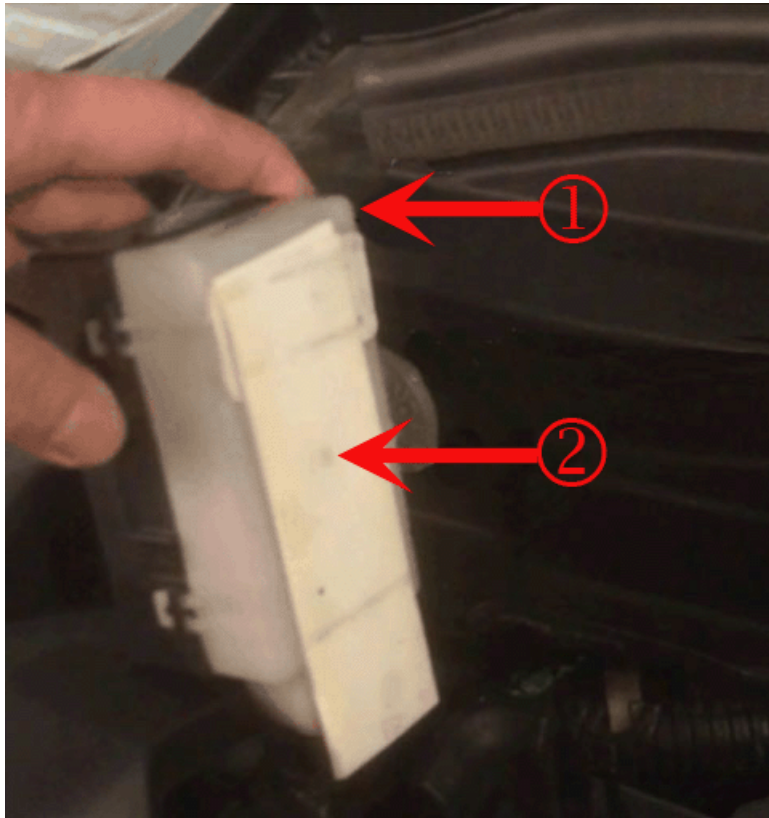
Connections: Cavity 47-Even bank and 51 Odd Bank Ignition Coil – All Models

1) Engine harness connector - UBEC 2) Foam tape used to support connector to UBEC in addition to assembly fasteners.

Check Coil terminal cavities for proper pin drag and fit.

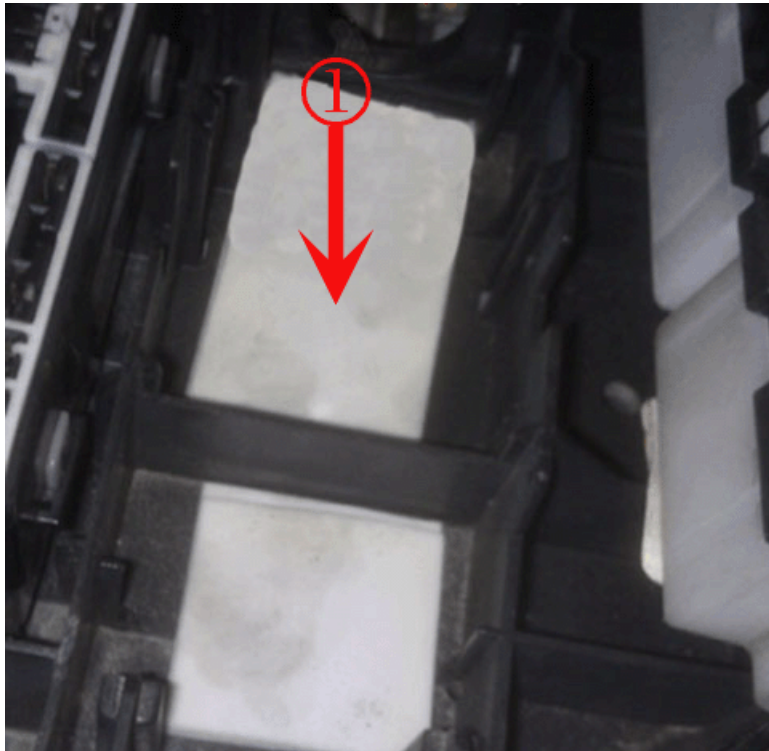
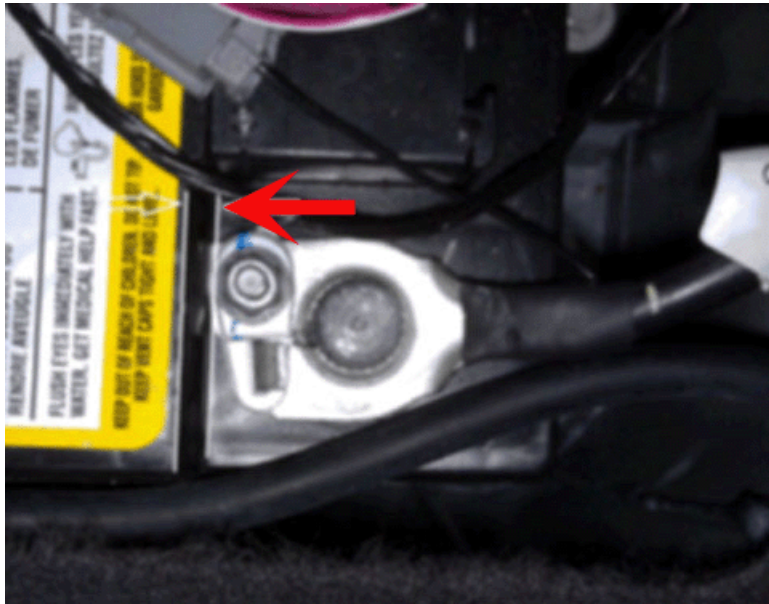
On the Enclave, Acadia, Traverse and Outlook products, proper alignment of the battery clamp to the battery is essential in ensuring that the battery clamp fully seats on the battery post. Improper alignment will result in the battery clamp interfering with the case of the battery.

This interference will give a false indication of a tight battery connection.

This is most likely to occur on the negative battery terminal due to the short length of the battery cable.
