# Service Bulletin

**Subject:** SES Lamp On With DTC P2270

**Models:** 2013 Chevrolet Silverado  
2013 GMC Sierra  
Built with 4.8L 5.3L 6.0L RPO L20 LC9 LMG L96

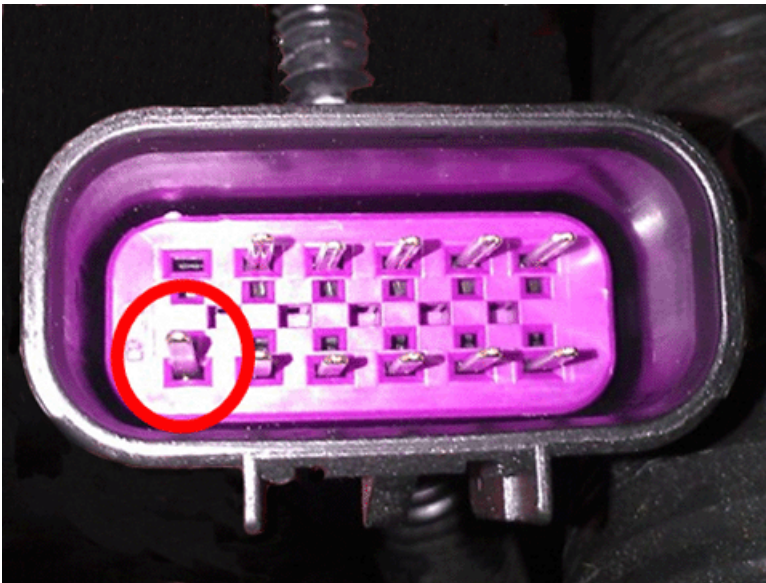
Concern of DTC P2270 setting along with any of the following codes P0140, P0139, P0138, P0137, P013A, P013B on vehicles built at the Fort Wayne assembly plant during February 2013.

Check connector X131 for a bent terminal F as indicated in the attached PIC and repair per SI procedures.

If no connector issue is found, follow SI diagnostics.

For wiring repairs covered under warranty, please refer to latest version of bulletin 10-00-89-005 for warranty information on wire/connector repairs.
