# Service Bulletin

**Subject:** SPARK EV (BEV) 1ET35 Drive Unit Exchange Program

**Models:** 2014 Chevrolet Spark EV (BEV)  
Equipped with 1ET35 Transaxle (RPO MME)

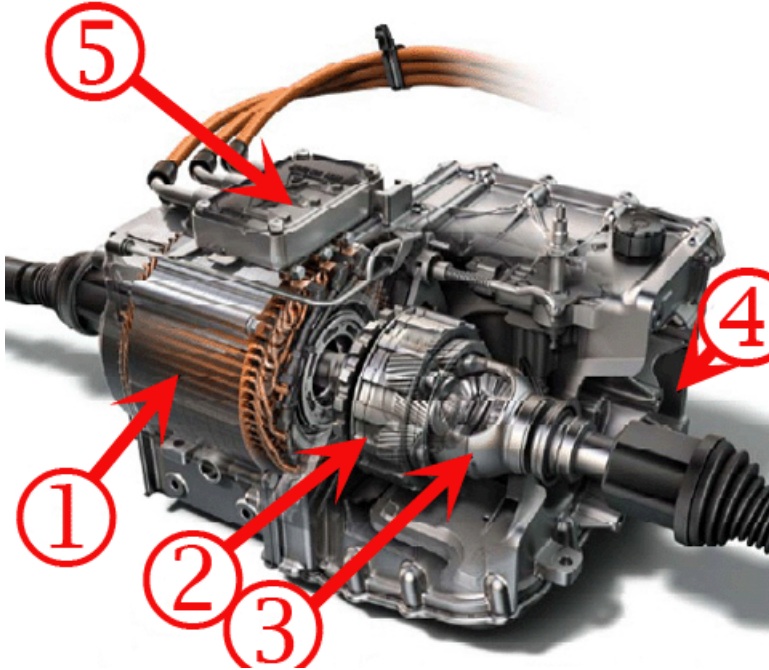
1. Drive Motor generator
2. Planetary Gears
3. Differential
4. Auxiliary Fluid Pump
5. 3-Phase Cable Connections

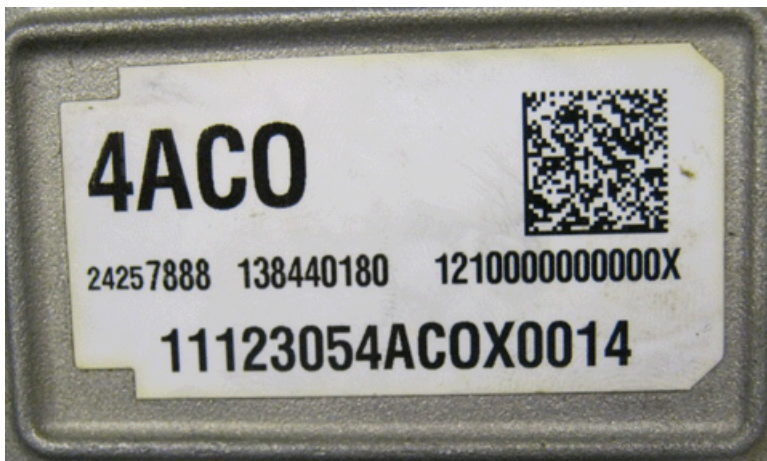
The Drive Unit Tag Number must be supplied to TAC when calling for a Drive Unit exchange.

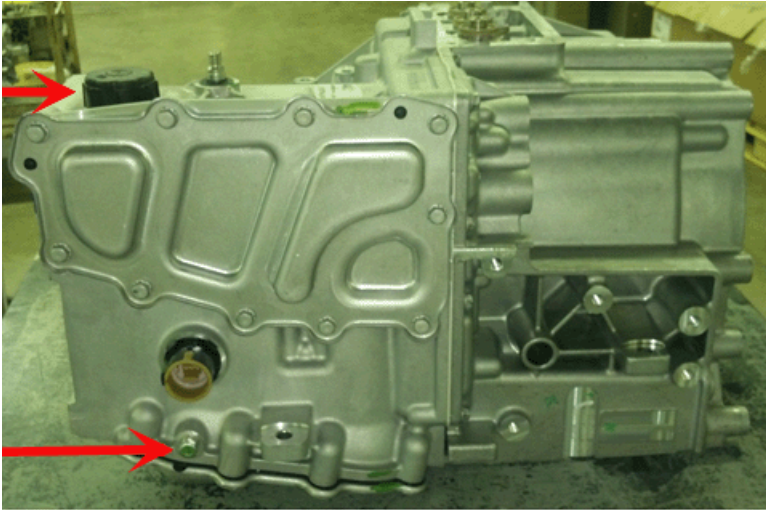
Therefore, a fill cap in the top of the Drive Unit (see top arrow) and level set plug (see lower arrow) sets the fluid level. 0

1. Operate vehicle until Drive Unit fluid temperature is 30–50°C (86–122°F).
2. Raise the vehicle.
3. Remove the front compartment air deflector.
4. Place the Drive Unit in Park.
5. With the scan tool, command the auxiliary Drive Unit Fluid Pump speed to ON for 10 minutes.
6. Remove the Drive Unit case level set plug.
7. Verify fluid slowly drips from the hole that the case level set plug was removed from.
  - a. If the fluid is flowing as a steady stream, wait until the fluid begins to drip from the case level set plug hole.
  - b. If no fluid comes out, add .5 L (.52 Qts.) of fluid until fluid drips out of the case level set plug hole.
8. Install Drive Unit case level set plug and torque to 12 Y (106 lb. in).
9. Turn off the vehicle.
10. Install the front compartment air deflector.
