# Service Bulletin

## PRELIMINARY INFORMATION

**Subject:** Intermittent IPC Indicators On Radio Display Blank Low Speed LAN Communication Issues DTC

**Models:** 2013 Chevrolet Equinox  
2013 GMC Terrain

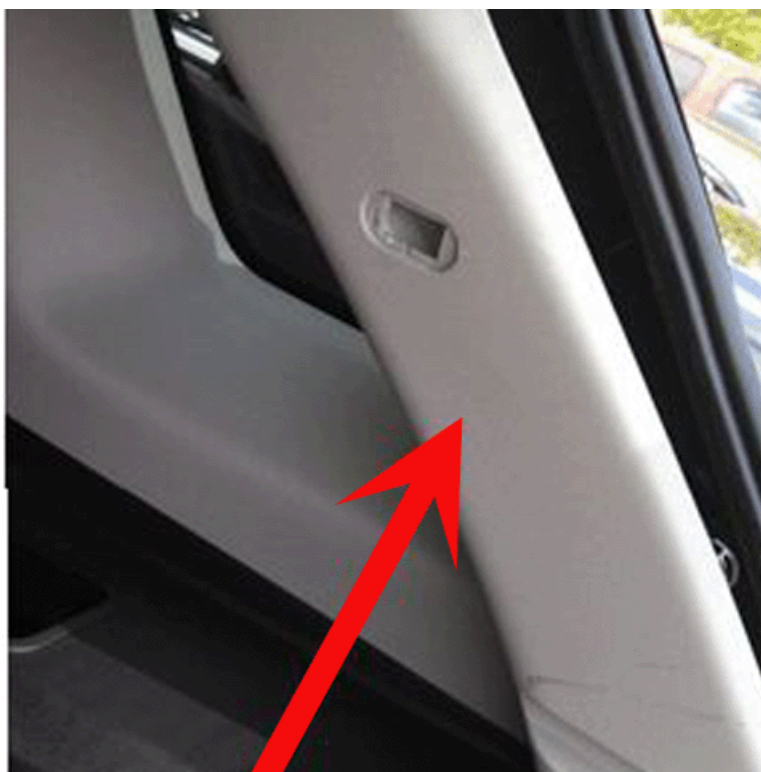
To gain access to X401 pull the passengers D pillar trim back.

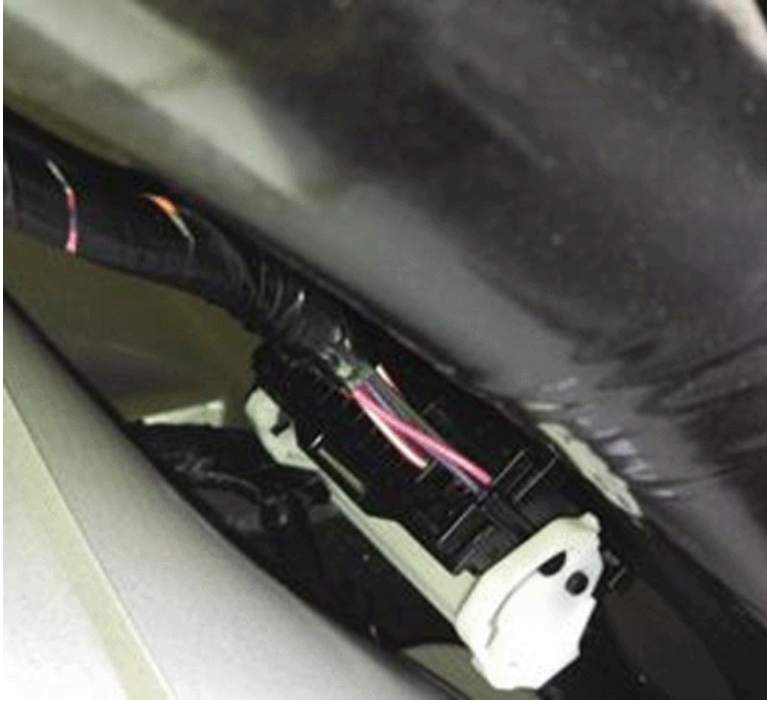
Locate X401 behind the D pillar.

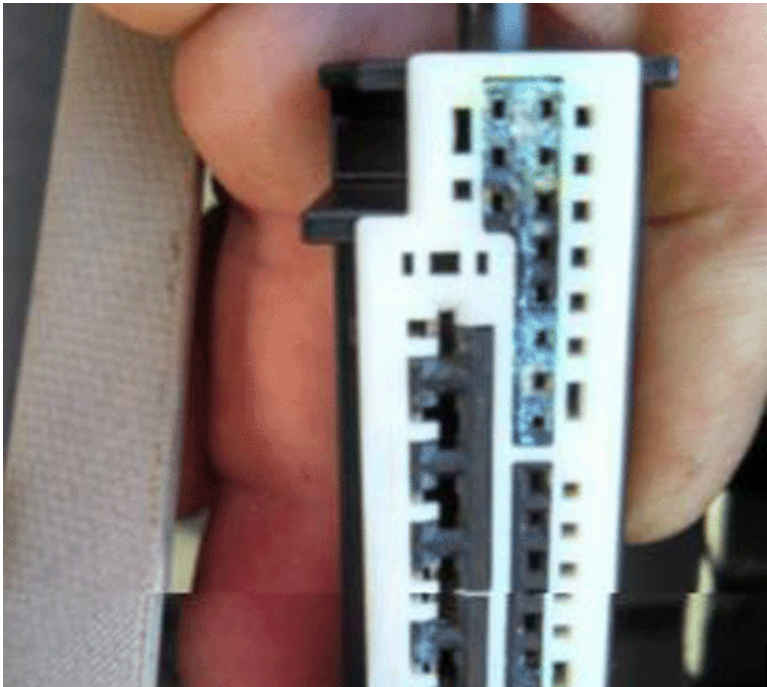
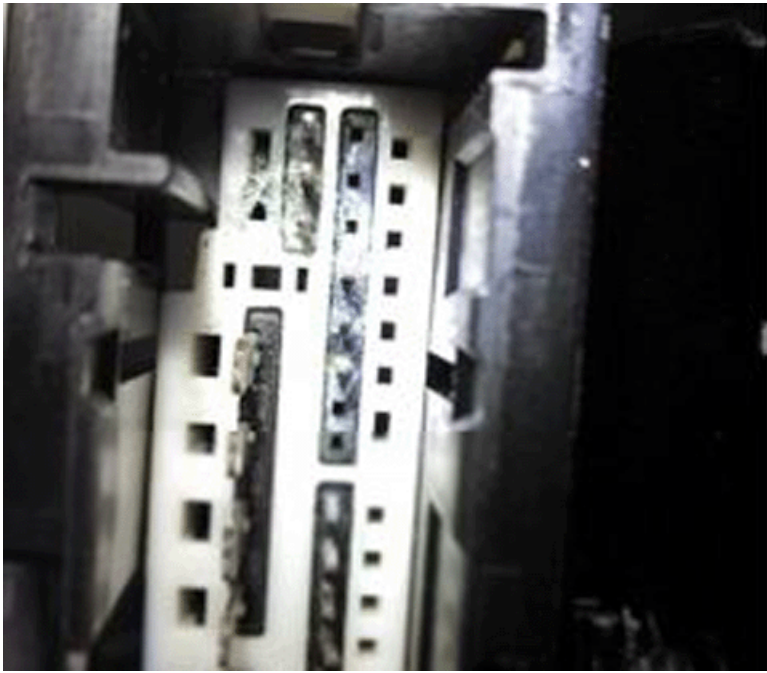
Inspect the connector X401 for terminal corrosion due to water intrusion. X401 terminal 12 circuit 24 may have a short condition between the backup camera input and the low speed data line circuit 5060 (terminal 14) to voltage when moisture was present in the connector and when shifted into reverse. Other circuits were also found corroded, but did not directly affect the customer's concern with the IPC and radio.

Disconnect X401 and check for corrosion.

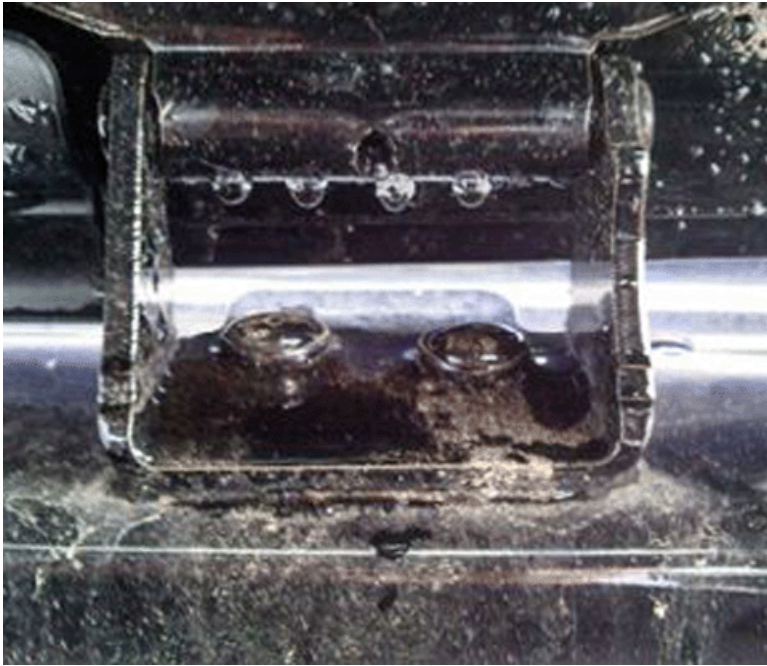
Water test the vehicle to isolate the cause of water intrusion above the passenger's side rear of the headliner. Water test around the passenger's side of the liftgate hinge.

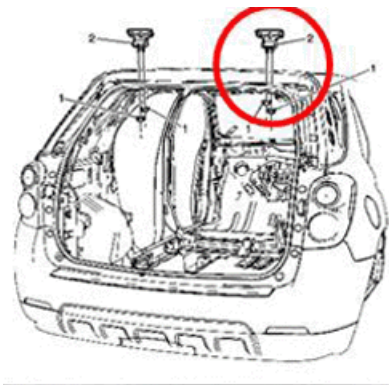
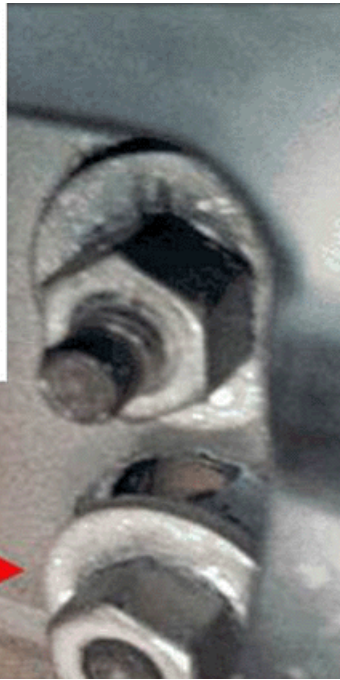
If water is found dripping from the passenger's side D pillar area, inspect the hinge nuts for proper Torque. Refer to SI for specifications.

To gain access to X401 pull the passenger-side D pillar trim back to gain access to the X401 connector. Possible water leak sources include the liftgate hinge fasteners. Please make sure that these fasteners are properly torqued. Refer to SI for specifications.
