Service Bulletin

PRELIMINARY INFORMATION

Subject: EBCM Wheel Speed Sensor Diagnostic Aid for ABS Message - Click Or Ratchet Noise - Service Traction Message - Service Stabilitrak Message - Service Steering Message

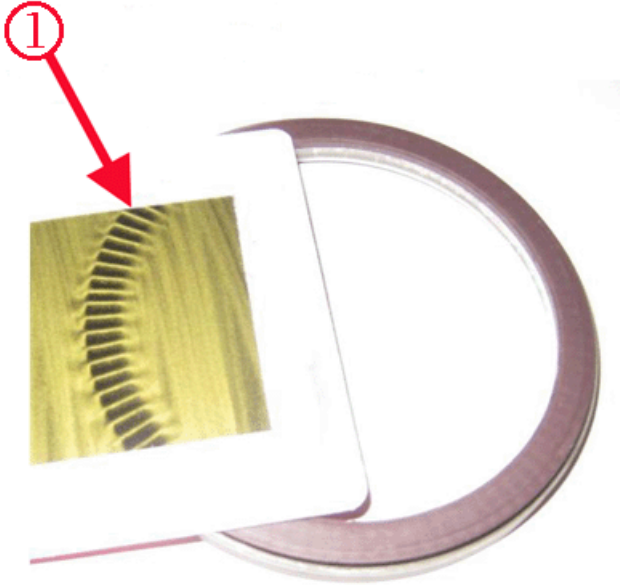
(1.) Wheel Speed Sensor

Magnetic Encoder Ring - North and South Poles are shown

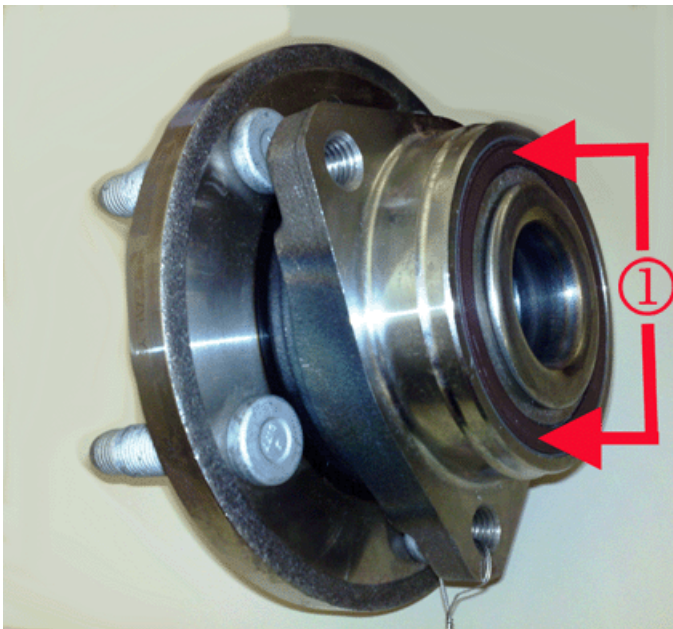
(1.) Magnetic Encoder Ring

Some new model vehicles today have begun to use a different type of wheel speed sensor encoder ring or tone wheel. Instead of a traditional mechanical type tooth tone wheel, the wheel speed sensor tone wheel is now made of a magnetized nitrile rubber ring, typically brown in color. This magnetic encoder consists of multiple North and South Pole pairs surrounding the outer circumference. When this magnetic encoder ring rotates and passes by the wheel speed sensor head; it generates a sign wave in the wheel speed sensor. The wheel speed sensor converts an analog signal to a digital square wave, and typical digital signal

values switch between 7mA (Low) and 14mA (High) DC current.

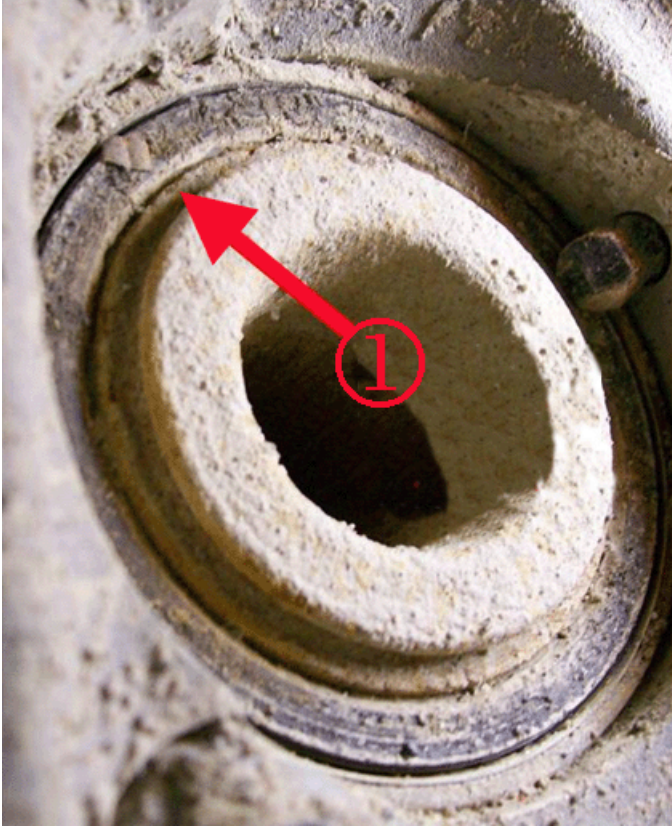
BEFORE CLEANING

These conditions may be caused by single or multiple pieces of ferrous metallic debris stuck to the wheel speed sensor magnetic encoder ring. This magnetic encoder ring is now part of the inboard bearing hub assembly.

(1.) Sample Debris

1. Based on the specific EBCM module Wheel Speed Sensor DTC code; inspect the appropriate corner magnetic encoder ring for possible debris.
 - C0035 Left Front Corner
 - C0040 Right Front Corner
 - C0045 Left Rear Corner
 - C0050 Right Rear Corner
2. If debris is found, perform the following cleaning recommendations.

- 2.1. Gently using a dry nylon soft bristle brush, remove the foreign debris off the magnetic encoder ring. If debris was removed, proceed to step 3.
- 2.2. If debris still remains, wash the encoder ring using a mild soap detergent and wipe dry.
