Service Bulletin

Subject: SES MIL DTC P0442

Models: 2010 - 2012 Buick LaCrosse
Equipped with 3.0L (RPO LF1) or 3.6L (RPO LLT)

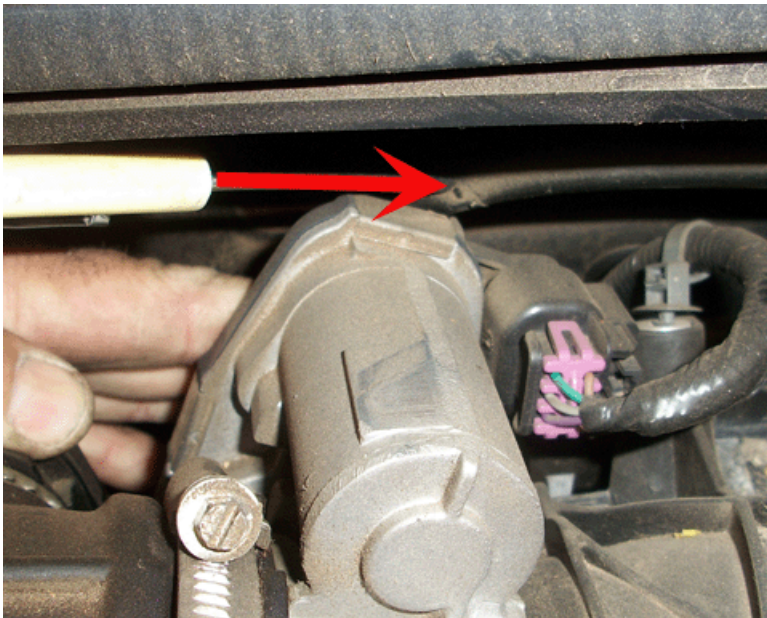
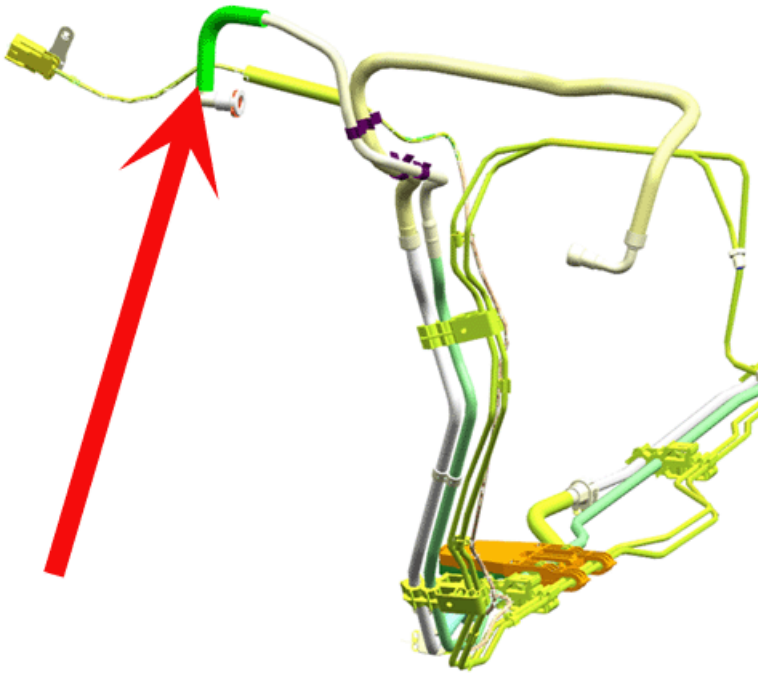
SES MIL illuminated with a DTC P0442 setting.

Note: The new evaporative pipe will have a conduit installed in the area of concern of the original pipe. Reference photos below.

Visually inspect evaporative pipe for contact with the throttle body. If contact is present, replace the evaporative pipe as needed and secure to eliminate future contact. Clear DTCs.
