Service Bulletin

Subject: SES Lamp On With DTC P2270

Models: 2013 Chevrolet Silverado
2013 GMC Sierra
Built with 4.8L 5.3L 6.0L RPO L20 LC9 LMG L96

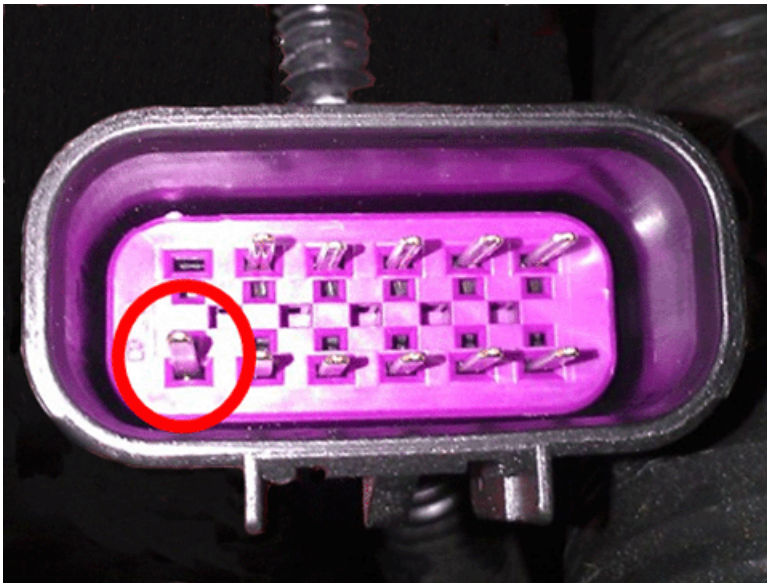
Concern of DTC P2270 setting along with any of the following codes P0140, P0139, P0138, P0137, P013A, P013B on vehicles built at the Fort Wayne and/or Silao assembly plants during January or February of 2013.

Check connector X131 for a bent terminal F as indicated in the attached PIC and repair per SI procedures.

If no connector issue is found, follow SI diagnostics.
