Service Bulletin

PRELIMINARY INFORMATION

Subject: Front Seat Cage Nut Spins - Unable To Remove Bolt

Models: 2010 - 2014 Chevrolet Camaro

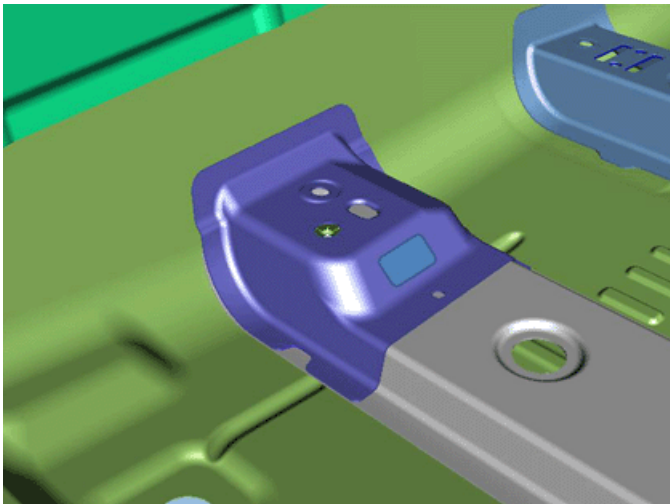
A technician may experience difficulty removing a seat and state the bolt is spinning but not coming out of the floor pan. This could be caused by a cage nut that broke loose from the weld in the floor pan during removal of the bolt.

1. To remove the seat you will need to cut or drill the head of the bolt off.
2. Remove the seat following published procedures and re-position the carpet as needed to allow the remainder of the steps to be completed.
3. Cut a square hole 45 mm (W) X 35 mm (H) in the Seat Anchor Bracket containing the loose cage nut, as illustrated below.

4. Remove the cage nut from the Seat Anchor Bracket and, using a vise and pliers, remove the remainder of the bolt from the nut. Clean the threads of the nut as necessary.
5. Drill two 5mm holes next to the bolt hole in the Seat Anchor Bracket. These holes should be 180 degrees opposite of each other. This will allow the nut to be tack welded back in place.

Important: It is critical that the nut be centered in the hole. If it is off to either side of the car, this will cause the seat track to bind.

6. Holding the nut in the proper location, place two tack welds in the previously drilled holes to retain the nut to the bracket.
7. Clean the welds to allow proper fit of the seat adjuster to the floor pan.
8. Apply the anti-corrosion materials to the repair area and paint as necessary.
