Service Bulletin

Subject: Rear Sliding Glass Inoperative Or Noisy (Pulley Cover Separation)

Models: 2014 Chevrolet Silverado LD 1500

2014 GMC Sierra LD 1500

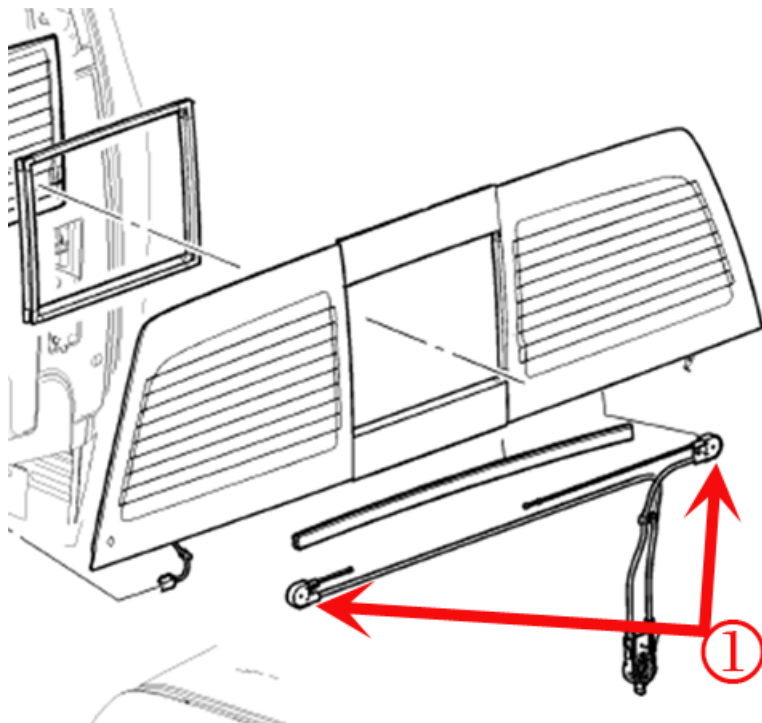
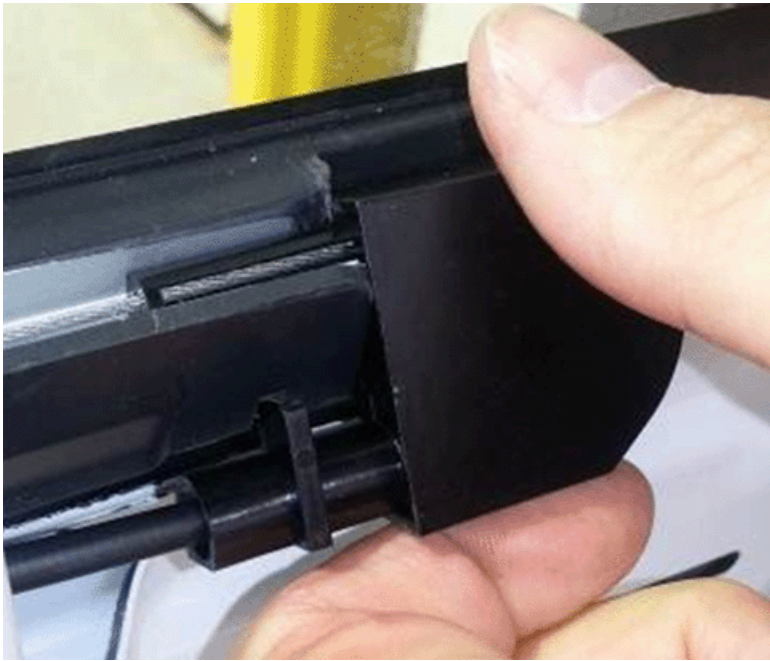
Some owners may comment on the rear sliding glass being inoperative or noisy when operated. This could be caused by the cable pulley cover becoming separated, see photos below.

Note: Do NOT replace the complete back sliding glass assembly for this issue.

Do replace the rear sliding window regulator assembly (GM part number 23175121).

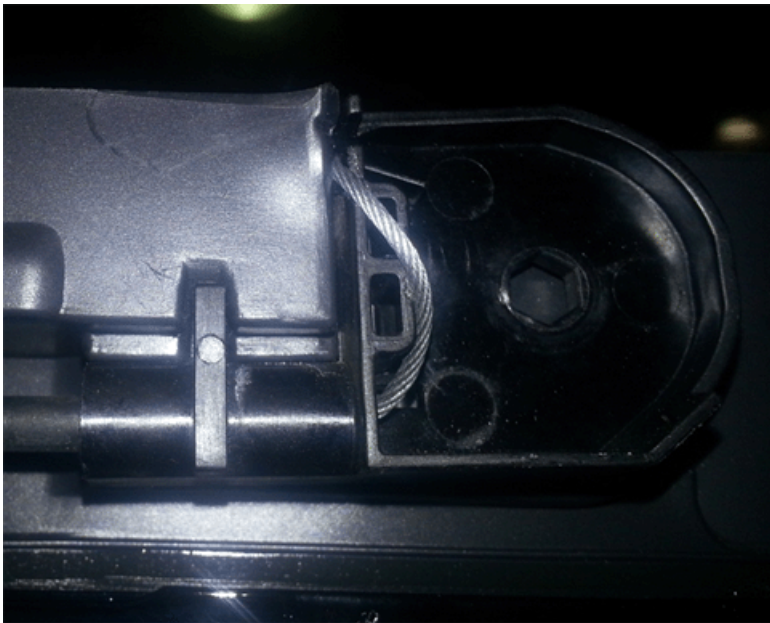
If the cable pulley cover completely disengages, the pulley can come off and cause the cable to bind, see photo below.
