Service Bulletin

PRELIMINARY INFORMATION

Subject: Tick Noise And/or Misfires On AFM Cylinders 1 4 6 And/or 7

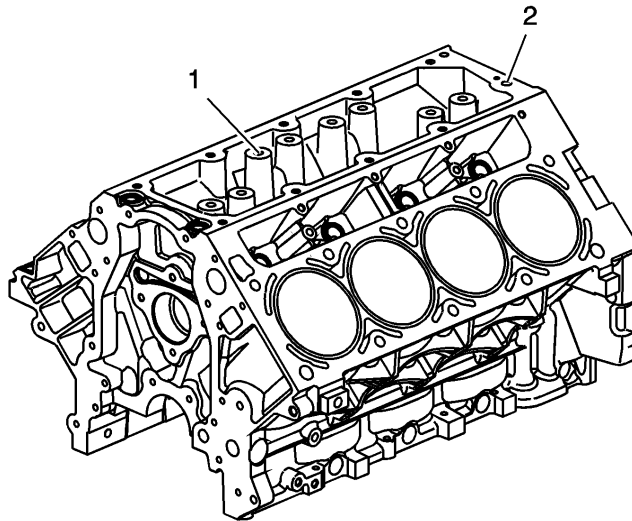
- Clean out the related lifter control oil passages (item 1 below) while the old lifters are removed. Generally, it is only necessary to blow through the passages with shop air but if a lot of debris is noted, it may also be necessary to flush the passages out with brake cleaner. The oil should be changed after doing this since the cylinder heads will be off to replace the lifters anyhow.
