Bulletin No.: PIT5224

# Service Bulletin

Subject: Updated Left and Right I/P Fuse Block Labeling

Models: 2014 Chevrolet Silverado 1500

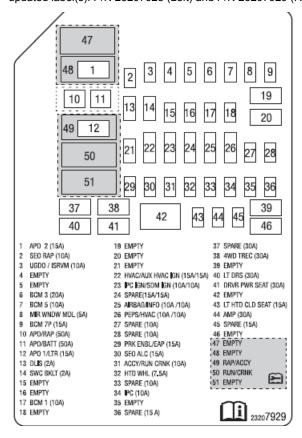
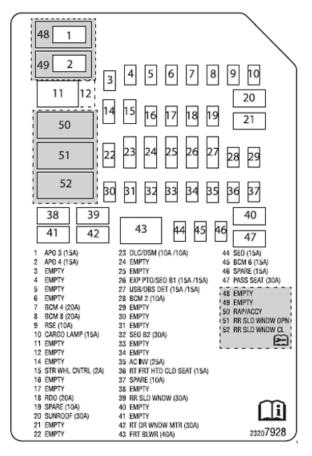
After inspecting the Left and/or Right I/P Fuse Block Labels, it may be noted the numbering is incorrect.

Inspect the lower right corner of each label for P/N 23114670 (Left) and/or P/N 23114671 (Right). If these part numbers are found, replace the label(s) with updated label(s): P/N 23207928 (Left) and P/N 23207929 (Right). See photos below of the updated labels.
