Service Bulletin

PRELIMINARY INFORMATION

Subject: Engine Misfires due to Major Carbon Deposits on the Intake and or Exhaust Valves

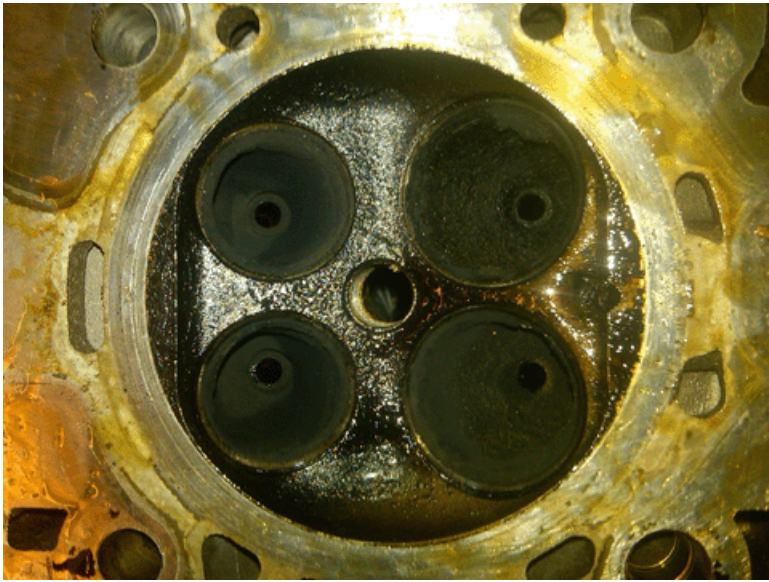
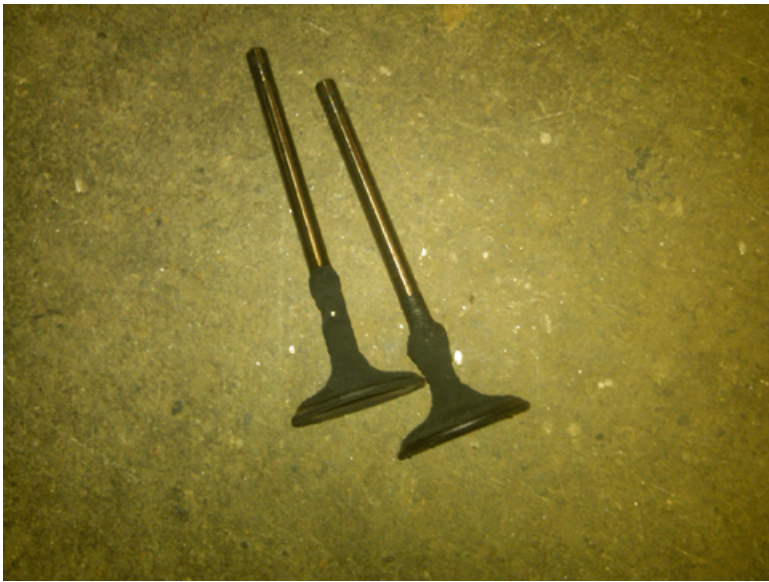
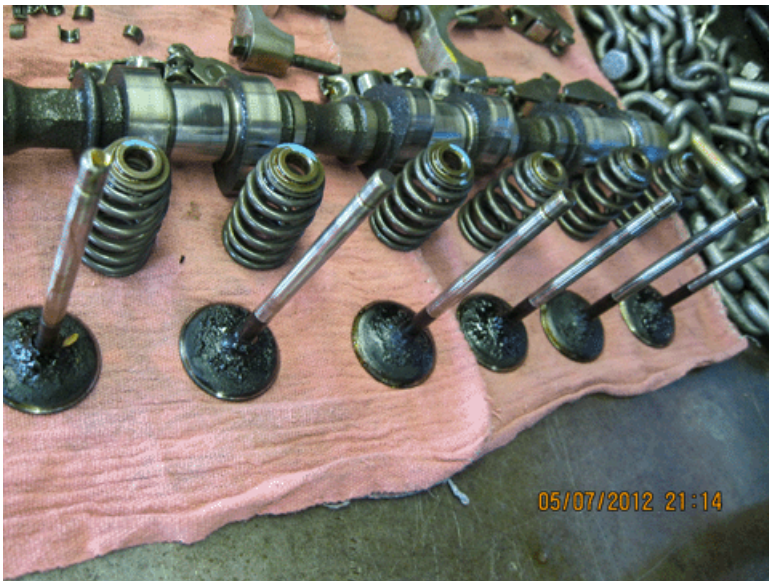
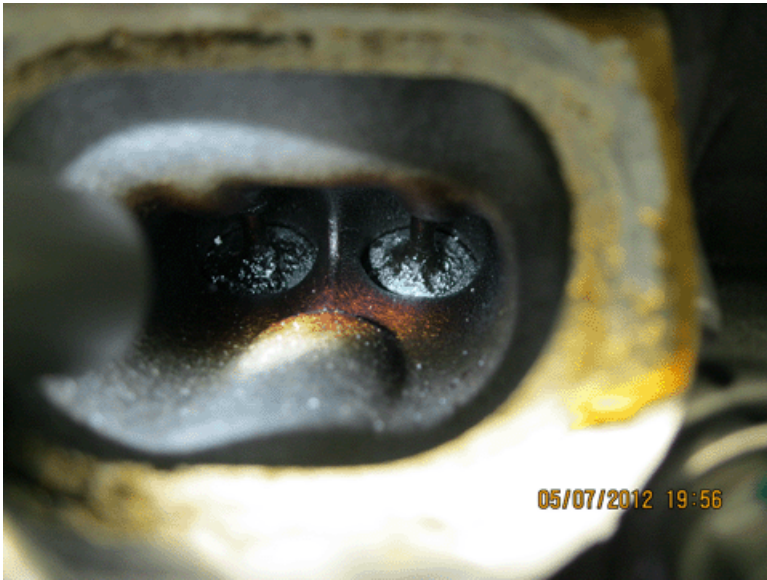
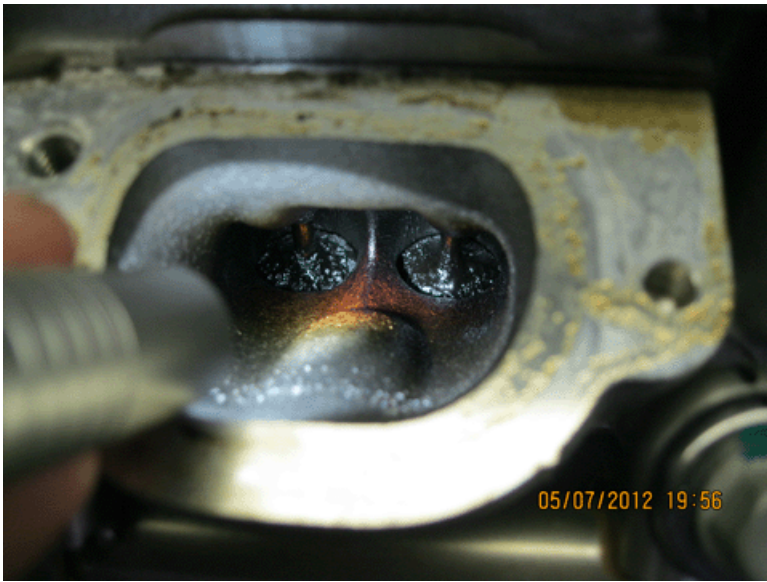
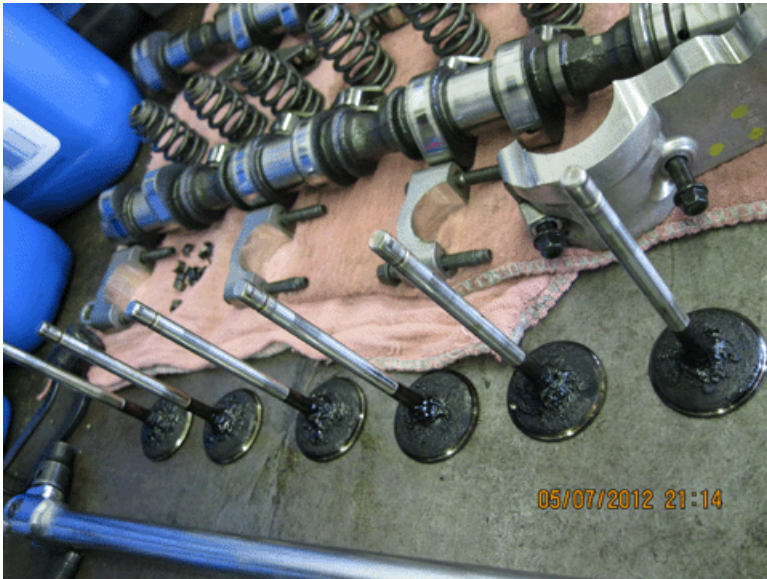
Some customers may complain of a MIL and engine misfire. In some cases, the misfire may be more apparent on a cold start, may count on a single cylinder or several cylinders, and may or may not be felt by the driver. Upon inspection, the technician will find one or more misfire codes (DTC P0300-P0306) stored in the ECM and SI diagnosis may or may not isolate the cause of the misfire depending on whether the intake/exhaust valves are sticking at the time of the diagnosis.

This may be the result of major carbon build up on the intake and/or exhaust valves as shown below so the misfires should not have appeared until accumulating at least 5,000 miles or more.

If this concern is encountered, perform SI diagnosis. If SI diagnosis isolates a valve sealing concern and/or eliminates everything else external to the engine, decarbon the engine with Upper Engine and Fuel Injector Cleaner by following the guidelines below:

1. In a well-ventilated area with the engine at operating temperature, slowly/carefully induce a bottle of GM Upper Engine and Fuel Injection Cleaner into the engine with RPM off of idle enough to prevent the engine from stalling (typically around 2,000 RPM or so). Depending on the engine configuration, induce the cleaner through the throttle body or an engine vacuum hose/pipe. For best results, it is suggested to induce the cleaner through the throttle body with Kent Moore Tool # J-45076 / J-35800-A or equivalent (shown below).

2. Turn the engine off after inducing the cleaner and allow the cleaner to soak with the engine off for 2.5 to 3 hours (Do not let cleaner soak for more than 3 hours as remaining deposits may start to harden back up again).
