Bulletin No.: PIC5822A

Service Bulletin

Subject: Water On Floor And/Or Carpet

Models: 2010 - 2014 Buick LaCrosse

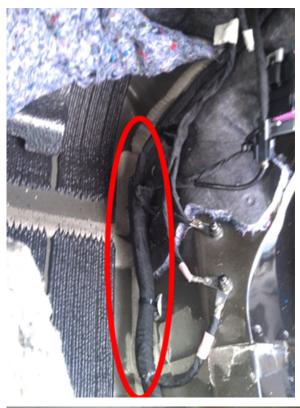
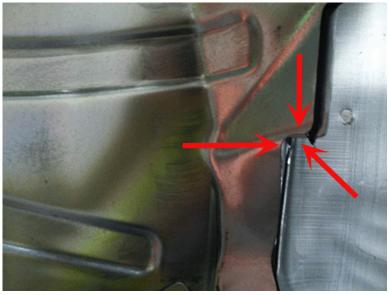
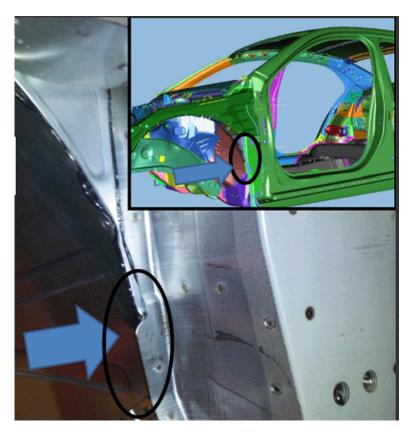
A customer may comment of mildew odor or water on front floor on either side of the vehicle.

Technician should pull back carpet and insulator as shown in pictures below for the suspect side of the vehicle (passenger side shown). Remove the front wheelhouse liner and spray water into the wheelhouse of the affected side and check for water in the area indicated in photo shown below. Water will enter around applied sealer as cavity fills. The front wheel house flange may have a void in the sealer. Seal the void using a thumb grade sealer (service manual calls for "heavy-bodied caulking material") pushed into the void from the wheel opening. For location of flange please reference the graphics below.
