Service Bulletin

Bulletin No.: PIT5223

Subject: Front Driver Or Passenger Seat Cover / Cushion Loose

Models: 2014 Chevrolet Silverado 1500

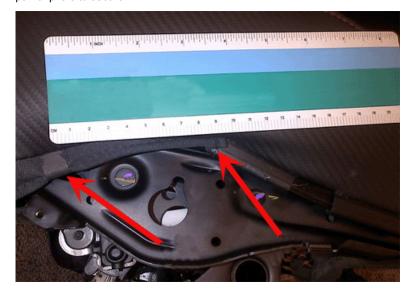
Some customers may comment that the front driver's or passenger's seat cover/cushion is loose.

To correct this issue, install U-clips to help secure the cover to the seat frame. Use a U-Clip on the inboard and outboard side of the seat (2 clips per seat), as shown below - with the clip to be installed approximately 9 cm away from the right arrow seat frame location. After the U-clips are installed, crimp each clip with pair of pliers to secure.
