Service Bulletin

Subject: Front Door Window Belt Molding Retainer Bolt Corrosion

Models: 2014 Chevrolet Silverado 1500

2014 GMC Sierra 1500

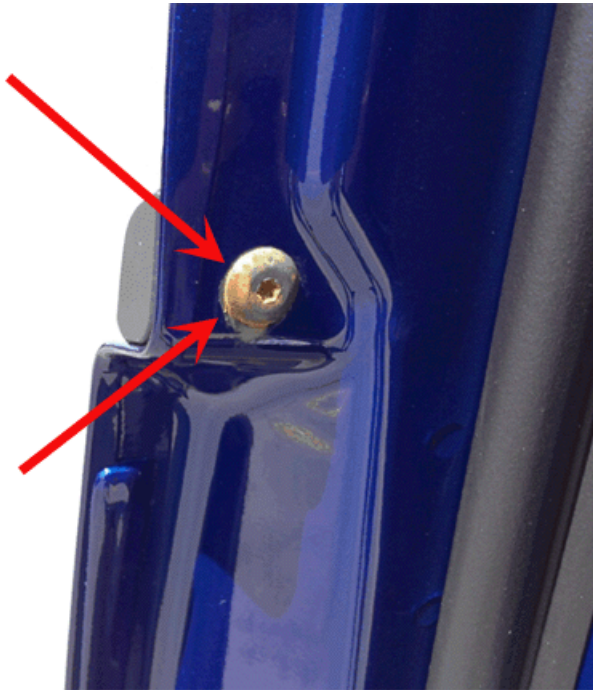
Some owners may comment that the front side door window belt molding retainer bolt is corroded, see photo below.

To correct this issue, replace the Bolt with GM Part # 11515397. Apply Red Thread Adhesive (GM Part # 89021297, Canada Part # 10953488 or equivalent) to the bolt threads and tighten to 27 lb-in (3 N-m).
