Date: Sep-2013

Service Bulletin

Subject: Trunk Lid Does Not Self Raise Completely

Models: 2014 Chevrolet Impala

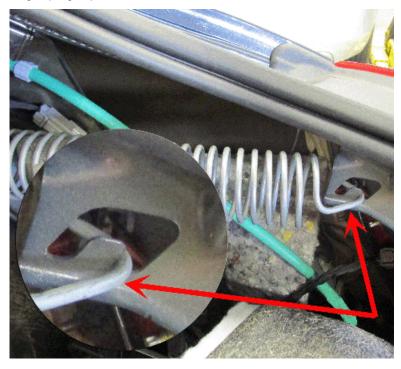
It may be noticed that the trunk lid does not self- raise to the full upright position when released. This applies only to vehicles with Factory-Installed Rear Spoiler or Dealer-Installed GM Accessory Rear Spoilers.

Assure that both trunk lift springs are in the rear-most position, as shown below. Refer to the procedure in Service Information for the Rear Compartment Lid Hinge Spring Replacement.
