# Service Bulletin

## PRELIMINARY INFORMATION

**Subject:** Radio Resets, Navigation Inoperative, Map Not Displayed, DVD Will Not Play or Resume, Bluetooth® Inoperable, Radio Lockup, Voice Recognition Cuts Off, USB Source not Returning to Last Song, OnStar® Default Volume Low

**Models:** 2013 Buick Enclave  
2013 Chevrolet Traverse  
2013 GMC Acadia  
Equipped with Radio RPOs UHU, UG4, UGU, UGY, UGX

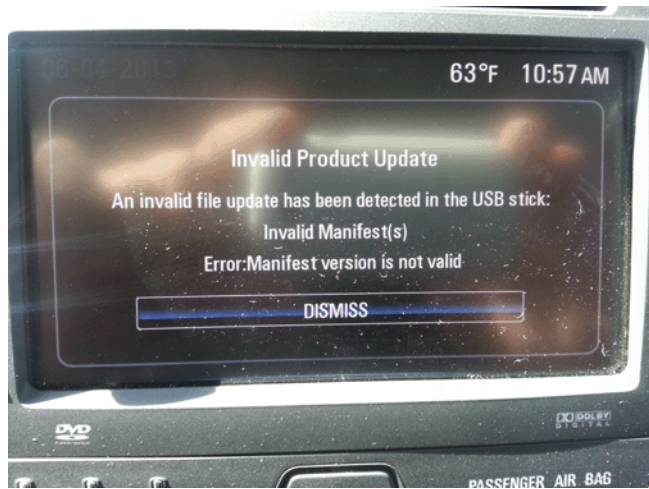
**Note:** If the following screen above is shown on the screen, the radio already has the latest calibration installed and no further action is required.

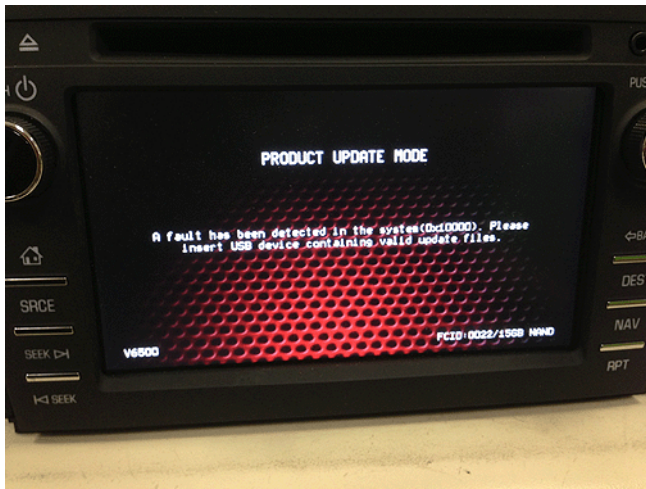
- Removing the USB drive during the software installation will cause radio failure.
  - If the above screen message is displayed or the radio will not power up after software update, hold Eject for 5-15 seconds. Once powered up, perform the software update. If this problem persists, contact TAC for further assistance.
5. To ensure the software update was successful, use Diagnostic tools Tech 2 to confirm the new software part number. If the part number is **23162853**, then the update was successful.
6. Re-enter any custom settings recorded prior to the update.
