Service Bulletin

PRELIMINARY INFORMATION

Subject: Exhaust Rattle Noise

Models: 2011-2013 Chevrolet Camaro Convertible
Equipped with V8 Engine (RPO L99)

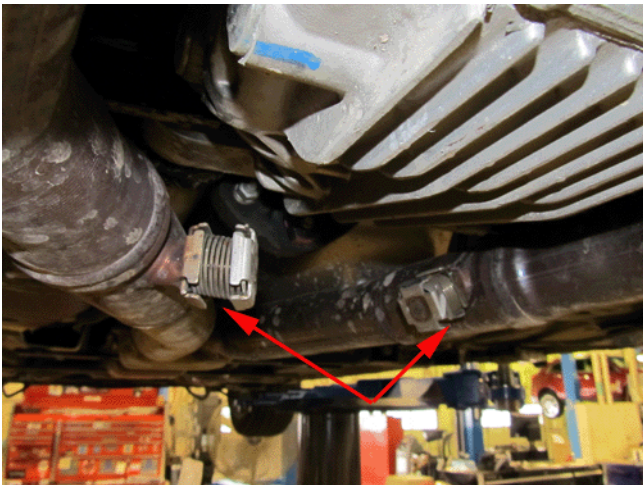
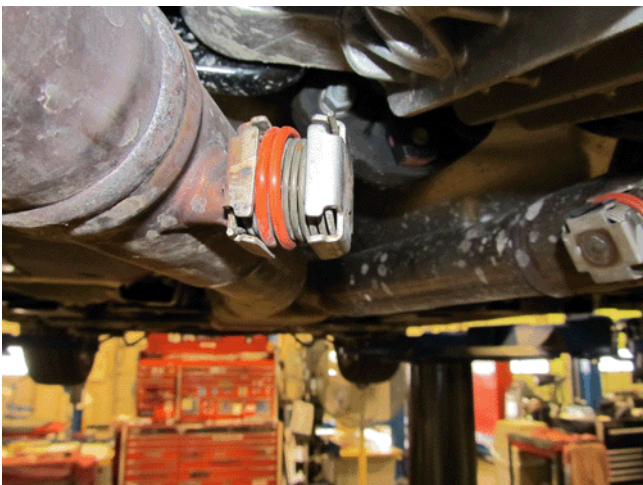
Some customers may comment on an exhaust rattle or noise when at idle or slow vehicle speeds up to 1300 engine rpm.

The spring in the exhaust valve may be causing the exhaust to rattle or make noise.

Technicians should follow the procedure below and install two silicone O-rings over each of the exhaust valve springs to dampen the rattle.

1. Raise the vehicle.
2. Install two O-rings onto the left exhaust valve spring.
3. Install two O-rings onto the right exhaust valve spring.
4. Lower the vehicle.
