Service Bulletin

Subject: Information on Water Pump Replacement

Models: 2013-2014 Buick Encore
2011-2014 Chevrolet Cruze
2012-2014 Chevrolet Sonic
2013-2014 Chevrolet Trax
All with Engine RPO LUJ, LUV

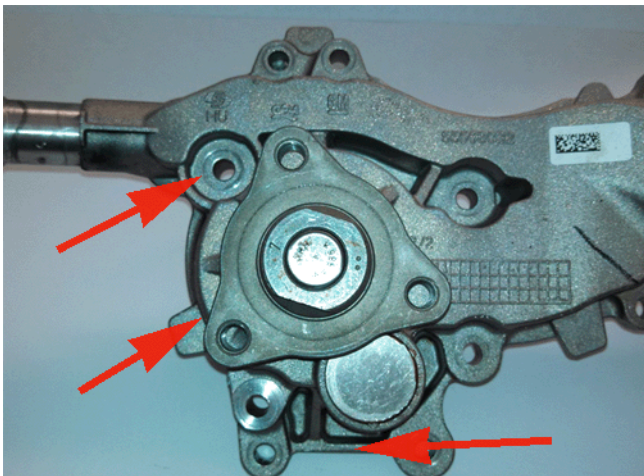
If the water pump housing shows minimal coolant deposits as shown below, do not replace the pump. The water pump is functioning as designed.

- No evidence of coolant leakage on the pump body.

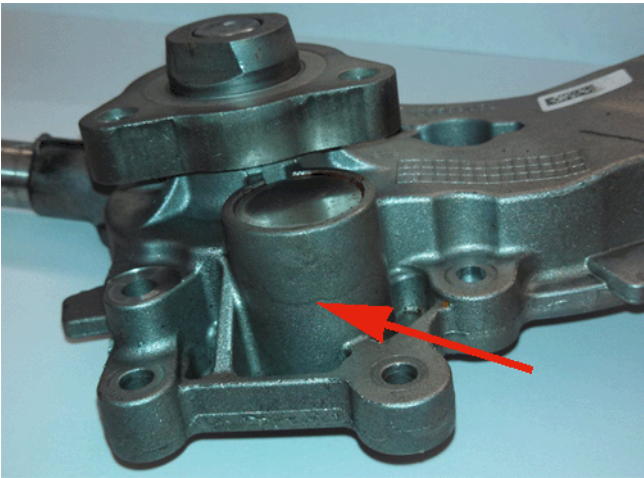
- Slight coolant staining on the underside of the housing.

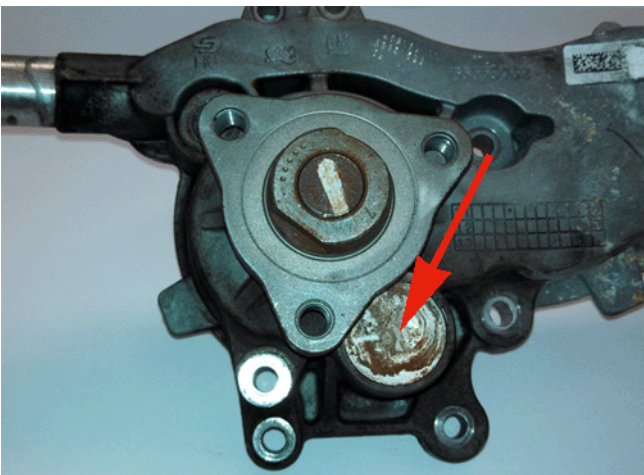
If the pump housing displays excessive evidence of leaking as shown below, replace the pump. Refer to Water Pump Replacement in SI.

- Significant coolant residue on the cover plate.
