Service Bulletin

SUBJECT: Service Update for Inventory Vehicles Only Rear Side Door Reveal Molding Contact Expires February 28, 2014

MODELS: 2012-2013 Cadillac Escalade ESV, Escalade EXT

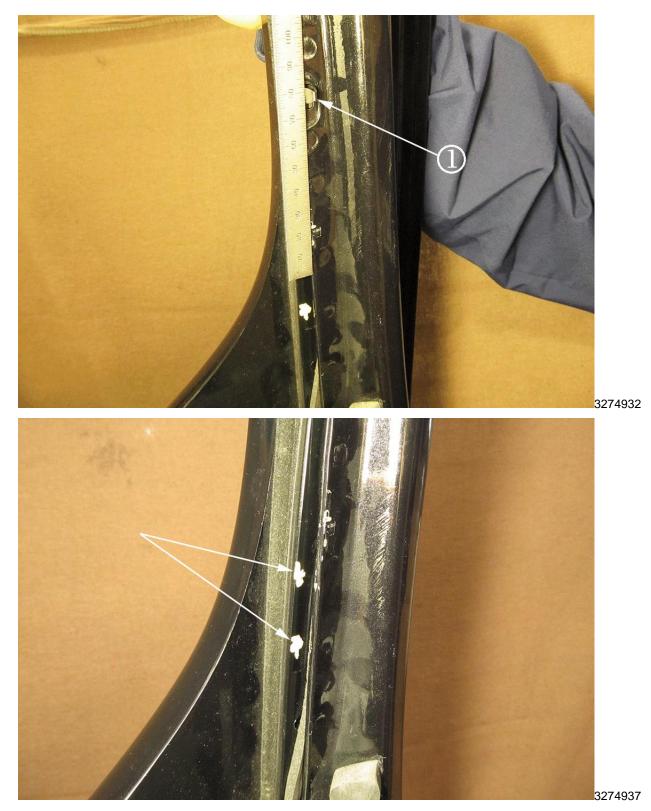
Note: The window reveal molding has a recessed flat area in the approximate location to mount the spacer.

Locate the lowest clip (1) on the rear edge of the window reveal molding. Measure 75mm (3 in) below the clip and mark the location on the molding. Measure 25mm (1 in) down from the first mark and mark the lower point.

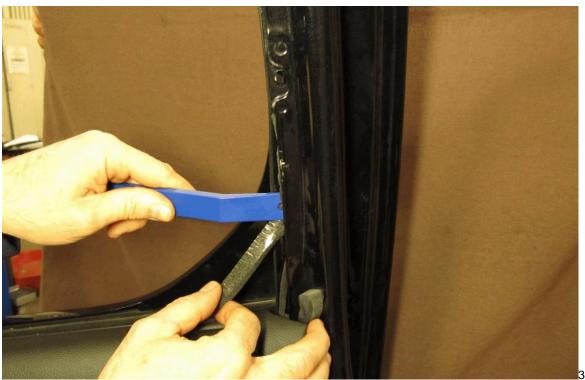
3274867

Note: The added weatherstrip is a wind / road noise measure.

- 9. Cut a section of 3/8" x 5/16" closed cell self-adhesive Kent Industries material P/N P46490, or the equivalent, to 210mm (8.26 in) length, and then remove the adhesive backing.
- 10. Using a trim stick, insert the weatherstrip just below the reveal molding clip, then around the spacer, and down toward the end of the molding below the beltline.
