# Service Bulletin

**SUBJECT:** Service Update for Inventory Vehicles Only  
Automatic Radio Volume Increase and/or Radio Control Assembly Buttons  
Not Operating as Designed  
Expires January 31, 2014

**MODELS:** 2013 Cadillac ATS, SRX, XTS

Date: February 1, 2013  
Subject: 13003A - Service Update - Inventory Vehicles Only  
Automatic Radio Volume Increase and/or Radio Control Assembly Buttons  
Revised Service Procedure  
Models: 2013 Cadillac ATS, SRX, XTS  
To: All Cadillac Dealers  
Attention: General Manager, Service Advisor, Service Manager, Parts and Service Director,  
Parts Manager, New Vehicle Sales Manager, and Warranty Administrator

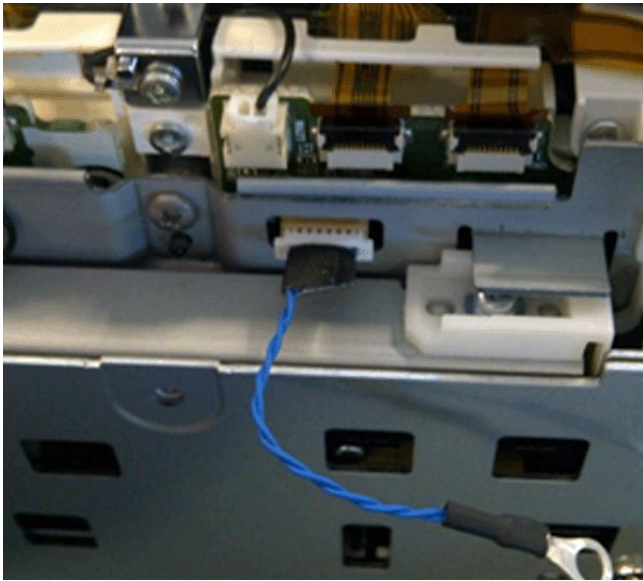
3269805

**Note:** Some radio control assemblies have the Ground Jumper “C” wire already installed. If the Ground Jumper “C” wire is installed, proceed to step 9. Perform steps 9-22.

6. Install Ground Jumper “C” wire. Refer to illustration. Ensure connector is carefully seated in a perpendicular fashion so pins do not bend.

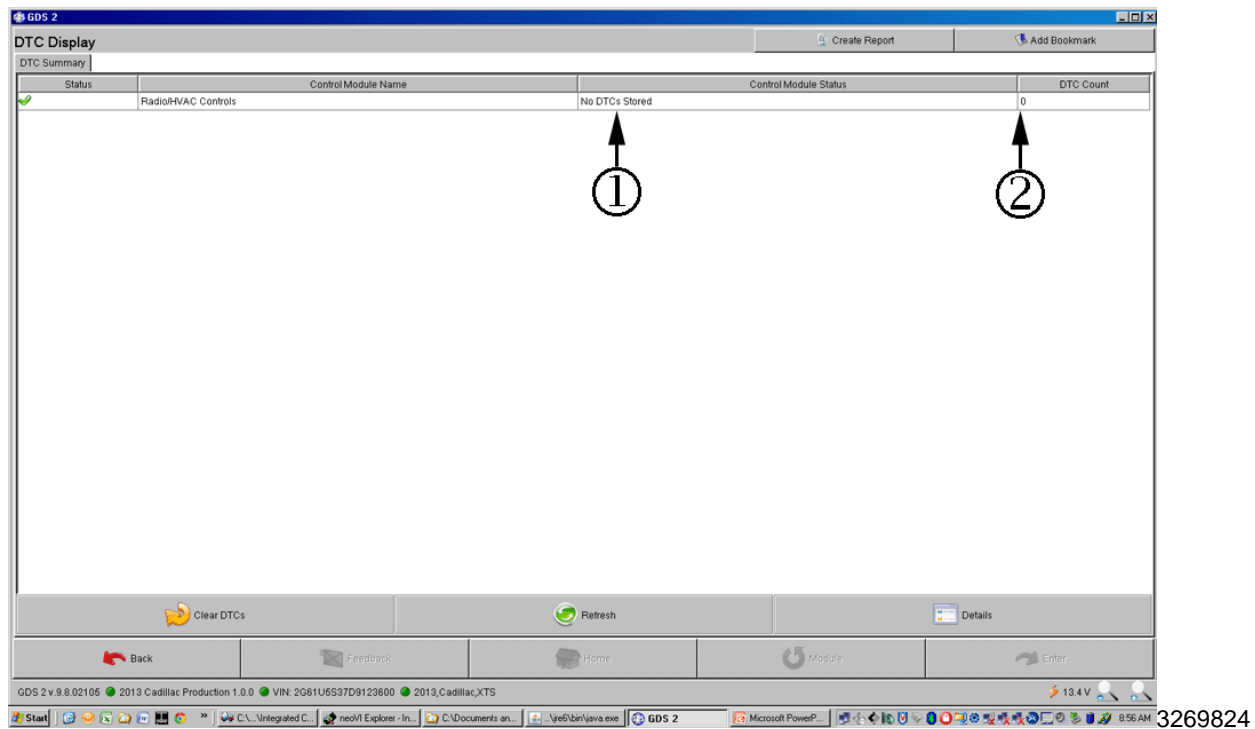
3269824

19. Select enter and wait for the DTC query to finish. A “No DTCs Stored” (1) and “0 DTC count” (2) message will appear in the center and upper right hand corner of the screen if no DTCs are present. A DTC count 1 message will appear if a DTC is present.

- If no DTCs have been set, proceed to step 20.
  - If DTC 101E.41 is set, reprogram the radio control assembly. Refer to Step 12.
  - If DTC 101D.3B is set, replace the radio control assembly. Refer to *Radio Control Assembly Replacement* in SI. **Proceed to step 20 after replacing the radio control assembly.**
