Service Bulletin

SPECIAL COVERAGE

SUBJECT: Special Coverage Adjustment - Shift Lever May Not Display Correct Gear

MODELS: 2007-2008 Saturn AURA
Equipped with 4-Speed Automatic Transmission (ME7/MN5)

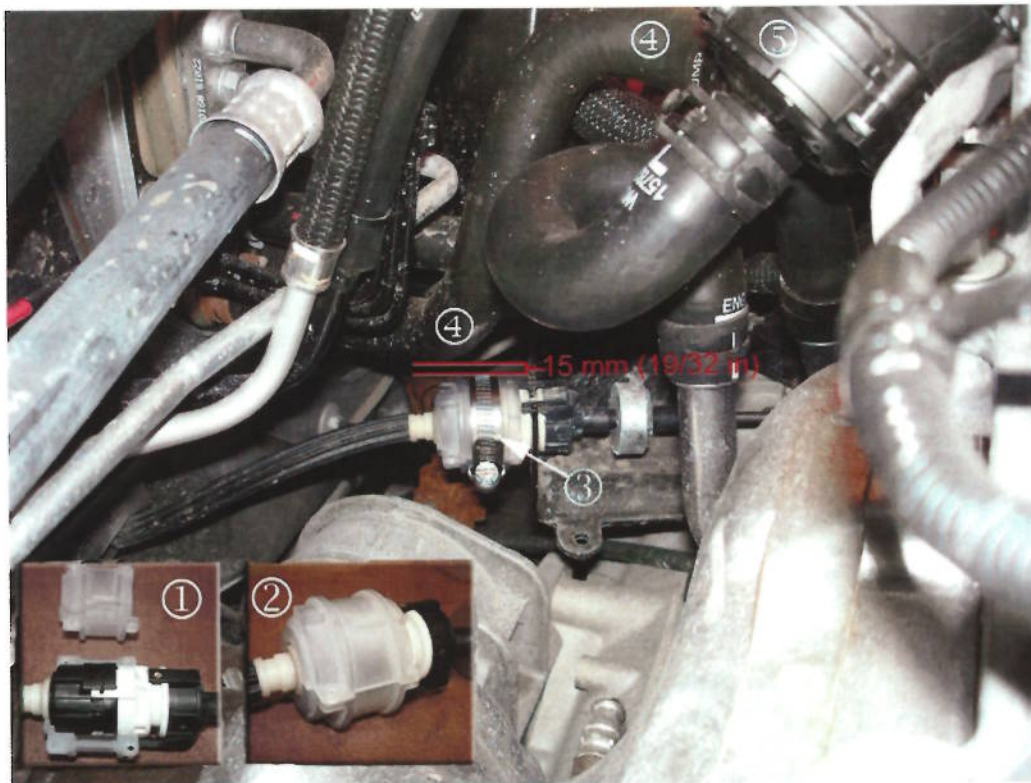
2269484

Hybrid vehicle shown. Combustion engine vehicle is similar.

- (1) Clam Shell in Two Pieces
- (2) Clam Shell Around Shift Cable Locking Tabs
- (3) Clamp on Clam Shell
- (4) Inlet Coolant Hose and
- (5) Heater Cooler Pump.

5. Install the clam shell (1) (2) over the shifter cable locking tabs.
6. Install the service clamp over the clam shell (3). Position the clamp fastener head away from the inlet coolant hose (4). **Tighten the clamp to 4 N·m (35 lb-in).**
7. Ensure that there is 15 mm (19/32 in) of clearance between the inlet coolant hose (4) and the clam shell (3). On hybrid equipped vehicles, it may be necessary to reposition the inlet coolant hose (4) to achieve the required 15 mm (19/32 in) of clearance. **To reposition the inlet coolant hose (4) on hybrid equipped vehicles, locate the heater cooler pump (5) and perform Steps 5.1-5.4.**

Caution: Do not kink or damage the inlet coolant hose (4) when repositioning the hose to obtain the 15 mm (19/32 in) clearance. To avoid damaging the hose clamp, use J-38185 or equivalent hose clamp pliers to loosen the hose clamp.

- 7.1. Using J-38185 or equivalent hose clamp pliers, loosen the inlet coolant hose (4) connected to the heater cooler pump (5). Note the location of the clamp on the inlet coolant hose (4).
- 7.2. Rotate the inlet coolant hose (4) clockwise until 15 mm (19/32 in) of clearance between the inlet coolant hose (4) and clam shell (3) is achieved.
- 7.3. Ensure that the inlet coolant hose clamp is secure on the inlet coolant hose (4) in the production location.
- 7.4. Install the generator control module cover. Refer to *Generator Control Module Cover Replacement* in SI.
