Service Bulletin

SUBJECT: Service Update for Inventory and Customer Vehicles
Product Enhancements – Interior Trim
Expires with Base Warranty

MODELS: 2013 Cadillac XTS

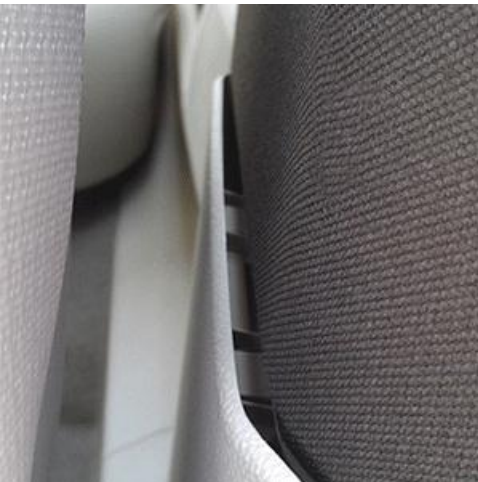
3257856

3. Inspect driver and passenger side center pillar trim panels to determine if the panels fit loose or have a gap between the lower and upper center pillar trim panels.
 - If the center pillar trim panels are not loose and no gap is present between the upper and lower center-pillar trim panels, proceed to step 4.
 - If the lower center pillar trim panels are loose and there is a gap between the upper and lower center pillar trim panels, replace the lower center pillar trim panel (s). Refer to *Center Pillar Lower Trim Panel Replacement* in SI.

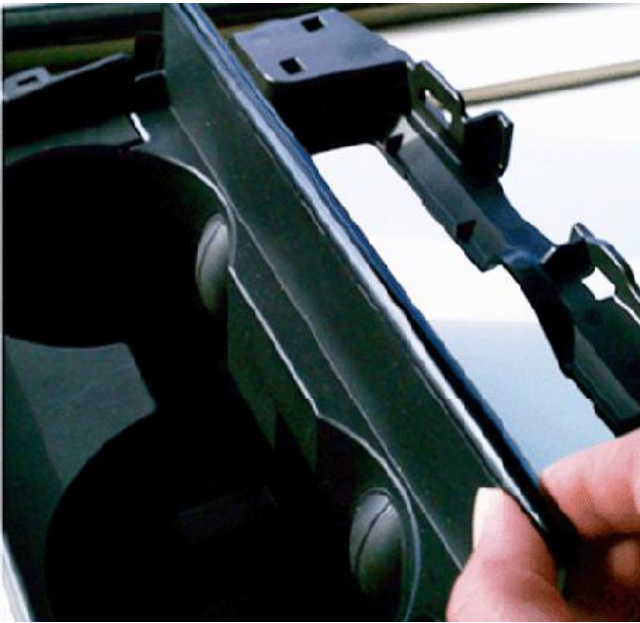
2964017

4. Inspect the condition and function of the console cup holder door assembly. The inner and outer portions of the console cup holder door cover may not be snapped together. Pinch the two corners of the door if they are separated to engage and snap fit the retention features.
5. Remove the windshield defroster grille. Refer to the *Windshield Defroster Nozzle Grille Replacement* in SI. Always use a flat bladed plastic trim tool to release the retainers to prevent damage to the instrument panel upper trim panel.
6. Place the windshield defroster grille on a clean level surface with the backside facing up.
7. Using Kent Automotive BRS (Felt) Tape, P/N KT13486 or equivalent, cut five 15 mm x 60 mm strips.

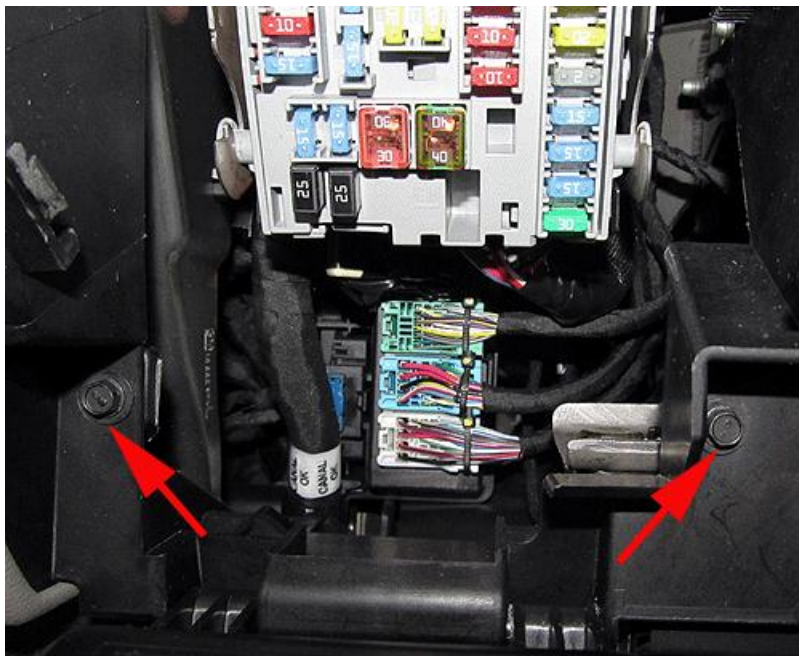
IP Storage Compartment Door Binds or Opens Very Slowly

Note: This procedure should move the rack upward slightly to release excessive engagement of rack and pinion gears.

1. Open bin door with release tabs.
2. Loosen two screws.
3. While pulling downward on left side, tighten the left screw first and then tighten the right screw.

Note: If the bin door is still slow, then repeat steps 2-3, but add an upward push at the bottom right side BEFORE tightening the right screw. Replace the IP storage compartment if the adjustment does not correct the condition. Refer to *Instrument Panel Knee Bolster Replacement* in SI.

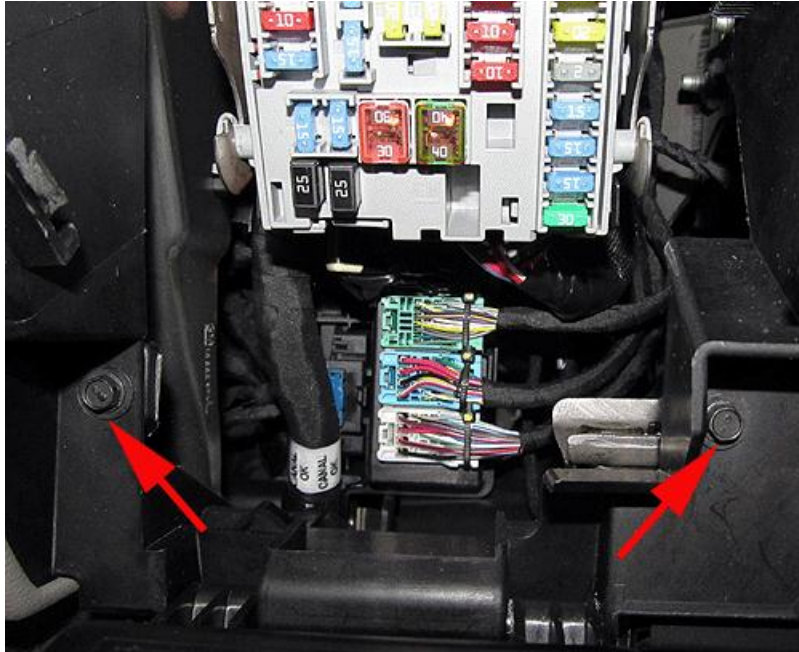
IP Storage Compartment Door Opens Very Fast and/or Creates Zip Noise

Note: This procedure should move the rack downward slightly to create more engagement of the rack and pinion gears.

1. Open bin door with release tabs.
2. Ensure pinion gear is seated.
3. Loosen two screws.
4. While pulling downward on the right side, tighten the right screw first and then the left screw.

Note: Replace the IP storage compartment if the adjustment does not correct the condition. Refer to *Instrument Panel Knee Bolster Replacement* in SI.

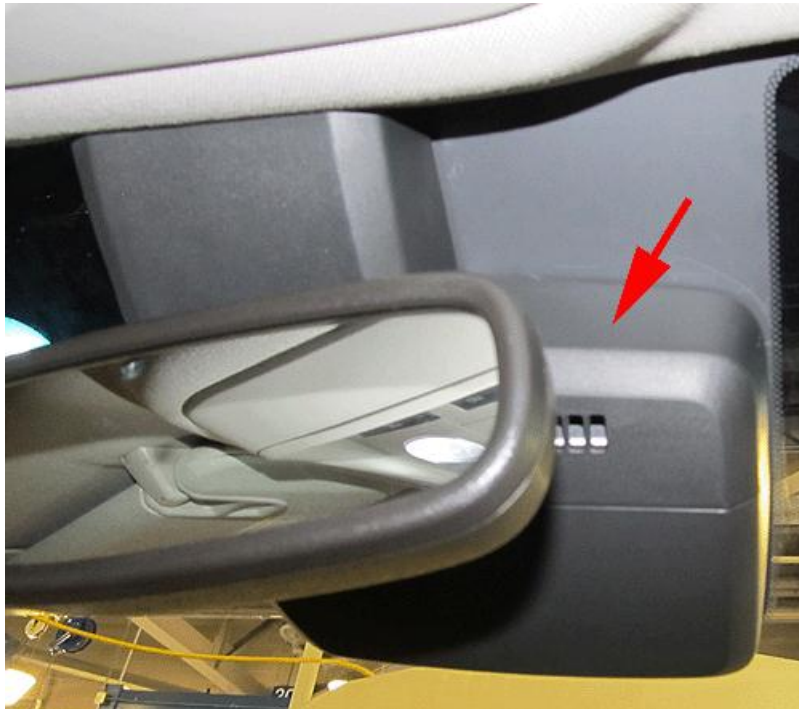
3258661

15. Locate the windshield multifunction sensor mount bracket cover. The inside rearview mirror arm protrudes through the center of the windshield multifunction sensor mount bracket cover.
16. Gently rock the windshield multifunction sensor mount bracket cover in a cross-car direction. The cover should feel solid and not separate into two halves or fall off the windshield.
 - If the windshield multifunction sensor mount bracket cover does not separate into two halves or fall off the windshield, no further action is required.
 - If the windshield multifunction sensor mount bracket cover does separate into two halves or falls off the windshield, proceed to step 17.
