# Service Bulletin

**SUBJECT:** Service Update for Inventory and Customer Vehicles  
Transmission Fluid Leak  
Expires with Base Warranty

**MODELS:** 2013 Cadillac SRX  
Equipped with 6-Speed Automatic Transmission (6T70)

Subject: 13077 – Service Update Bulletin  
Transmission Fluid Leak

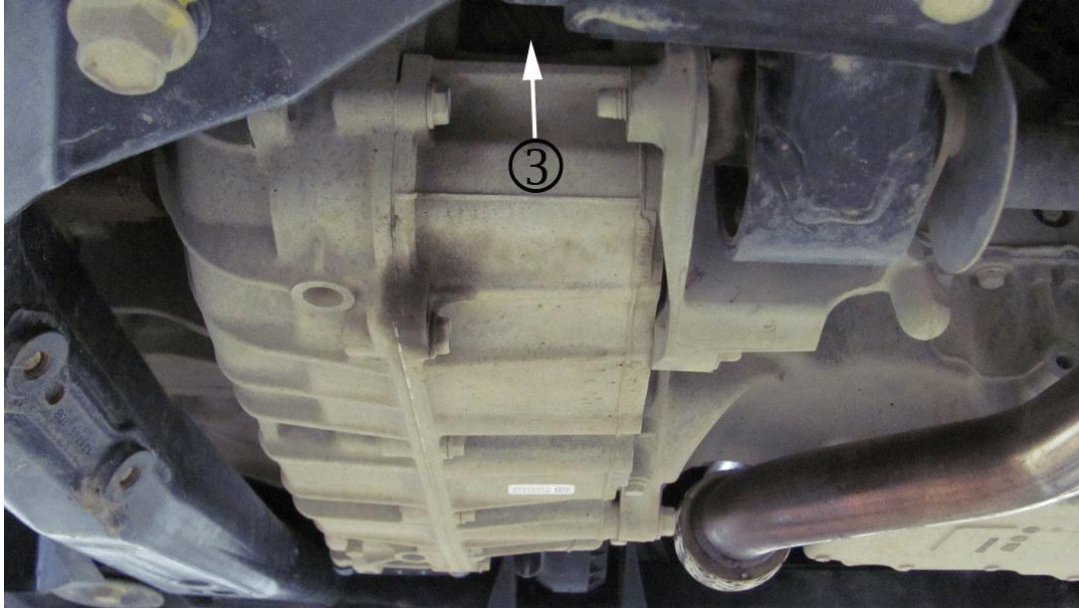
3337569

The arrow in the photograph points to where the casting information is located on the torque converter housing. Use a flash light and mirror to obtain the Julian date and the mold cast number.

2. Locate the torque converter housing (3) on the transmission assembly.

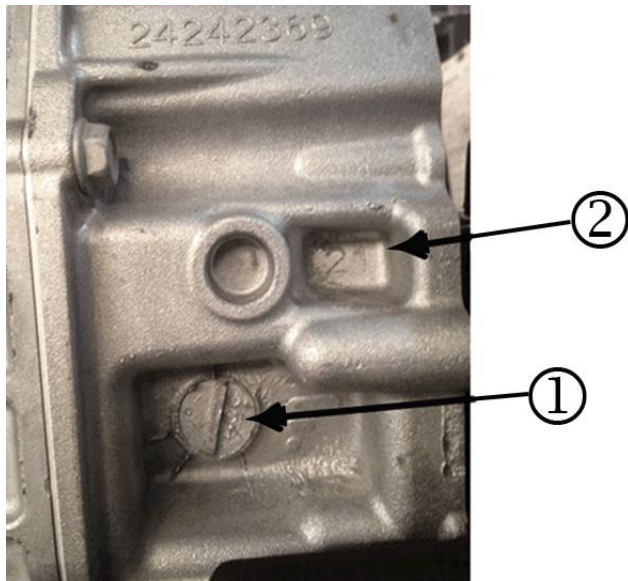
3337579

(1) Julian Date Location (2) Mold Casting Number Location

3. Locate the casting information on the torque converter housing (1) (2).

3.1 Locate the Julian date (1).

- If the Julian date is 037 or 038, proceed to step 3.2.
- If the Julian date is NOT 037 or 038, no further action is required. Proceed to step 4.

3.2. Determine the mold casting number (2).

- If the mold casting number is 11, remove and replace the transmission assembly. Refer to *Transmission Replacement* in SI. Submit a warranty claim for the transmission replacement.
- If the mold casting number is NOT 11, no further action is required. Proceed to step 4.
