Service Bulletin

SUBJECT: Service Update for Inventory and Customer Vehicles
Product Enhancements – Interior Trim
Expires with Base Warranty

MODELS: 2013 Cadillac XTS

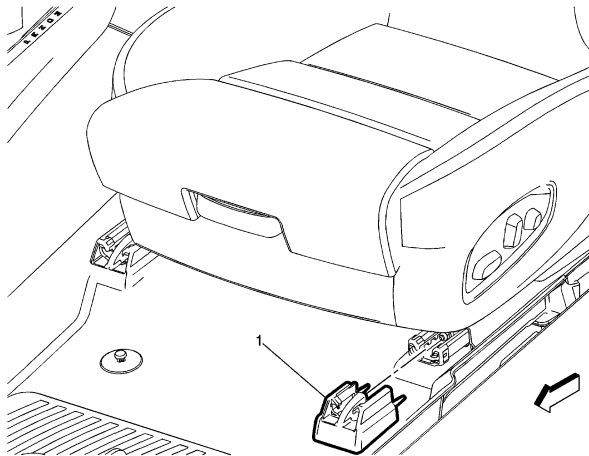
2755689

1. Remove the driver and passenger seat outer track front covers (1). Refer to *Front Seat Track Cover Replacement* in SI.
2. Install new driver and passenger seat outer track front covers (1). Refer to *Front Seat Track Cover Replacement* in SI.

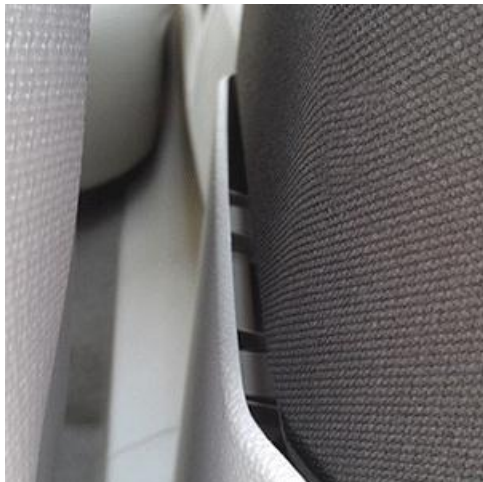
3257856

3. Inspect driver and passenger side center pillar trim panels to determine if the panels fit loose or have a gap between the lower and upper center pillar trim panels.
 - If the center pillar trim panels are not loose and no gap is present between the upper and lower center-pillar trim panels, proceed to step 4.
 - If the lower center pillar trim panels are loose and there is a gap between the upper and lower center pillar trim panels, replace the lower center pillar trim panel (s). Refer to *Center Pillar Lower Trim Panel Replacement* in SI.

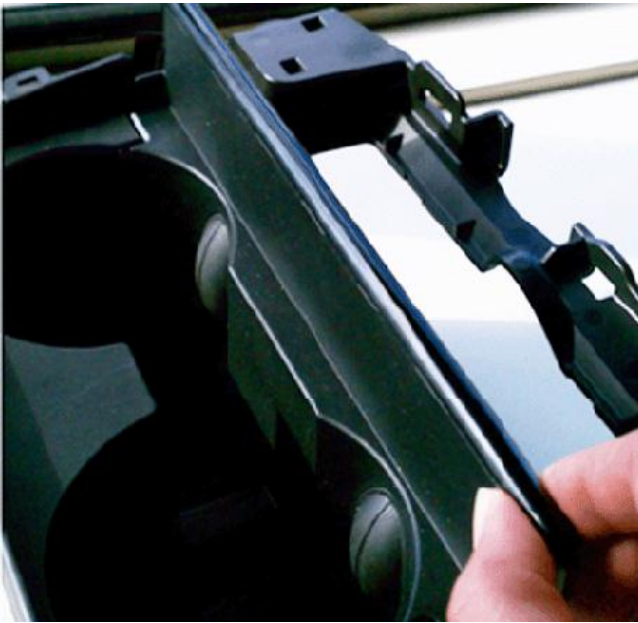
2964017

4. Inspect the condition and function of the console cup holder door assembly. The inner and outer portions of the console cup holder door cover may not be snapped together. Pinch the two corners of the door if they are separated to engage and snap fit the retention features.

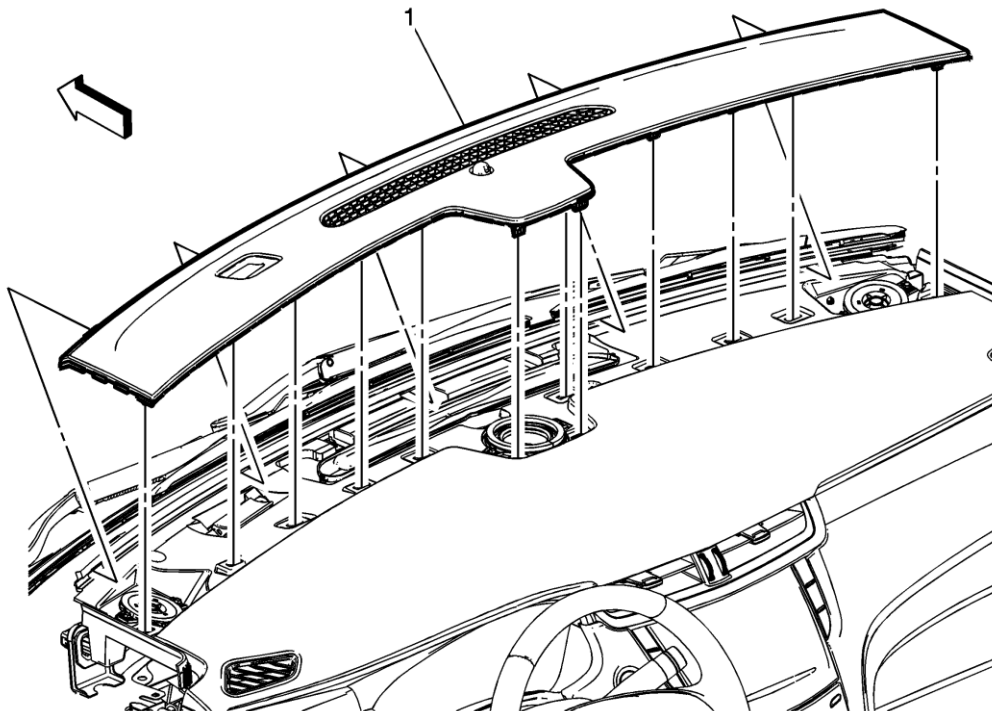
2759601

5. Remove the windshield defroster grille. Use a flat bladed plastic trim tool to release the 12 retainers to prevent damage to the instrument panel upper trim panel.
6. Place the windshield defroster grille on a clean level surface with the backside facing up.
7. Using Kent Automotive BRS (Felt) Tape, P/N KT13486 or Sheet, KT13487, cut five 15 mm x 60 mm strips.

Note: Contrary to what the replacement procedure in SI states, the windshield garnish moldings do not require removal.

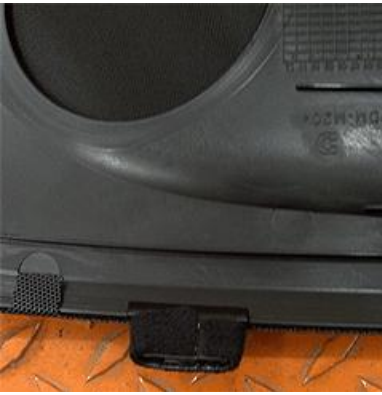
3257797

8. Add the felt to the five windshield defroster grille front plastic tabs as shown. Completely wrap each tab ensuring the felt tape covers the rib near the metal screen.
9. Install the windshield defroster grille.
10. Locate the IP storage compartment.
11. Activate the IP storage compartment release mechanism 10 times to check the operation of the IP storage compartment.
 - If the IP storage compartment does NOT make noise or ratchet while the IP storage compartment door opens or closes, proceed to step 12.
 - If the IP storage compartment does make noise or ratchet while the IP storage compartment door opens or closes, proceed to *IP Storage Compartment Door Binds or Opens Very Slowly* or *IP Storage Compartment Door Opens Very Fast and/or Creates Zip Noise* in this bulletin.

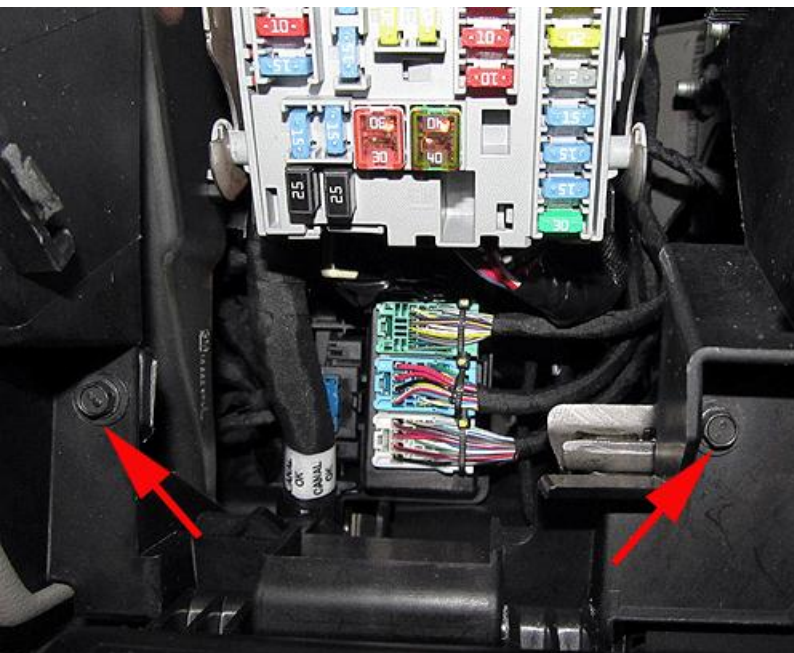
3258653

IP Storage Compartment Door Binds or Opens Very Slowly

Note: This procedure should move the rack upward slightly to release excessive engagement of rack and pinion gears.

1. Open bin door with release tabs.
2. Loosen two screws.

3. While pulling downward on left side, tighten the left screw first and then tighten the right screw.

Note: If the bin door is still slow, then repeat steps 2-3, but add an upward push at the bottom right side BEFORE tightening the right screw. Replace the IP storage compartment if the adjustment does not correct the condition. Refer to *Instrument Panel Knee Bolster Replacement* in SI.

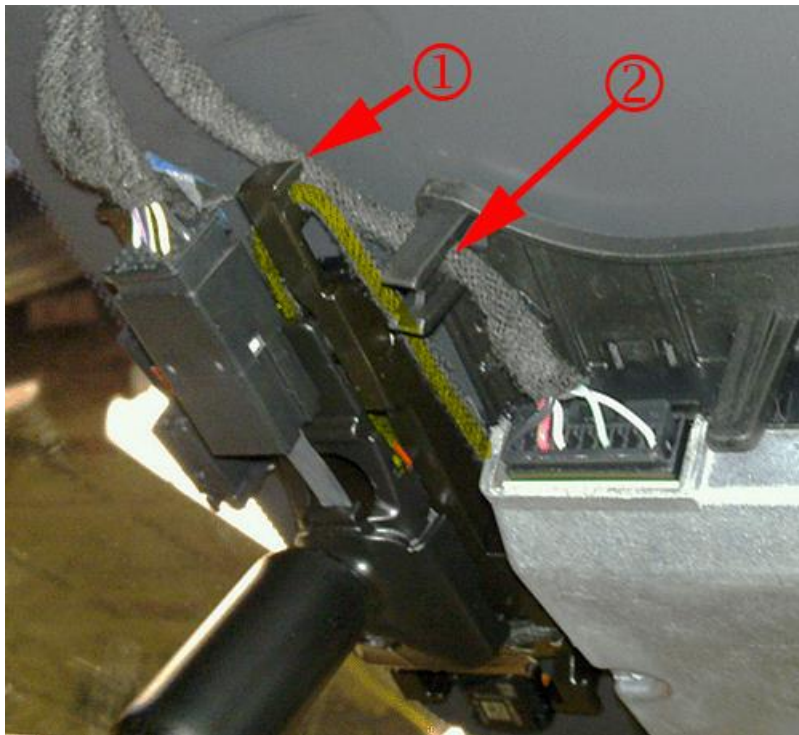
3258669

17. Remove the windshield multifunction sensor mount bracket cover and inspect the molded-in plastic clips located on the inside of the cover. Ensure the plastic clips are not bent or damaged. Straighten the bent clips and reinstall the windshield multifunction sensor mount bracket cover. Proceed to step 18. If the plastic clips are broken or badly damaged, replace the windshield multifunction sensor mount bracket cover. Proceed to step 18.

18. Inspect the rain sensor harness routing. Ensure the rain sensor harness (1) is routed along the side of the humidity sensor. Also ensure that the harness is routed inside of the “U” shaped bracket (2). Refer to the illustration. Tuck excess harness in tight along the side of the humidity sensor.
19. Turn inside rearview mirror lengthwise with the car.
