# Service Bulletin

**SUBJECT:** Service Update for Inventory and Customer Vehicles  
Front Seat Cushion Trim Retention  
Expires with Base Warranty

**MODELS:** 2013 Cadillac XTS

Subject: 12290A – Service Update  
Front Seat Cushion Trim Retention  
Revised Service Procedure

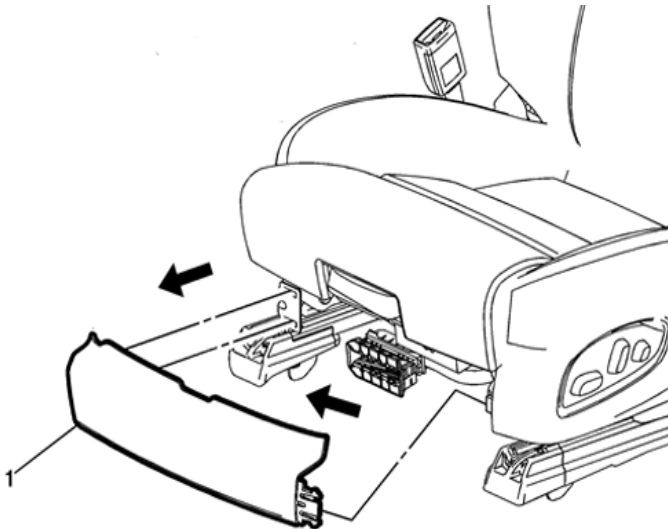
2910856

1. Position the affected seat fully rearward and the seat cushion fully upward.

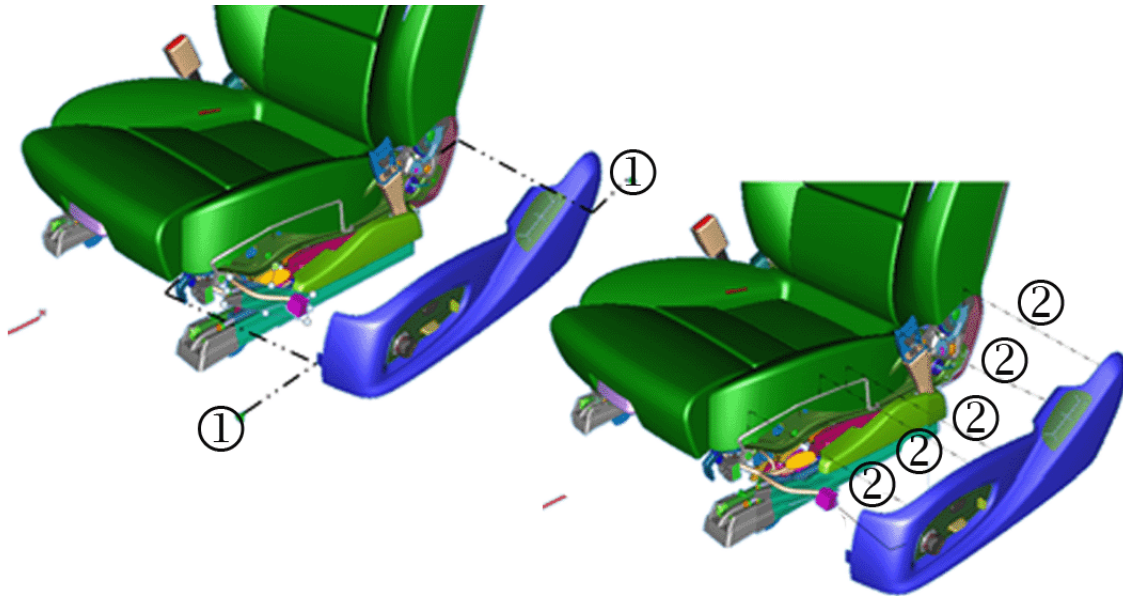
3350732

2. Remove the front seat adjuster finish cover (1). Refer to *Driver or Passenger Seat Adjuster Finish Cover Replacement* in SI. The knobs do not need to be removed because the switch(s) will remain attached to the Adjuster Finish Cover. After removing the screw, the Adjuster Finish Cover must be gently pulled upwards to release the hook features. Use care to avoid pulling on electrical wiring prior to disconnecting the switch(s). Once the switch(s) on the Seat Adjuster Finish Cover is disconnected, the cover can be removed to allow access to the seat cushion cover for repair.

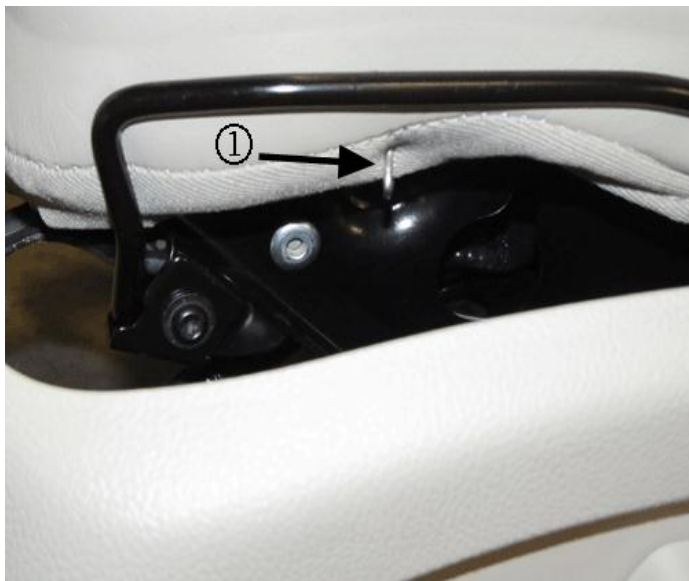
2965479

3. Starting the outboard side repair, remove the front screw (1) retaining the seat cushion outer finish panel (2) and detach the front half of the panel from the seat frame.

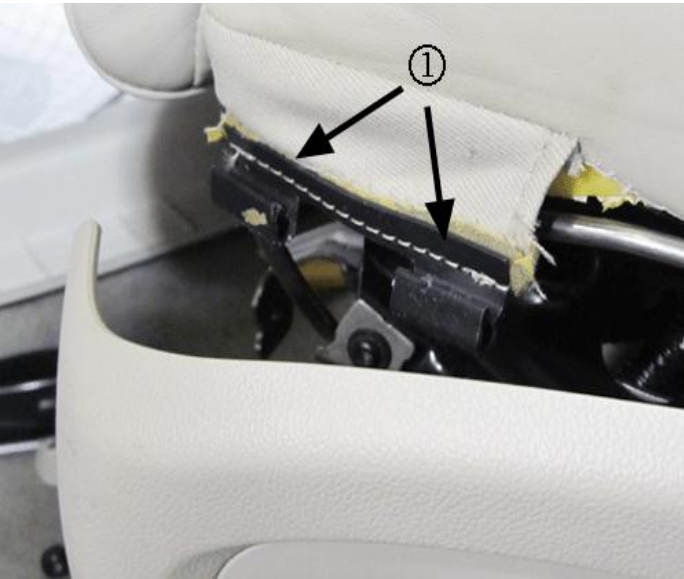
2910863

Note: Some seats may have a single hog ring (1) at either or both front corners of the seat.

- For the outboard corner repair, it will be necessary to remove this hog ring to fully release the J-channel from the seat frame.
- For the inboard corner repair, leave the existing hog ring intact.

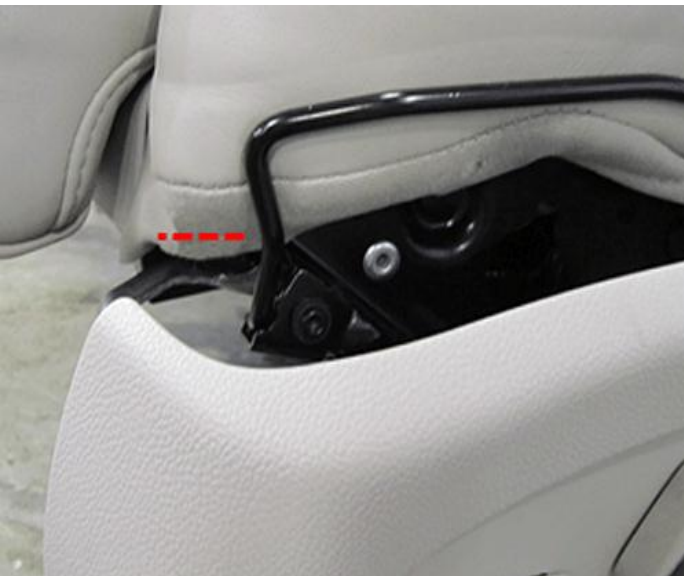
2965480

4. Fully release the outboard front corner seat cushion cover J-channel (1) from the seat frame.
5. Add a retaining clip to the outboard front corner of the seat, completing the following steps:

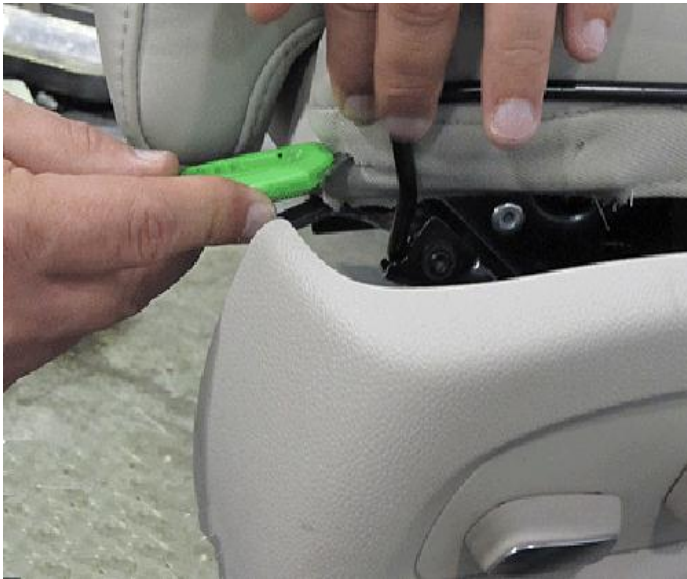
2965482

- 5.1. Fold the J-channel back under the cover fabric material, but do not attach to the frame. Note the location of the bottom edge of the channel through the material.

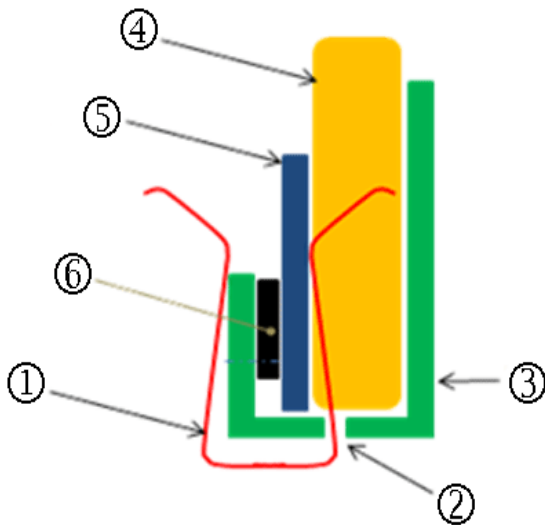
2965484

- 5.2. Using a utility knife or similar tool, cut a slit in the material fabric along the bottom edge of the J-channel, about half the width of the channel.
- 5.3. Reinstall the J-channel to the front corner of the seat frame.

Note: A cross section of the clip installation is shown in the illustration above. Ensure the clip (1) is inserted through the slit (2) in the seat material (3), between the foam (4) and the seat frame (5), capturing the material and J-channel (6).

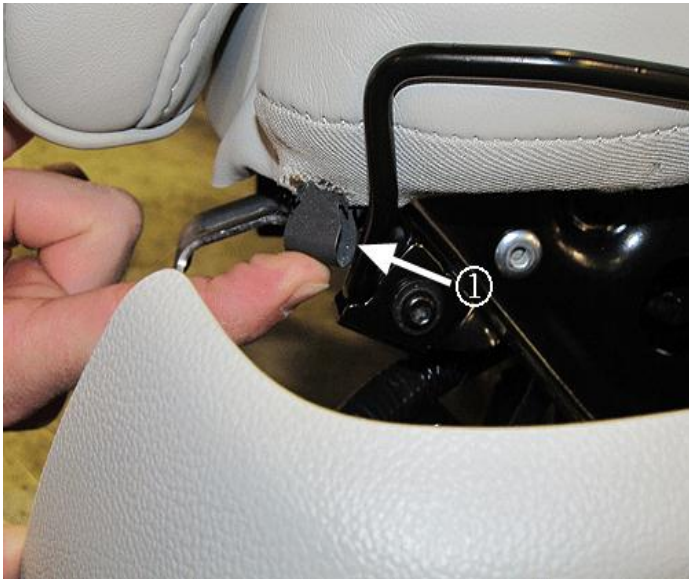
- 5.4. Install one of the seat cushion cover retainers (1) to the seat, pushing one leg through the slit in the fabric and the other over the seat frame, capturing the J-channel against the frame.

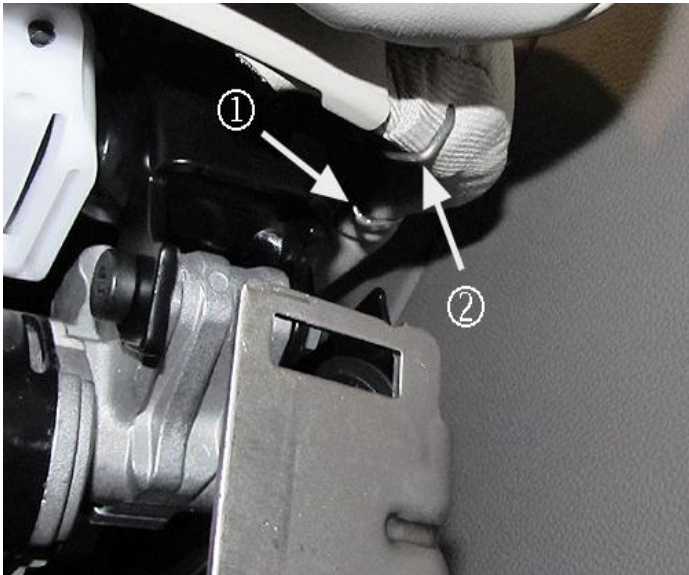
**Note:** The graphic above shows the original (1) and the added hog ring (2) on the passenger front seat.

6. Add a hog ring, or equivalent, to the inboard front corner of the cushion cover and J-channel. Snap the hog ring around the front end of the J-channel and the seat frame as shown in the graphic above.

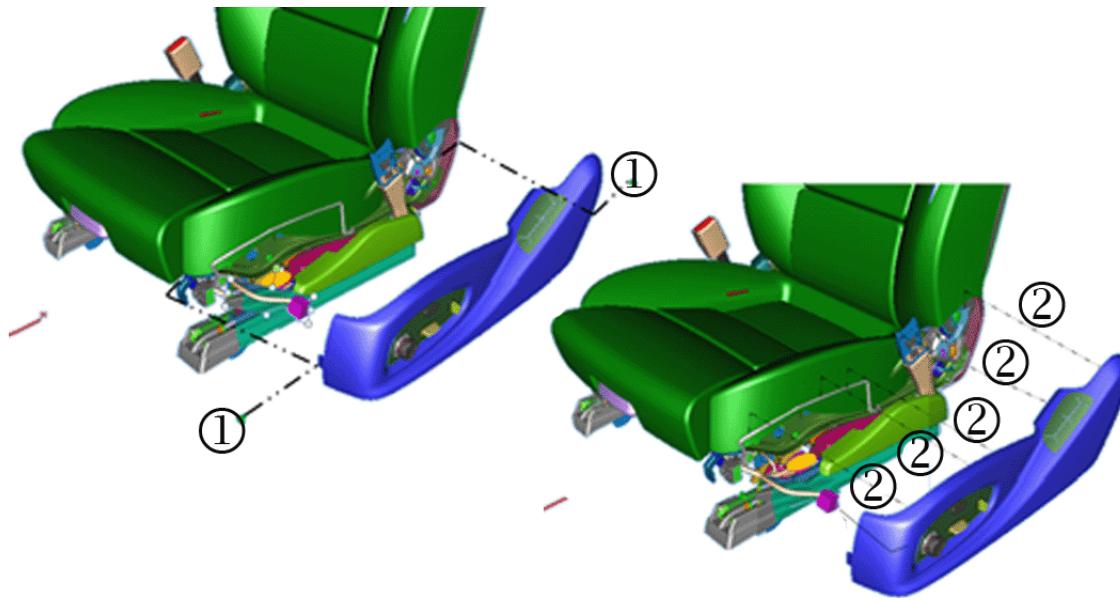
3350732

7. Reposition the outer finish panel (2) to the seat frame and install the front retaining screw (1).

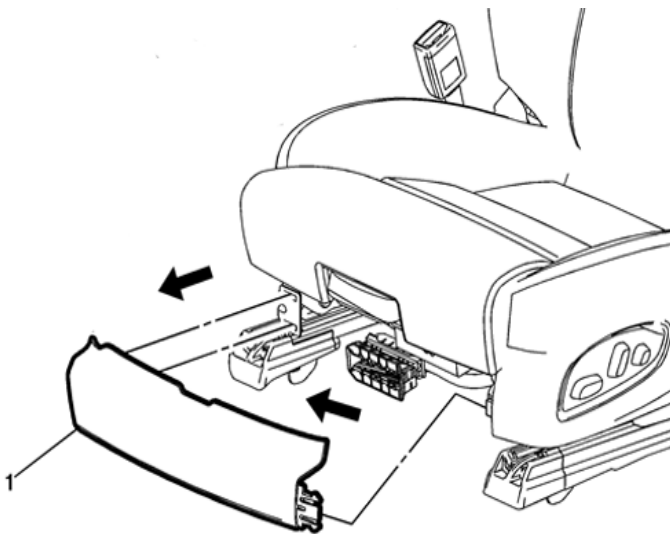
2910856

8. Reinstall the front seat adjuster finish cover. Refer to *Driver or Passenger Seat Adjuster Finish Cover Replacement* in SI.

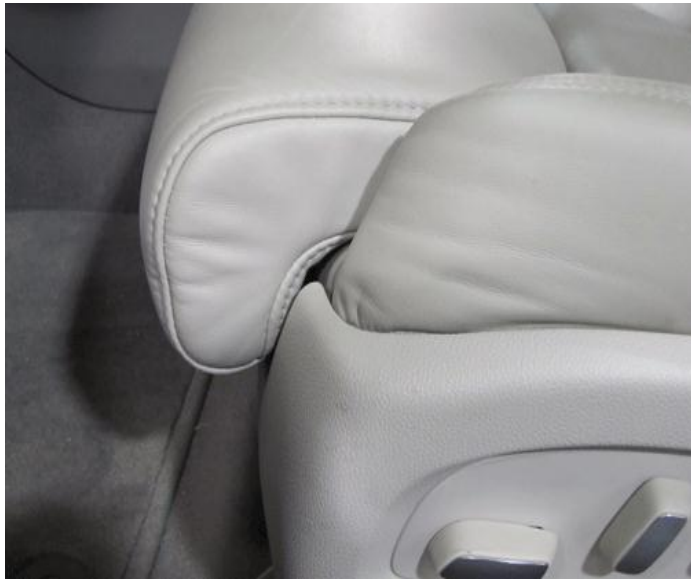
2910874

9. Verify proper retention and appearance of the seat cushion cover as shown above.
10. Repeat Steps 1-9 on the opposite side front seat.
