CUSTOMER SATISFACTION PROGRAM

SUBJECT: Windshield Water Leak

MODELS: 2012 Buick Verano

Subject: 13054 - Customer Satisfaction Program
Windshield Water Leak

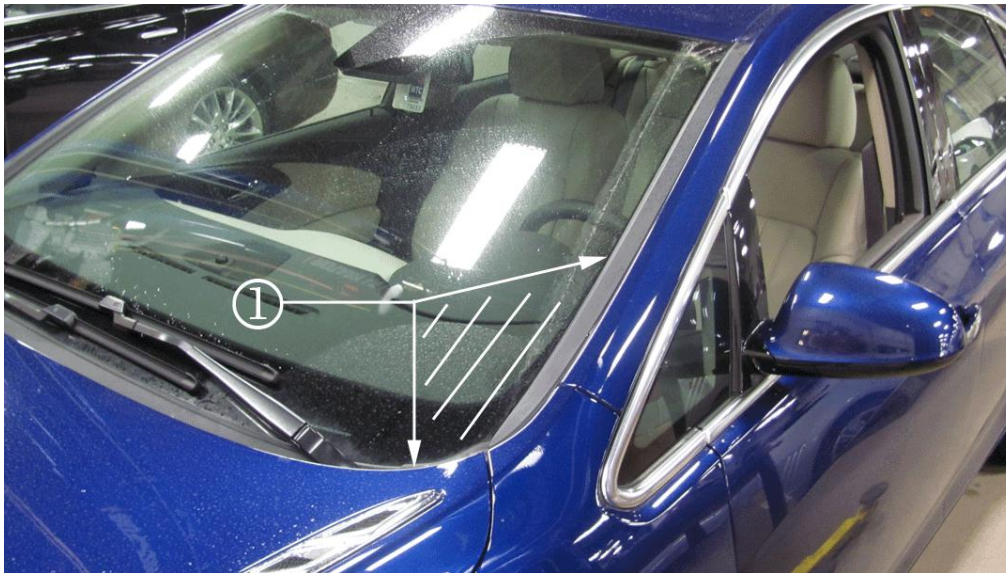
3350863

The windshield on **certain** 2012 model year Buick Verano vehicles may not be completely sealed to the body at the lower left side of the windshield. Water could leak into the vehicle at this point and drip onto the body harness connector, causing corrosion on the terminals or shorting between terminals. Depending on the terminal(s) involved, it could cause one or more of the following conditions: automatic OnStar® emergency calls, flashing of the park brake light, rough engine operation, improper air conditioning system operation, illumination of the Service Engine Soon light, and other malfunctions.

Remove the windshield side reveal molding before performing the water test.

3. Perform a windshield water leak test on the driver side of the windshield in the A-pillar area of the windshield using a water hose without the nozzle attached. Refer to photograph to view where to apply water (1).

- 3.2 Perform the water test for 2-3 minutes to ensure the driver side A-pillar area of the windshield is exposed to enough water to determine if a leak is present.
 - If a water leak is not present, proceed to step 7.
 - If a water leak is present, proceed to step 4.
4. Clean the edge of the windshield in the area of the leak with a 50/50 mixture of isopropyl alcohol and water and lint-free cloth. Ensure the windshield and the metal around the edge of the windshield are clean BEFORE applying the urethane adhesive.
