Program Bulletin

CUSTOMER SATISFACTION PROGRAM

SUBJECT: Driver's Seat Rear Blocking Clips May Be Missing

MODELS: 2013 Buick Encore
Equipped with Driver's 6-Way Power Seat (AG9) and without Memory Seat Feature (AAG)

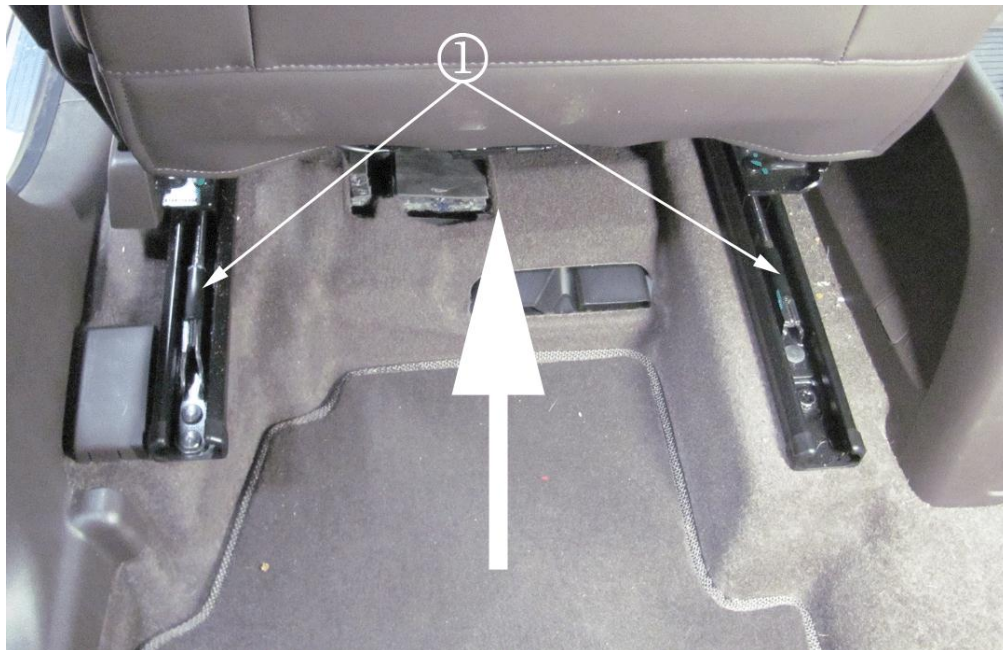
1. Adjust the driver seat to the full forward position.

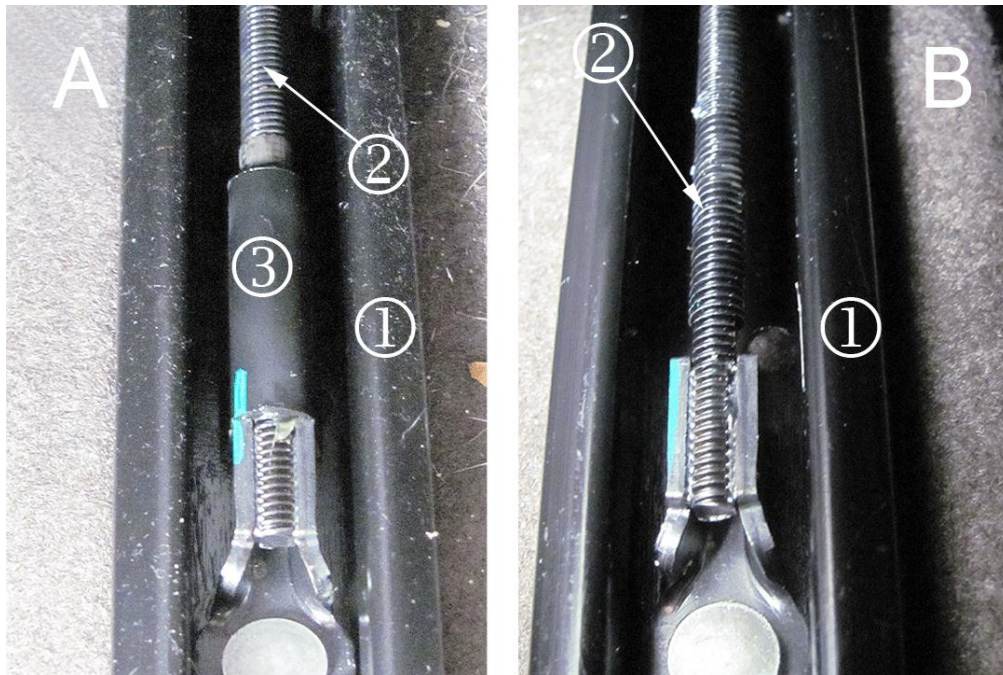
There should be about a 50.8 mm (2 in) section of the adjuster screw threads (2) that are NOT visible. A seat travel restriction feature called a blocking clip (3) should be installed. The “A” portion of the photograph shows the blocking clip (3) installed. The blocking clip is missing in the “B” portion of the photograph.

2. Examine the rear portion of the inboard and outboard seat tracks (1) to determine if the blocking clips (3) are installed.
 - If the blocking clips (3) are installed, proceed to step 4. No further action is required.
 - If the blocking clips (3) are NOT installed, proceed to step 3.
