Program Bulletin

CUSTOMER SATISFACTION PROGRAM

SUBJECT: Clunking Noise When Turning

MODELS: 2013 Chevrolet Cruze

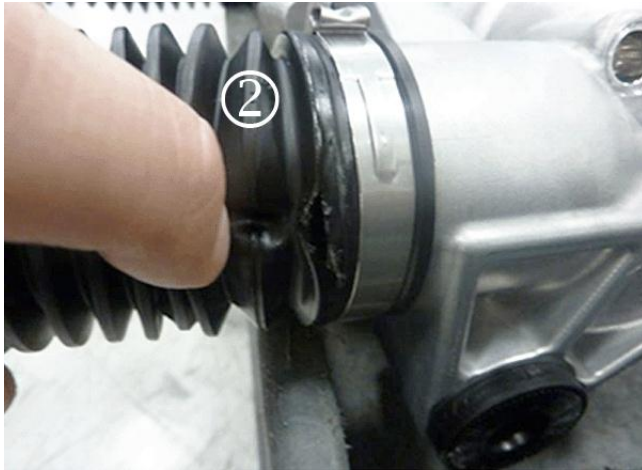
3359424

7. Inspect steering gear boot (2) for cut (reference picture) on the side facing downwards in vehicle. Discard the boot.
8. Inspect inner tie rod, inner steering gear boot (2), and surrounding internal areas for any evidence of moisture (such as rust) or environmental contamination (such as sand, dirt, or grime). Note: the discoloration on exterior of gear housing does not indicate leakage and should not be used to determine the integrity of the interior of the steering gear.
 - If evidence of contamination is apparent, replace the steering gear. Refer to *Steering Gear Replacement* in SI.
 - If contamination is NOT present, replace only the steering gear boot (2) using Boot Kit P/N 13354440. Proceed to Step 9.
