SUBJECT: Service Update for Inventory Vehicles Only
Turn Signal May Not Automatically Cancel

MODELS: 2013 Cadillac XTS

Subject: 13138 – Service Update Bulletin
Turn Signal May Not Automatically Cancel

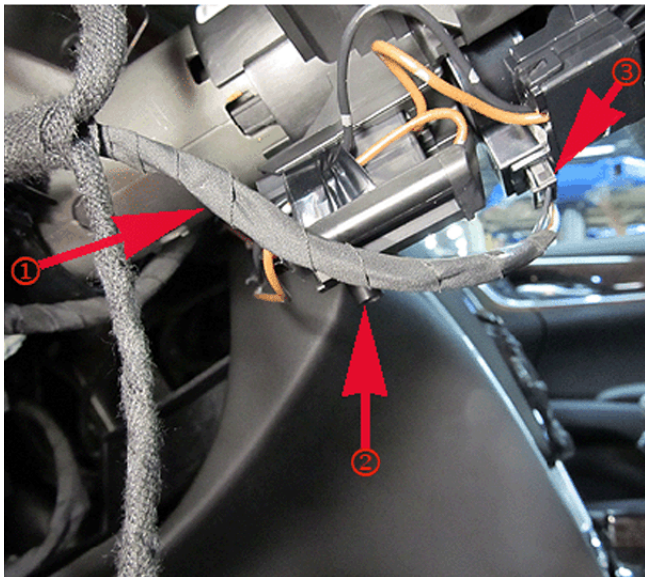
3401815

Note: The steering column wiring harness may be causing the Steering Angle Sensor (SAS) to interfere with the self-cancel mechanism of the turn signal. If the wiring harness (1) is routed on the outboard side of the column trim mounting pedestal (2), it may put strain on the 6 way SAS connector (3) causing the SAS to interfere with the turn signal cancel pawl. This interference cannot be seen. It is on the steering wheel side of the SAS. Refer to the service procedure below to reposition the steering column wiring harness and relieve the strain on the 6-way connector.

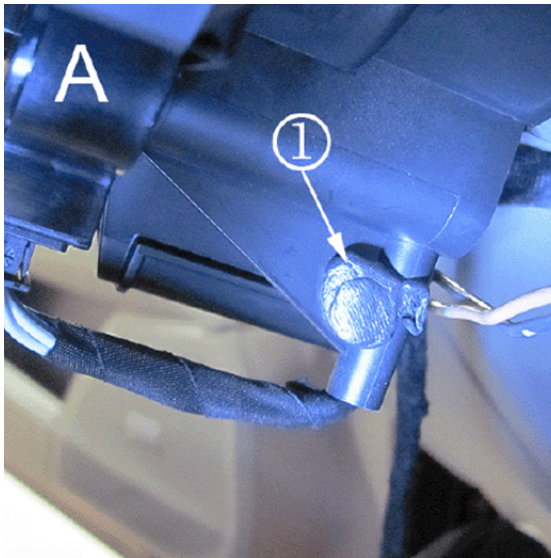
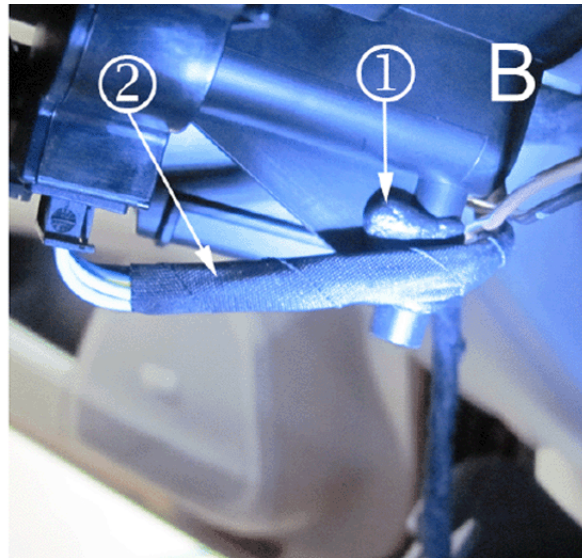
3401826

Caution: Ensure the steering column wiring harness is positioned such that it does not put tension or slack on the Steering Angle Sensor (SAS) at the connector. Any load on the SAS may cause a noise or accelerated wear within the sensor.

3. Position the steering column wiring harness (2) to the inboard side of the column electrical assembly (CEA) mounting pedestal (or right hand side from the center of the column assembly) as shown in the 'B' portion of the photograph. This step is required to route the harness in its natural form on the right hand side first.
4. Roll a 12mm (1/2 in.) piece of Kent Industries butyl tape or an equivalent butyl tape into a marble size ball.

5. Install the butyl (1) tape at the base of the column electrical assembly (CEA) mounting pedestal on the right hand/inboard side as shown in the 'A' portion of the photograph.
6. With the steering column wiring harness in the correct position, push the wire bundle into the butyl material (1) to keep the harness in position during re-installation of steering column lower trim cover. Refer to the 'B' portion of the photograph.
7. Reinstall the steering column lower trim cover. Refer to Steering Column Lower Trim Cover Replacement in SI.
8. Road test the vehicle to verify the turn signals self-cancel and to re-establish the steering angle sensor communication.
