CUSTOMER SATISFACTION PROGRAM

SUBJECT: Front and Rear Door Handles May Stick or Bind

MODELS: 2013 Buick LaCrosse, Regal, Verano
2013 Cadillac SRX
2013 Chevrolet Cruze, Malibu
Equipped with Keyless Entry Feature (ATH)

Subject: 13125 - Customer Satisfaction Program
Front and Rear Door Handles May Stick or Bind

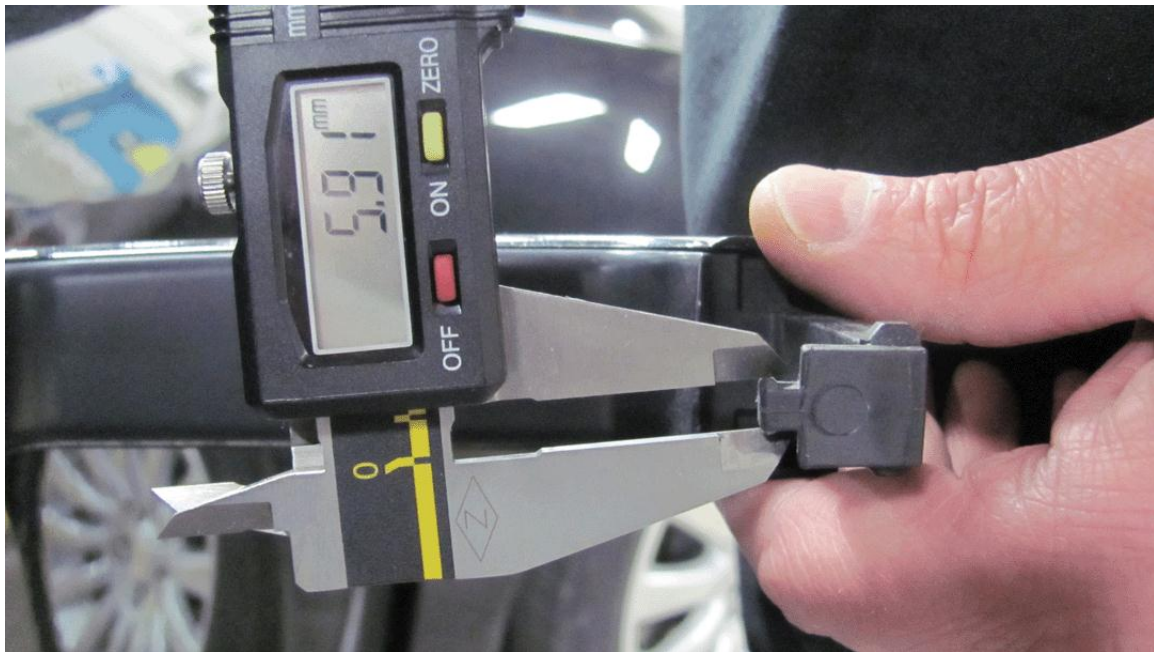
3407727

On **certain** 2013 model year Buick LaCrosse, Regal, Verano; Cadillac SRX; and Chevrolet Cruze and Malibu vehicles, equipped with the keyless entry feature (ATH), there may be an interference condition between the outside door handle and the door handle bracket assembly. This could cause the outside door handle to stick or bind in the open position when the door is opened from outside of the vehicle. If this occurs, the door may bounce back when attempting to close it. If the door does not latch, a warning chime will sound and a warning message in the instrument cluster will illuminate. Tapping on the outside door handle or closing the door with higher effort should free the door handle and allow it to latch.

7. Measure the leg of the door handle as shown. Ensure the thickness is between 5.7 mm (0.224 in) and 5.9 mm (0.232 in).

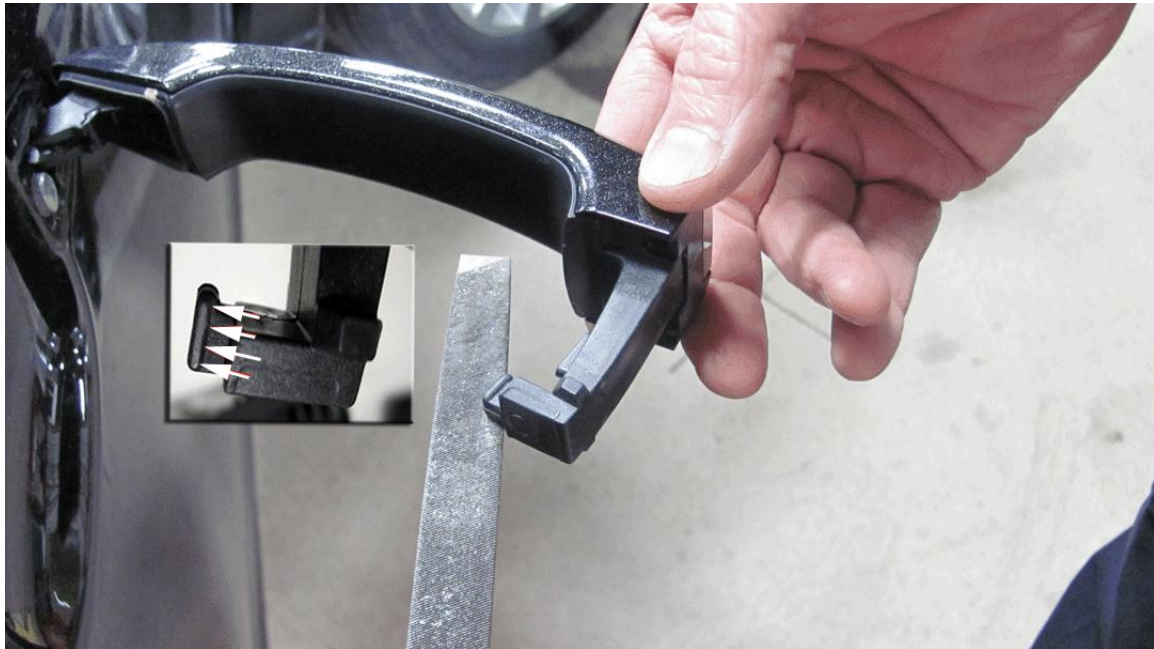
3415788

- If the thickness is between 5.7 mm (0.224 in) and 5.9 mm (0.232 in), the door handle leg does NOT require modification. Proceed to step 8.

Note: Removing too much material may create a rattle condition. The final thickness should be 5.7 mm (0.224 in).

- If the thickness is greater than 5.9 mm (0.232 in), use a flat file or fine grade sand paper to remove material from the area identified by the arrows. Remove an equal amount from both sides of the door handle leg. The final thickness should be 5.7 mm (0.224 in). Proceed to step 8 after removing the appropriate amount of material from the door handle.
