# Service Bulletin

**SUBJECT:** Service Update for Inventory and Customer Vehicles  
Software Enhancement Update  
Expires with Base Warranty

**MODELS:** 2013 Chevrolet Sonic, Spark, Trax  
Equipped with MyLink Radio (UF7)

Subject: 13128A – Service Update  
Software Enhancement Update  
Revised Service Procedure

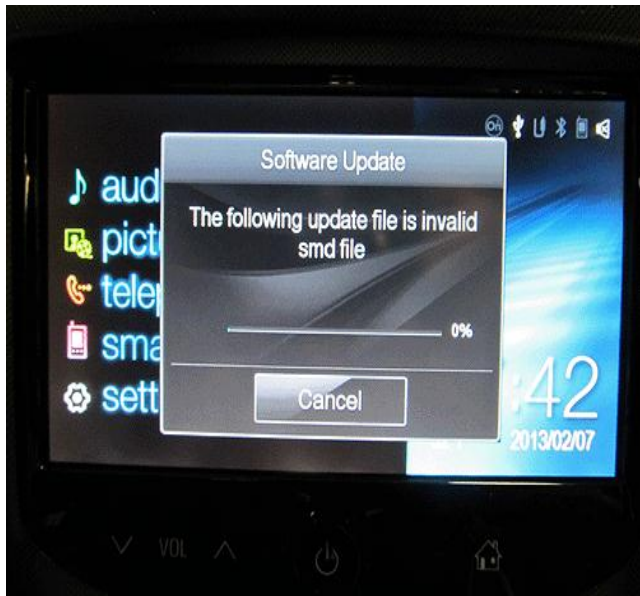
3286662

8. If you see the message as shown above "The following update file is Invalid SMD file," continue to the next step. Otherwise, skip to Step 14.

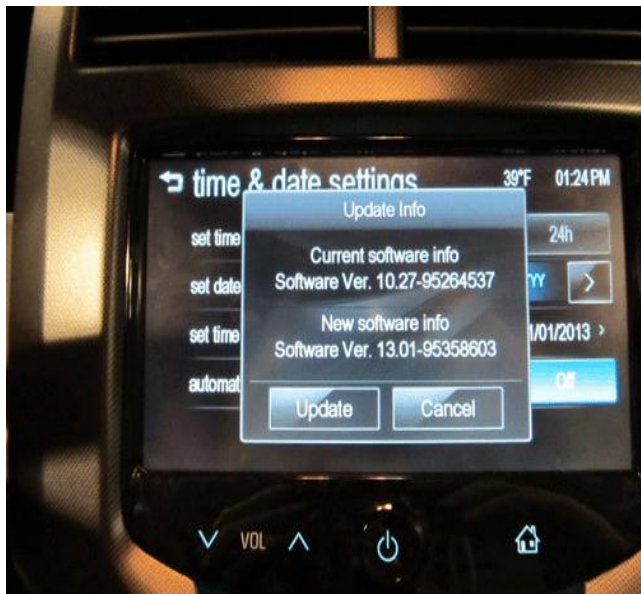
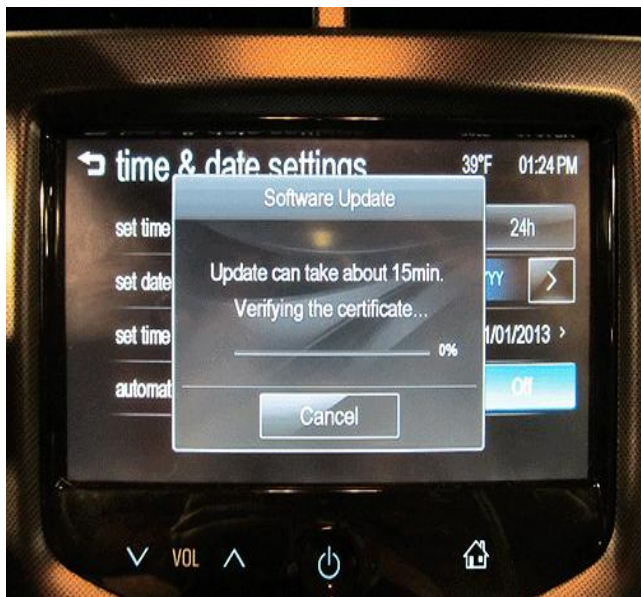
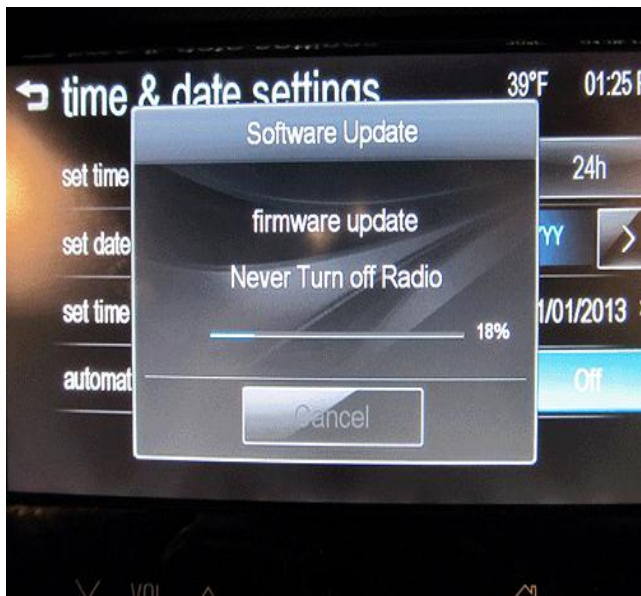
**Note:** If you still see the message “The following update file is Invalid SMD file,” the date has not been changed correctly on the radio.

15. When the update info screen comes on, select UPDATE.
