# Service Bulletin

**SUBJECT:** Service Update for Inventory and Customer Vehicles  
Possible Windshield Water Leak  
Expires with Base Warranty

**MODELS:** 2013 Cadillac ATS

Subject: 13185 – Service Update Bulletin  
Possible Windshield Water Leak

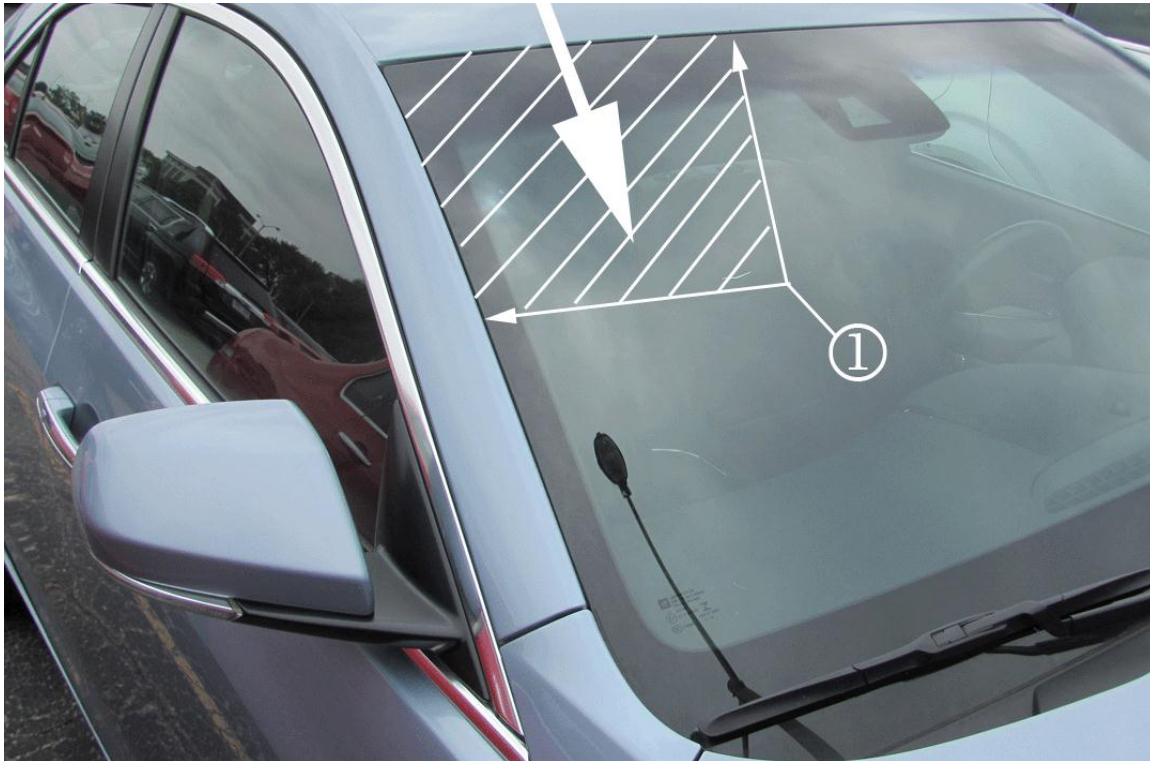
3468438

1. Perform a windshield water leak test on the passenger side of the windshield in the A-pillar area of the windshield using a water hose without the nozzle attached. Refer to photograph to view where to apply water (1).

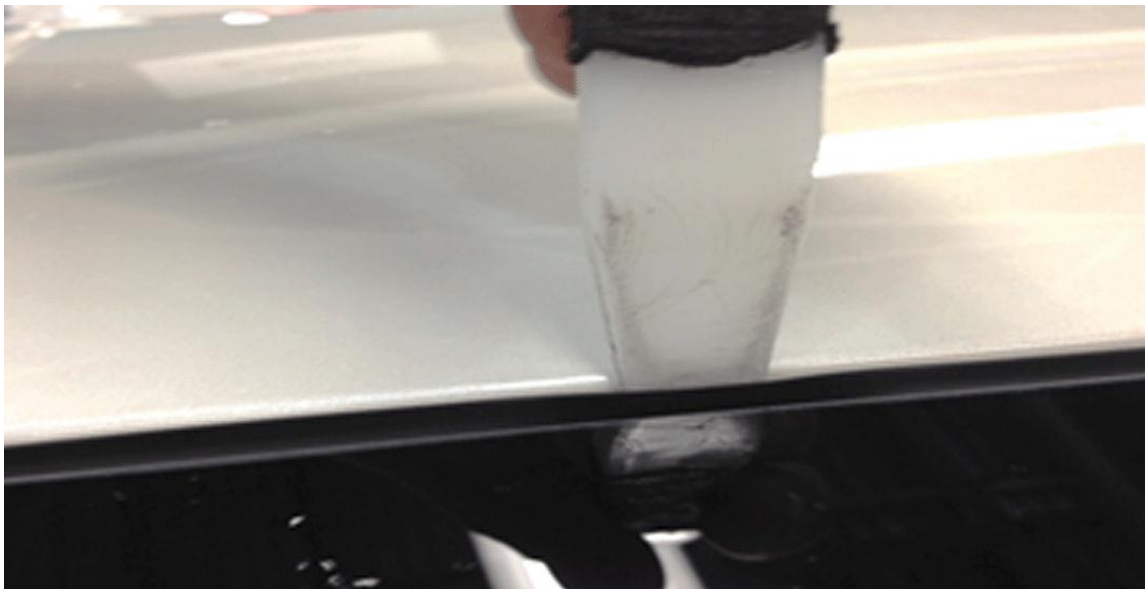
3468441

- 1.1 Using a trim stick start at the passenger side top corner of the windshield lace and gently run under the lace with the trim stick to separate it from windshield.

**Note:** Flow water into the access opening created by the trim stick in the test area of the windshield for 1-2 minutes.

1.2 Flow water into the access opening created by the trim stick until it flows over windshield.

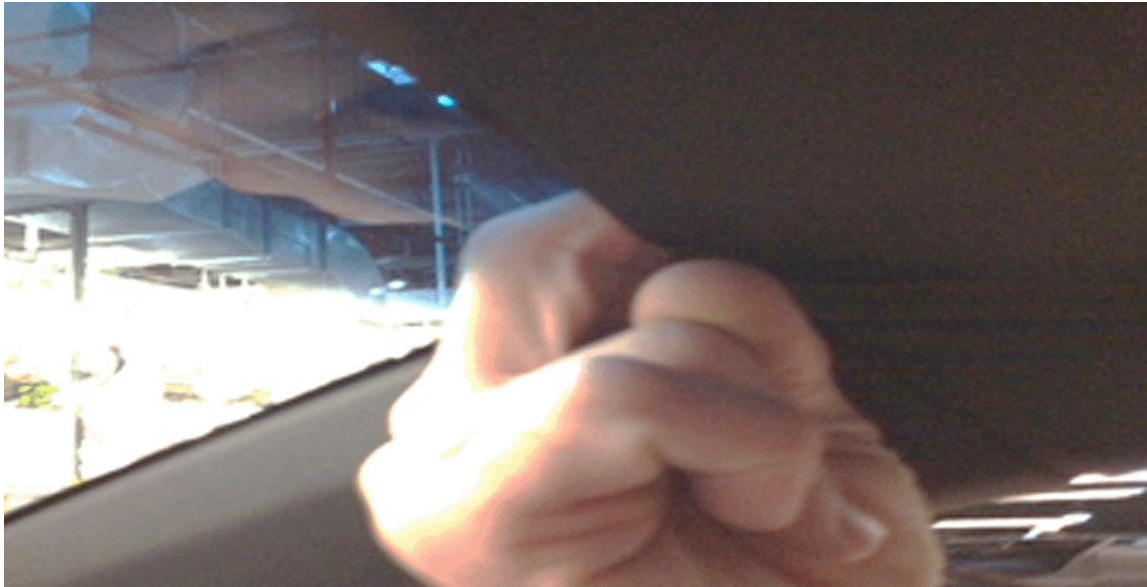
3468443

1.3 Using your fingers, inspect the inside the edge of headliner near top of A-pillar trim for moisture to determine if a water leak is present.

- If a water leak is NOT present, no further action is required.
- If a water leak is present, proceed to step 2.
