Service Bulletin

SUBJECT: Service Update for Inventory and Customer Vehicles
Software Enhancement Update
Expires with Base Warranty

MODELS: 2013 Chevrolet Sonic, Spark, Trax
Equipped with MyLink Radio (UF7)

Subject: 13128B – Service Update
Software Enhancement Update
Revised Service Procedure

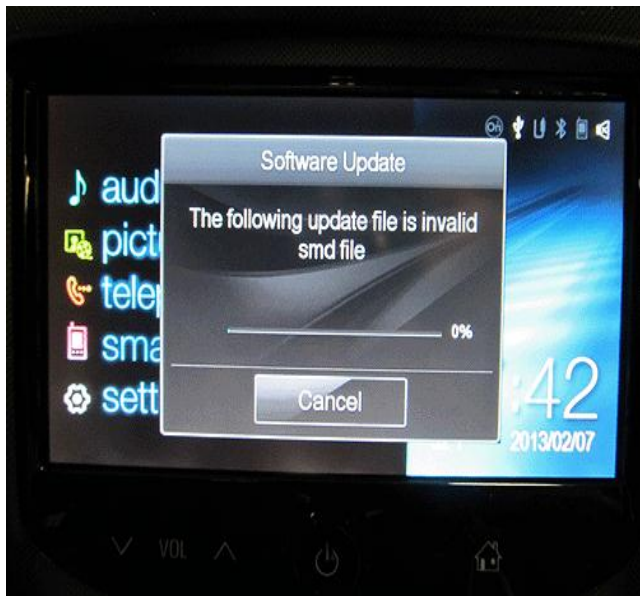
3286662

8. If you see the message as shown above "The following update file is Invalid SMD file," continue to the next step. Otherwise, skip to Step 14.

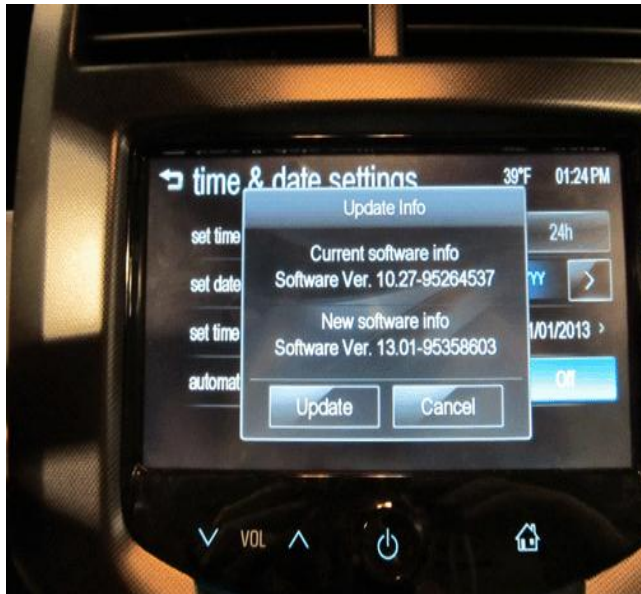
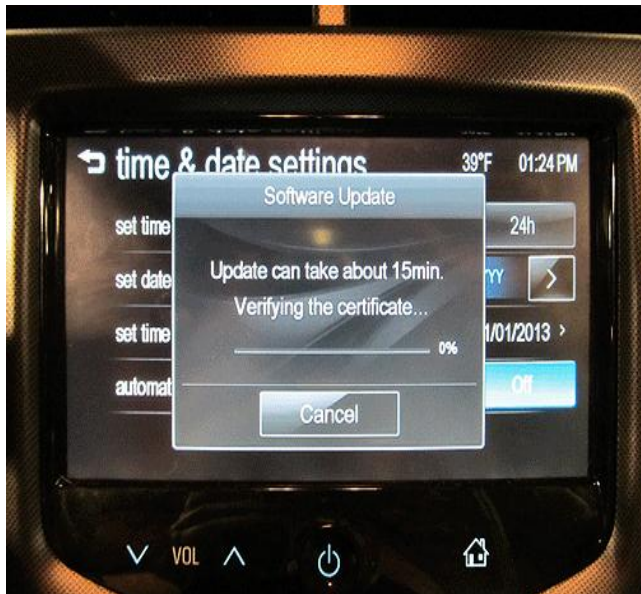
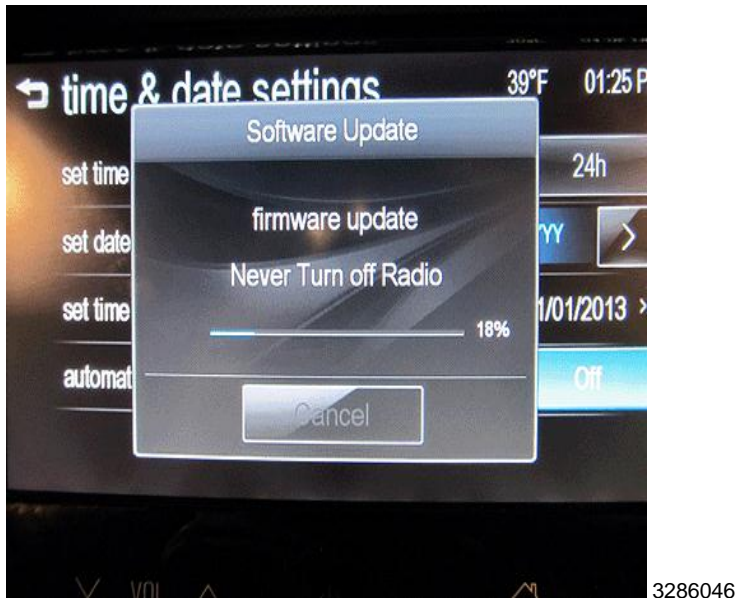
Note: If you still see the message “The following update file is Invalid SMD file,” the date has not been changed correctly on the radio.

15. When the update info screen comes on, select UPDATE.
