Service Bulletin

SUBJECT: Service Update for Inventory and Customer Vehicles
Turbo-to-Exhaust Manifold Joint May Relax
Expires with Base Warranty

MODELS: 2013 Cadillac ATS
2013 Chevrolet Malibu
Equipped with 2.0L Engine (LTG)

Subject: 13013B – Service Update
Turbo-to-Exhaust Manifold Joint May Relax
Revised Service Procedure

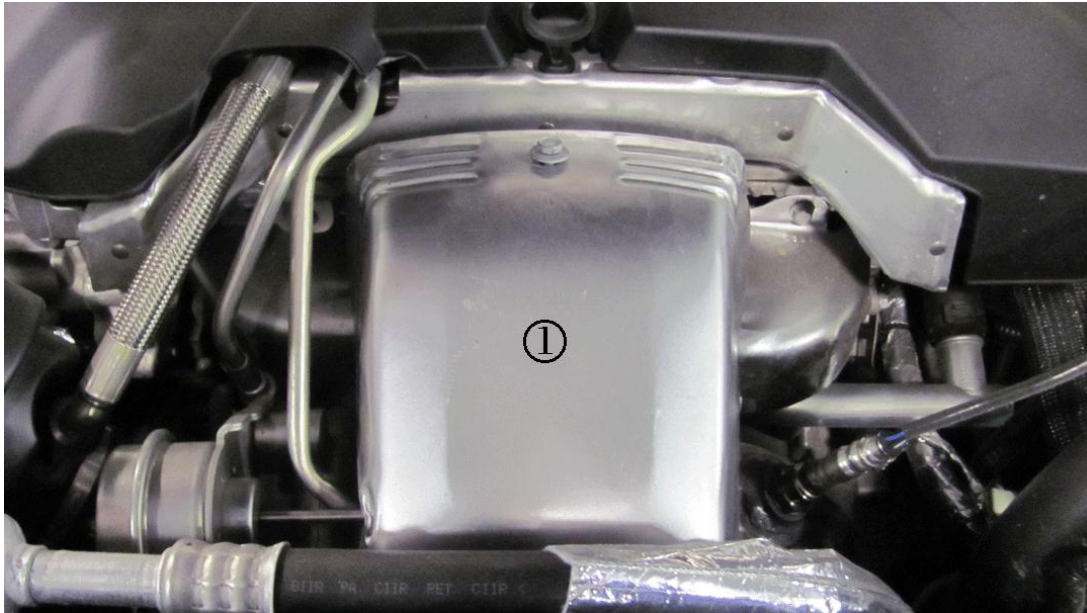
Chevrolet Malibu shown for illustration purposes, Cadillac ATS similar.

2. Locate the turbocharger exhaust heat shield (1).

3. Remove the turbocharger exhaust heat shield. Refer to *Exhaust Manifold Heat Shield Replacement (LTG)* in SI.

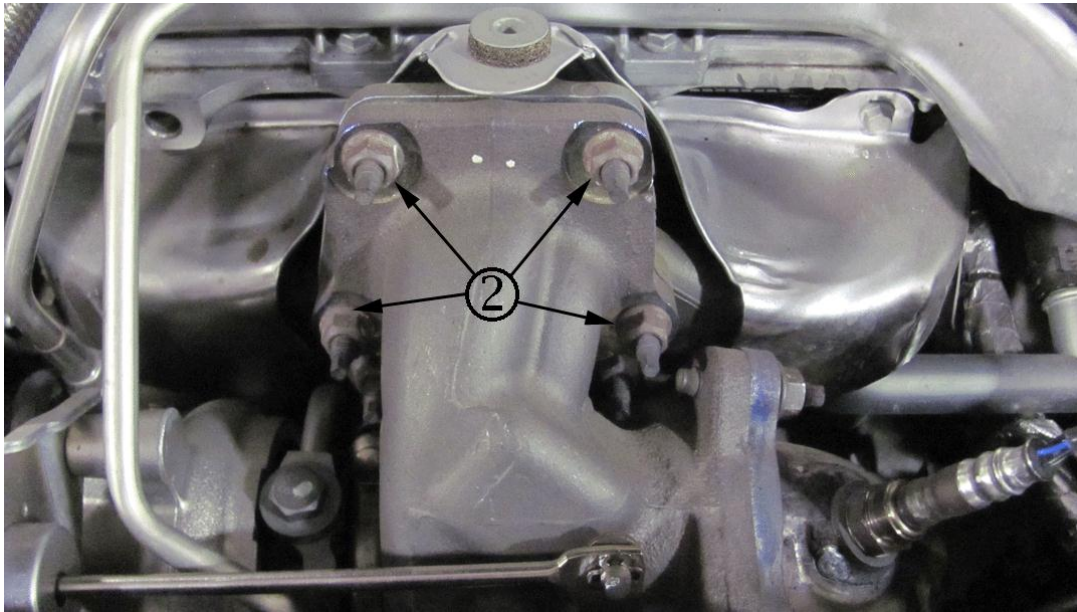
3268366

This bulletin provides a service procedure to tighten all 4 exhaust manifold bolts on **certain** 2013 model year Cadillac ATS and Chevrolet Malibu vehicles, equipped with a 2.0L engine (LTG). The ring gasket may be pinched between the flanges on the inside diameter of the joint leading to a visible gap. As the pinched part of that gasket relaxes, clamp load is lost at that stud location.

4. Loosen the four turbocharger-to-exhaust manifold nuts (2).
5. Tighten the four turbocharger-to-exhaust manifold nuts (2) to **30 Nm (22 lb-ft) + 90 degrees**.
6. Re-install the turbocharger exhaust heat shield. Refer to *Exhaust Manifold Heat Shield Replacement (LTG)* in SI.

7. Tighten turbocharger exhaust manifold heat shield fasteners to **9 Nm (80 lb-in)**.
8. Close the hood of the vehicle.
