SUBJECT: Service Update for Inventory and Customer Vehicles
Turbo Vacuum Hose Routing - Inspect
Expires with Base Warranty

MODELS: 2014 Cadillac XTS
Equipped with 3.6L V6 Engine (LF3)

Subject: 13275 – Service Update Bulletin
Turbo Vacuum Hose Routing – Inspect

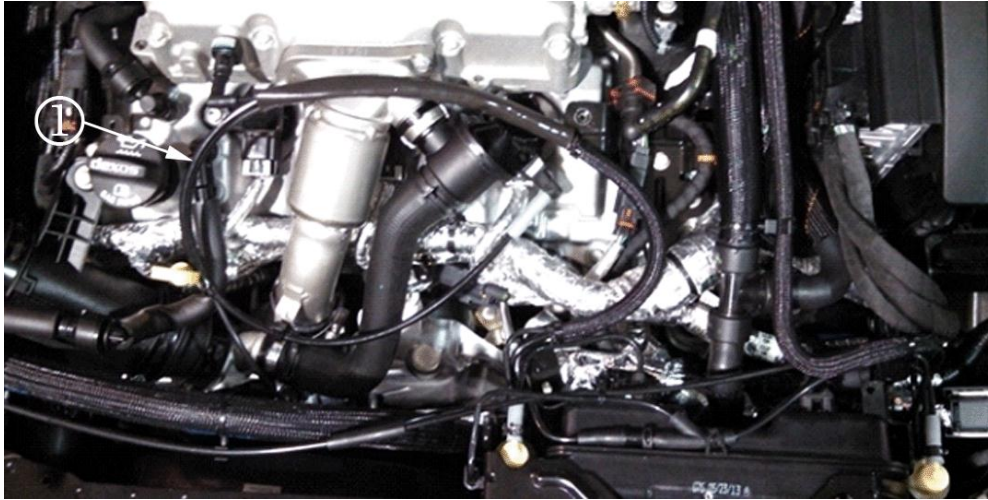
3609931

Correct Routing

- If the turbo charger wastegate actuator vacuum boost tube bundle (1) is routed correctly, no further action is required. Install the intake manifold cover and front compartment front sight shield. Refer to *Intake Manifold Cover Replacement* and *Front Compartment Front Sight Shield Replacement* in SI.

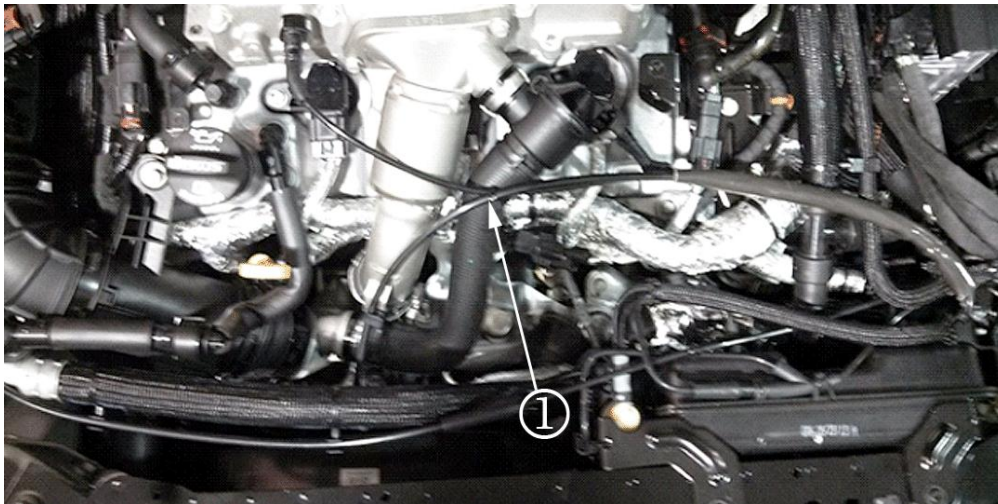
3609947

Incorrect Routing

- If the turbo charger wastegate actuator vacuum boost tube bundle (1) is NOT routed correctly, disconnect the tube bundle from the attachment points and re-route the tube bundle. Install the intake manifold cover and front compartment front sight shield AFTER completing the repair. Refer to *Intake Manifold Cover Replacement* and *Front Compartment Front Sight Shield Replacement* in SI. Refer to the following sections in this bulletin for information about how to correctly route the turbo charger wastegate actuator vacuum boost tube bundle:
 - Charge Air Bypass Valve Vacuum Tank Tube Routing and Connection Aids on Engine
 - Charge Air Bypass Valve Vacuum Tank Tube Routing and Connection Aids At Turbo Wastegate Regulator Solenoid

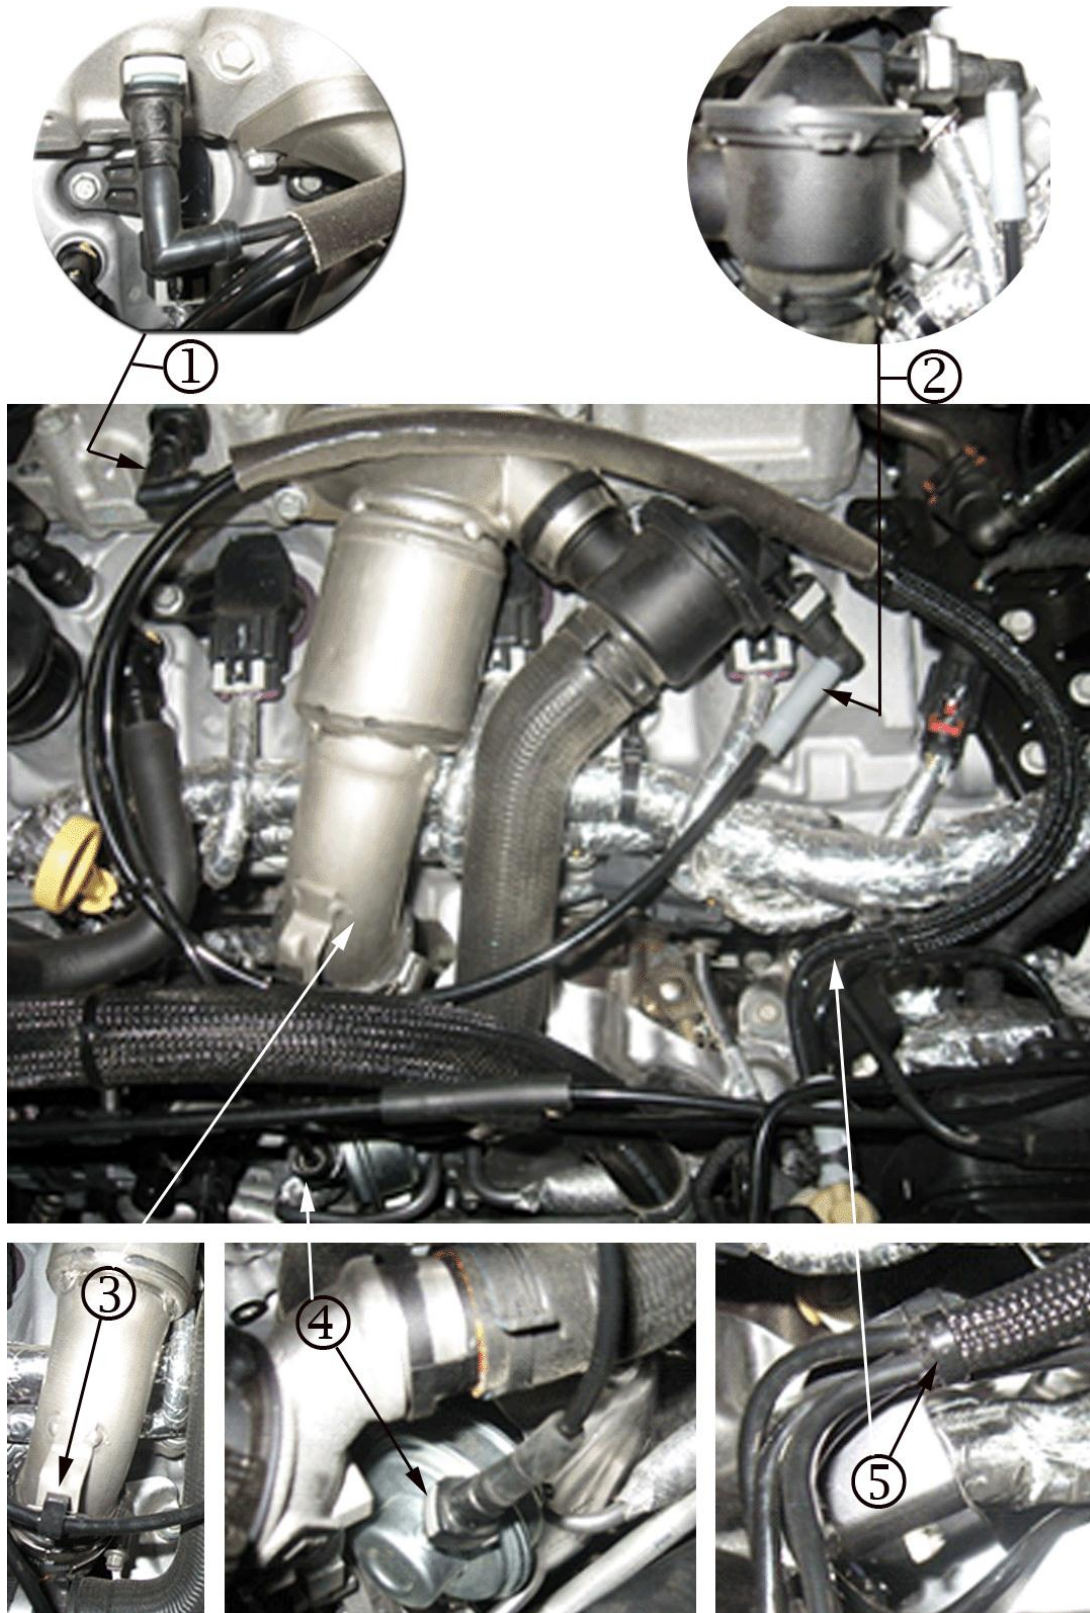
3609938

Charge Air Bypass Valve Vacuum Tank Tube Routing and Connection Aids on Engine

Black 90 Degree Connector (2) Gray 90 Degree Connector (3) Gray 90 Degree Connector Tube Attachment Clip Point (4) Black Straight Turbo Actuator Connection (5) Christmas Tree Fastener Attached to Bracket Hole

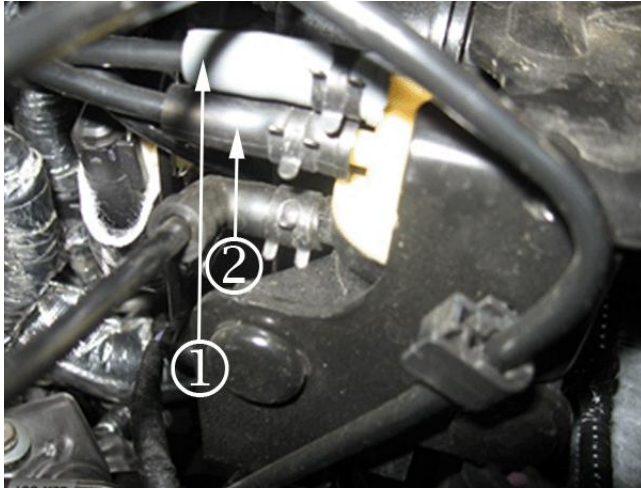
3609952

Charge Air Bypass Valve Vacuum Tank Tube Routing and Connection Aids At Turbo Wastegate Regulator Solenoid

- (1) Straight Gray Tube Connection (Side View)
- (2) Straight Black tube Connection (Side View)

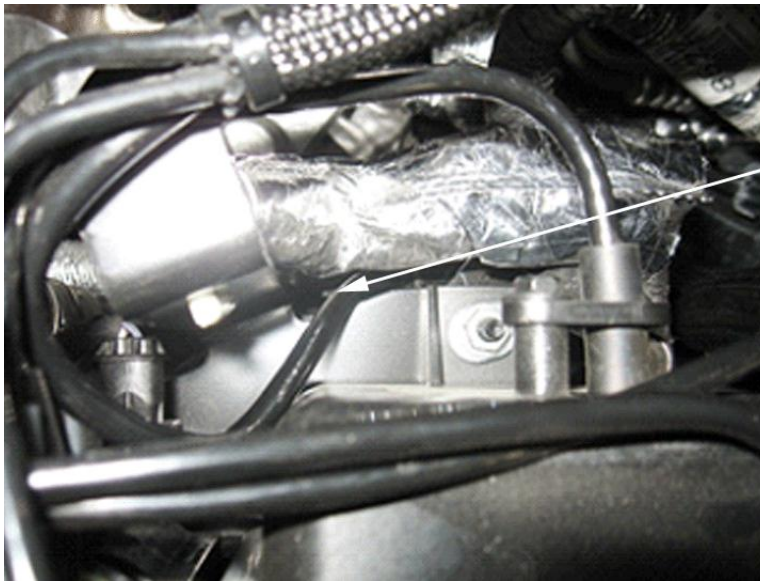
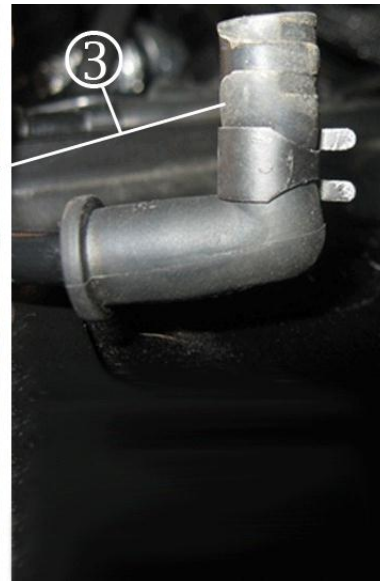
3609926

- (3) 90 Degree Black Connector Charged Air Bypass Valve Solenoid (Top View)
